## INTEGRATED APPROACH TO GAS TURBINE ROTOR CONDITION ASSESSMENT AND LIFE MANAGEMENT

**John Scheibel/Electric Power Research Institute**  
3420 Hillview Avenue; Palo Alto, California, USA  
650.855.2446  
Jscheibel@epri.com

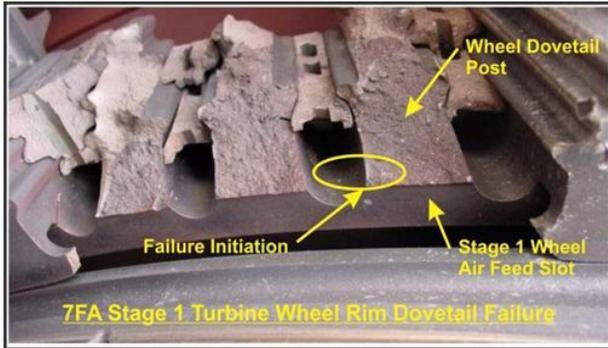
Since the rotor contains significant kinetic energy, sudden failure of rotating components represents various safety risks to personnel and equipment. An example of the substantial shortfall in expected rotor lives is the GE F-Class Stage 1 and stage 2 turbine wheel rim dovetail post cracking shown by Figure 1. These failures can happen in less than 50,000 hours and can cause additional millions of dollars in collateral damage to the gas path components. Other recent examples are the GE aft compressor rotor dovetail cracking on both the E-Class and F-Class turbines, resulting in a number of replacement Stage 17 compressor wheels. The Siemens V-X4.X Class turbines have similarly been identified to have significantly shorter lives due to premature embrittlement of the 12Cr turbine wheels. A failure incident related to compressor tie bolts on the Siemens-Westinghouse 501F resulted in extensive flowpath and rotor damage. The Alstom 11N's are also experiencing early retirement or shop rework due to turbine rotor life limiting design issues, such as the cracking in the turbine L-bore cooling channel. However, to date rotor damage has not resulted in outright catastrophic failure and safety impacts.

**Figure 1. Frame 7FA First Stage Rim Failure**

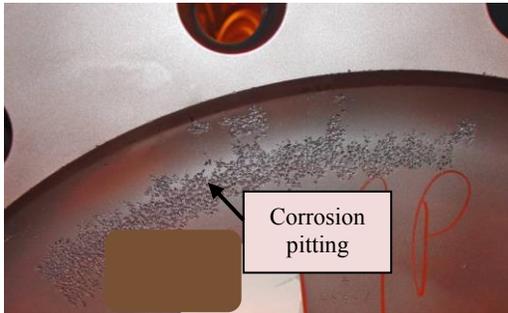
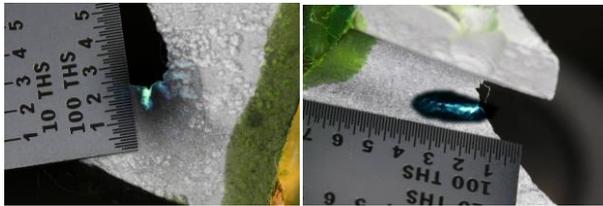
**Figure 3. Corrosion pitting of an IGT compressor disc (top) and fluorescent particle indication of a crack at blade attachment dovetail (bottom)**

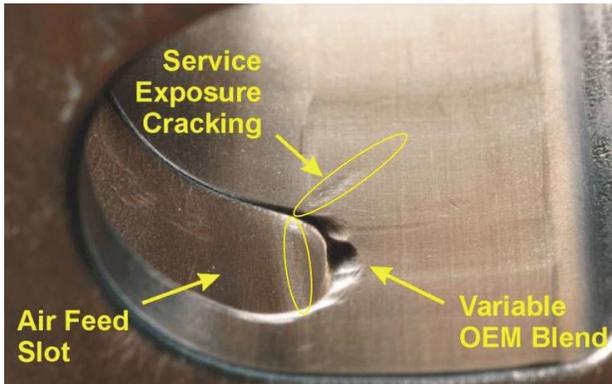
Cracking at the inlet air feed slot of a Frame FA turbine is shown in Figure 4.

**Figure 4. Air-feed slot crack at the first stage disc of a Frame FA rotor**

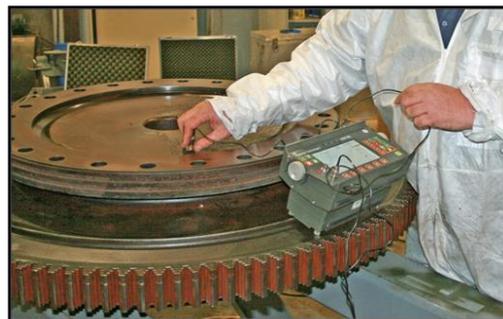
**Figure 12. Ultrasonic inspection of the MS 5001 first stage disc**

No detectable indications were reported by the various inspection techniques utilized to inspect this disc. However, minimum detectable crack size was used in the life assessment of the wheel by the fracture mechanics methodology described above.

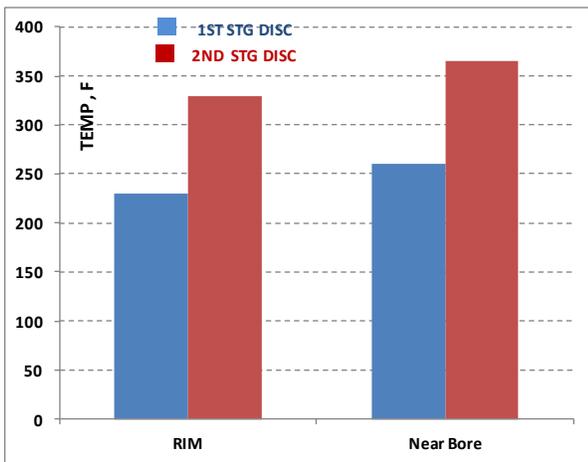
Chemistry testing revealed relatively high amounts of phosphorous and sulfur in the first stage disc. Given the pre-1980 steel vintage and long operating history, these impurities raised concerns that the material had embrittled. The rotor discs were subsequently sectioned and destructively tested. Figure 13 indicates the overall FATT results based on Charpy impact specimens and confirms embrittlement. The baseline FATT of 66C (150F) was established by testing de-embrittled heat treated material and colder rotor shaft end material. Small punch testing was independently performed. Figure 14 shows that the standard large specimen results correlated exceptionally well with miniature small punch samples. The difference in FATT ( $\Delta$ FATT) from the de-embrittled condition is (365 - 150 = 215F [119C]), This data shows that a significant degree of embrittlement occurred during service exposure in this disc and resulted in toughness loss (References 4,5).

Figure 13 FATT of the two as-received discs measured by Charpy impact testing at the rim and near bore regions showing significant temper embrittlement (FATT Increase) during service

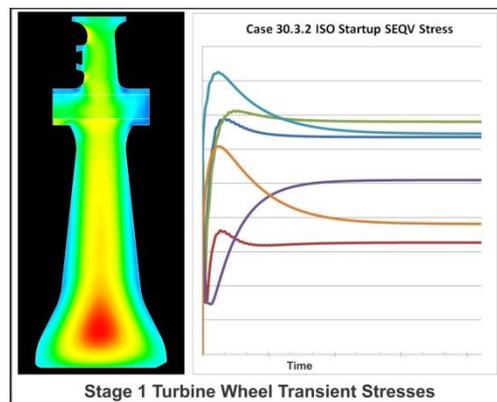
An example of the transient response of a turbine wheel during a cold start transient is shown by Figure 18. The stress peaking, when combined with the cold metal temperatures, could create a life limiting combination. The peak thermal stress occurs internally at about 3 in radius from the bore surface. The material fracture toughness is a strong function of temperature, with lower temperature resulting in lower fracture toughness. The aging turbine rotor material could further reduce the fracture toughness due to embrittling phenomena, if present. The life analysis evaluates the time dependent stress and temperature to establish the volumetric distribution of allowable flaw sizes.

**Figure 18. Example of transient stress versus time in a turbine disc during a cold start at a various distances from the bore surface**

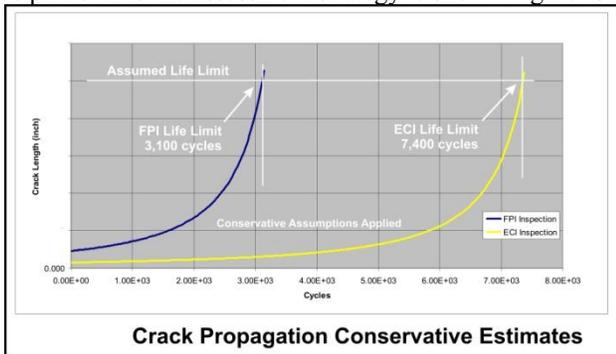
**Figure 19. Results of crack propagation analysis**

The assumed life limit is based on a critical crack size formation at the most life limiting location of the disc based on the structural analysis results. These curves are highly location and crack/defect orientation and local stress field dependent.
