HOT SECTION LIFE MANAGEMENT THROUGH IMPROVED MATERIAL PROPERTY RECOVERY

John Scheibel/ Electric Power Research Institute, **Rajeev Aluru**/ Duke Energy,
Hans van Esch, Stijn Pietersen/ Turbine End User Services

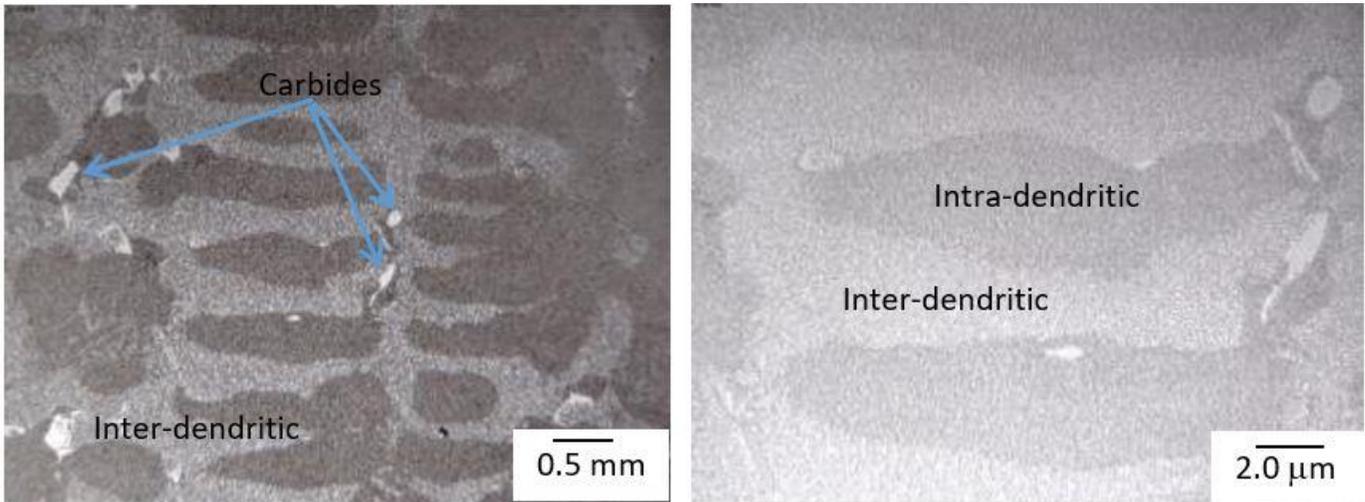
Scanning electron microscopy of the same sections was performed to study the gamma-prime morphology and distribution. Figure 3 provides representative detail on the inter-dendritic (outside the dendrite arm) and intra-dendritic (inside the dendrite) regions for reference. Figure 4 represents the microstructure of the bucket in as-run condition. The morphology appears to be different between inter-dendritic and intra-dendritic regions. The primary gamma prime of the inter-dendritic regions appear to be smaller and more cuboidal of shape than intra-dendritic regions. The size of gamma-prime was compared across different regions and the root section was assumed to be the baseline. The primary gamma prime at the TE was rounded and had grown significantly (1.0 - 1.8 μm , spherical), and the growth was somewhat less significant at the LE (0.7 - 1.2 μm , spherical / rounded). At the mid airfoil cross and longitudinal sections, the size of the primary gamma prime (0.7 - 1.0 μm , rounded) was just a little larger than the root (0.6 - 1.0 μm , rounded / cuboidal) and maintained almost the same shape compared to the root. The secondary gamma prime was mostly not present at the TE, less present at the LE and about the same size (0.10 - 0.20 μm) and shape (spherical) at the mid airfoil and root.

Figure 3
Representative Micrograph Showing Inter-dendritic and Intra-dendritic Regions. The picture on left shows dendritic microstructure and the one on right shows more detail on the difference in gamma-prime.

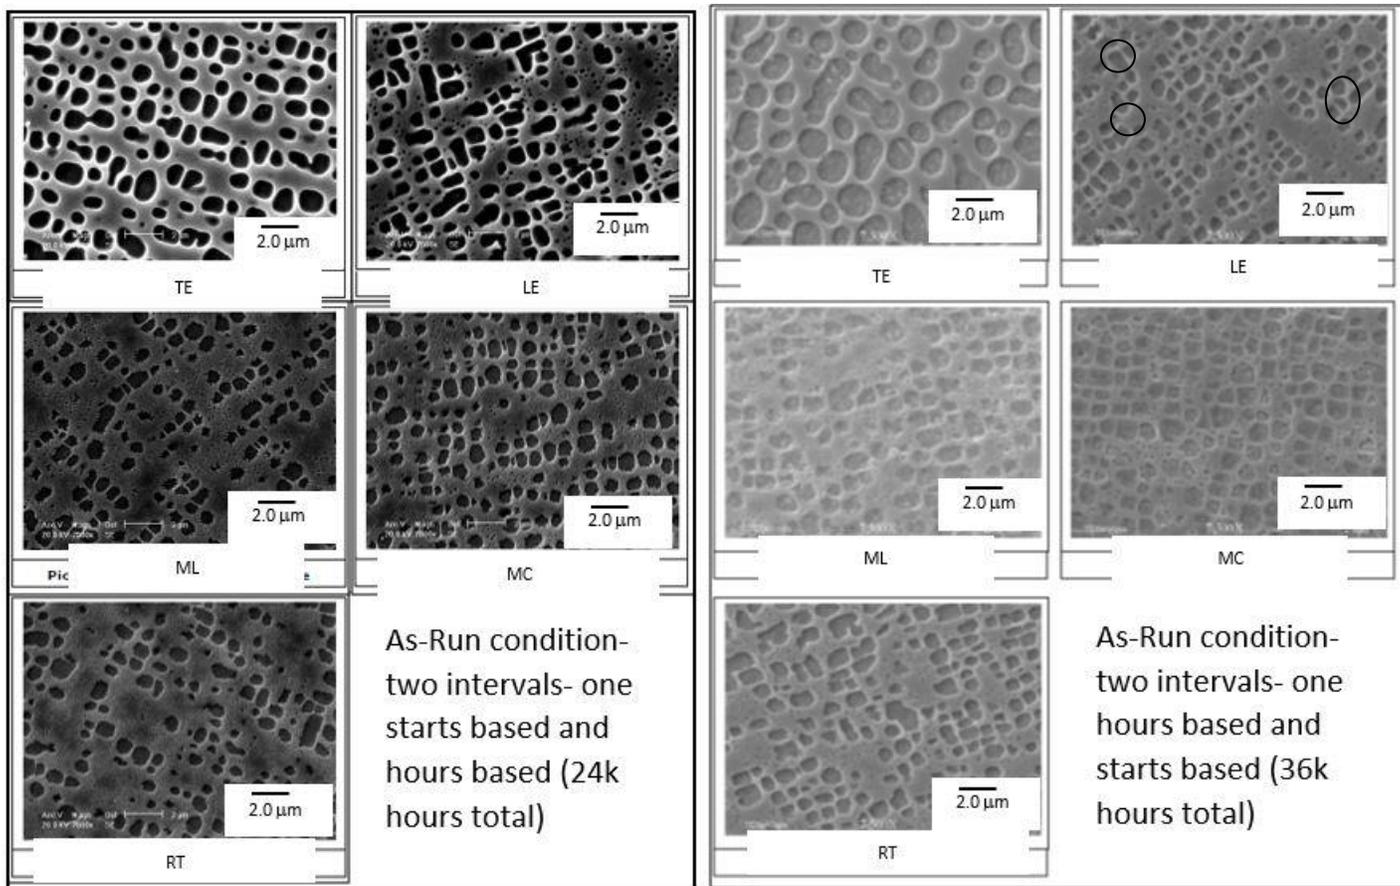
Figure 4

In summary, for the as-run buckets in different conditions, microstructural investigations on one-interval and two-intervals buckets revealed that the size of the primary gamma-prime increased significantly in the TE area (hottest regions of the bucket), and less significantly in the other areas of the buckets compared to the root section.

Microstructure of the Specimens Extracted from Buckets after Two Intervals-one starts based and on hours based in As-run Condition [buckets accumulated 24k total hours on the left and the ones accumulated 36k total hours on the right]. Details of sample locations are listed in Table 3.

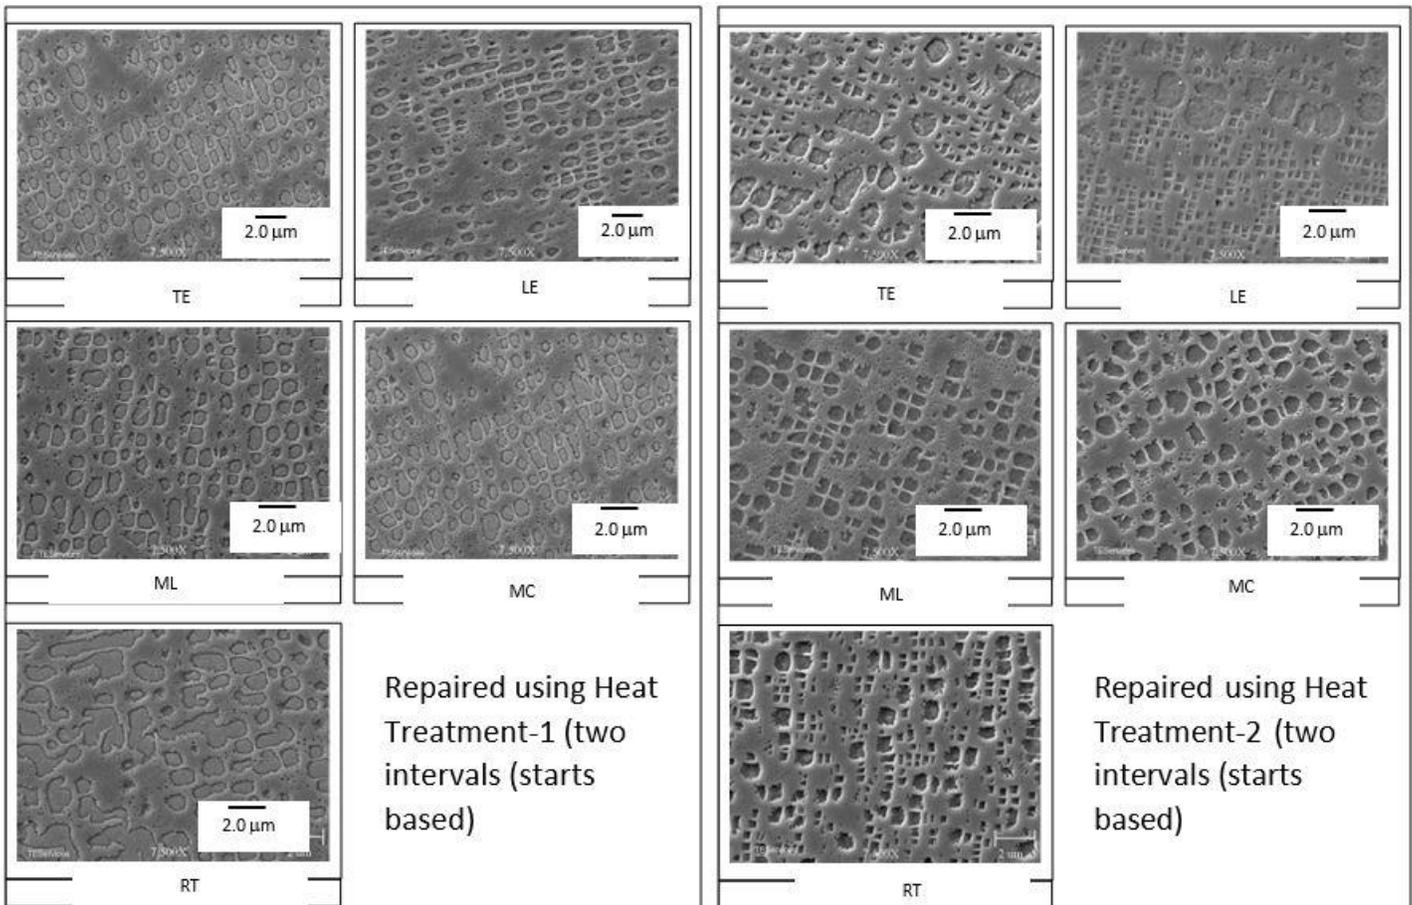
Repaired buckets included buckets processed in three conditions listed in Table 2. Scanning electron microscopy revealed significant differences of gamma-gamma prime morphology between different heat treatments. This can be seen in Figure 5 and Figure 6. Figure 5 represents the microstructure in buckets processed using heat treatment-1 and heat treatment-2, whereas Figure 6 represents the microstructure of the buckets processed using and heat treatment-3. It needs to be noted that the buckets from the same set were selected for as-received and different heat treatments so that accurate comparison of the microstructures with different heat treatments can be performed. Higher amounts of cuboidal primary gamma prime (0.4 – 0.5 μm) with some spherical shaped (0.10 – 0.15 μm) was observed in buckets processed using heat treatment-3 sequence. The size of gamma-prime in the non-dendritic and dendritic locations was observed to be in the range of (0.4 – 0.5 μm), and (0.8 –

Figure 5
Microstructure of the specimens extracted from buckets after two starts based intervals and treated with heat treatment-1 (on the left) and heat treatment-2 sequence (on the right). Details of the sample locations are listed in Table 3.

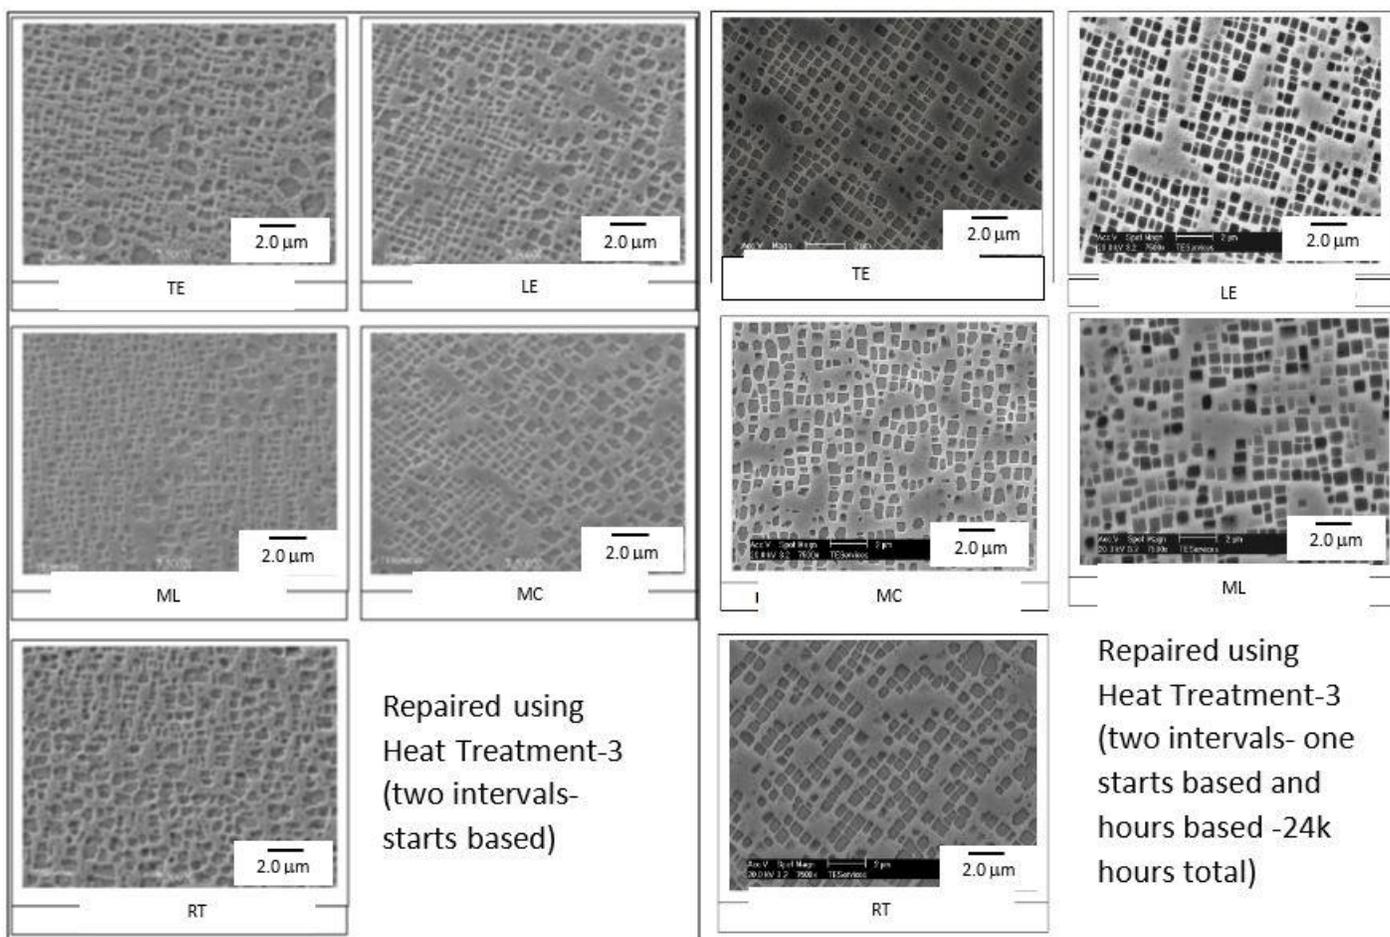
Microstructural investigations on repaired two-intervals buckets revealed that heat treatment-3 resulted in better morphology including refined gamma-gamma prime distribution and higher volume fraction. The average gamma prime size in heat treatment-3 is in the order of 0.4-0.5 μm as opposed to 0.8-1.0 μm in the case of other heat treatments. In addition, heat treatment-3 resulted in smaller secondary gamma-prime size and lower volume fraction compared to the other heat treatments. Hence, it appears that heat treatment-3 results in an optimized microstructure similar or better than the original condition. This size distribution and the possible impact of the microstructure on mechanical properties will be discussed in the next section.

Figure 6
Microstructure of specimens extracted from buckets processed using heat treatment-2 and heat treatment-3 sequence. Details of the sequence are listed in Table 3.

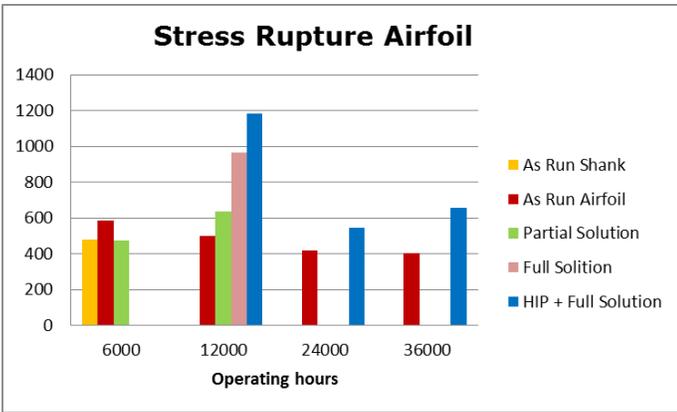
The stress rupture testing results of the partial heat treatment specimens at 6000 hours are comparable to the As Run results. (As Run is the condition after operation without heat treatment performed). This indicates that this heat treatment does not positively or negatively change the stress rupture life, see Figure 9. The heat treatments HIP + full solution, full solution and partial solution do result in increased stress rupture lives for the 12000 hours specimens compared to As Run and even new. This indicates that the heat treatments performed at new manufacturing were not optimal.

Figure 7
Average values of airfoil specimen stress rupture strength

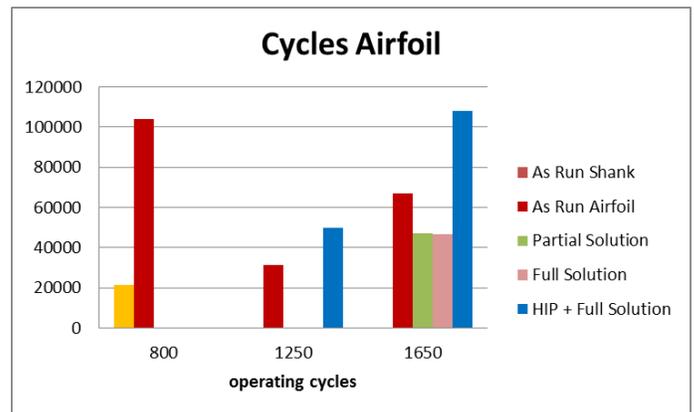
For the 1650 cycle specimens, the partial solution and the full solution heat treatment results in a lower LCF life (although higher than was measured for 1250 cycle As Run), while the HIP + full solution heat treatment increased the LCF life, see Figure 12.

Figure 10
Average LCF life of airfoil specimens

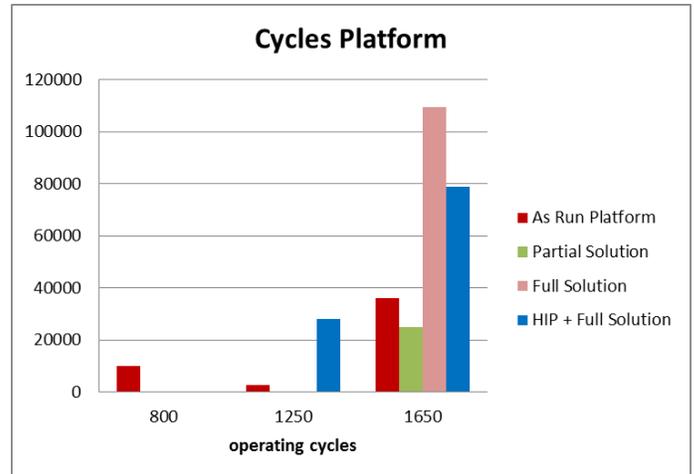
For the 1650 cycles platform specimens, full solution heat treatment gave the best LCF life, followed by the HIP + full solution heat treatment and the partial solution heat treatment, see Figure 16. Note: The partial solution heat treatment results were lower than the As Run LCF tests. The number of test specimens was limited and the LCF data also showed a significant scatter and therefore more LCF testing is required to substantiate above observations.

Figure 13
Average LCF life of specimens extracted from the platform
