Extending the Life of F-Class Gas Turbine Rotors for Improved Operational & Maintenance Costs

Dr. Scott Keller
 Technical Lead, Structures
 October 10, 2018

IGTC
 International Gas Turbine Conference

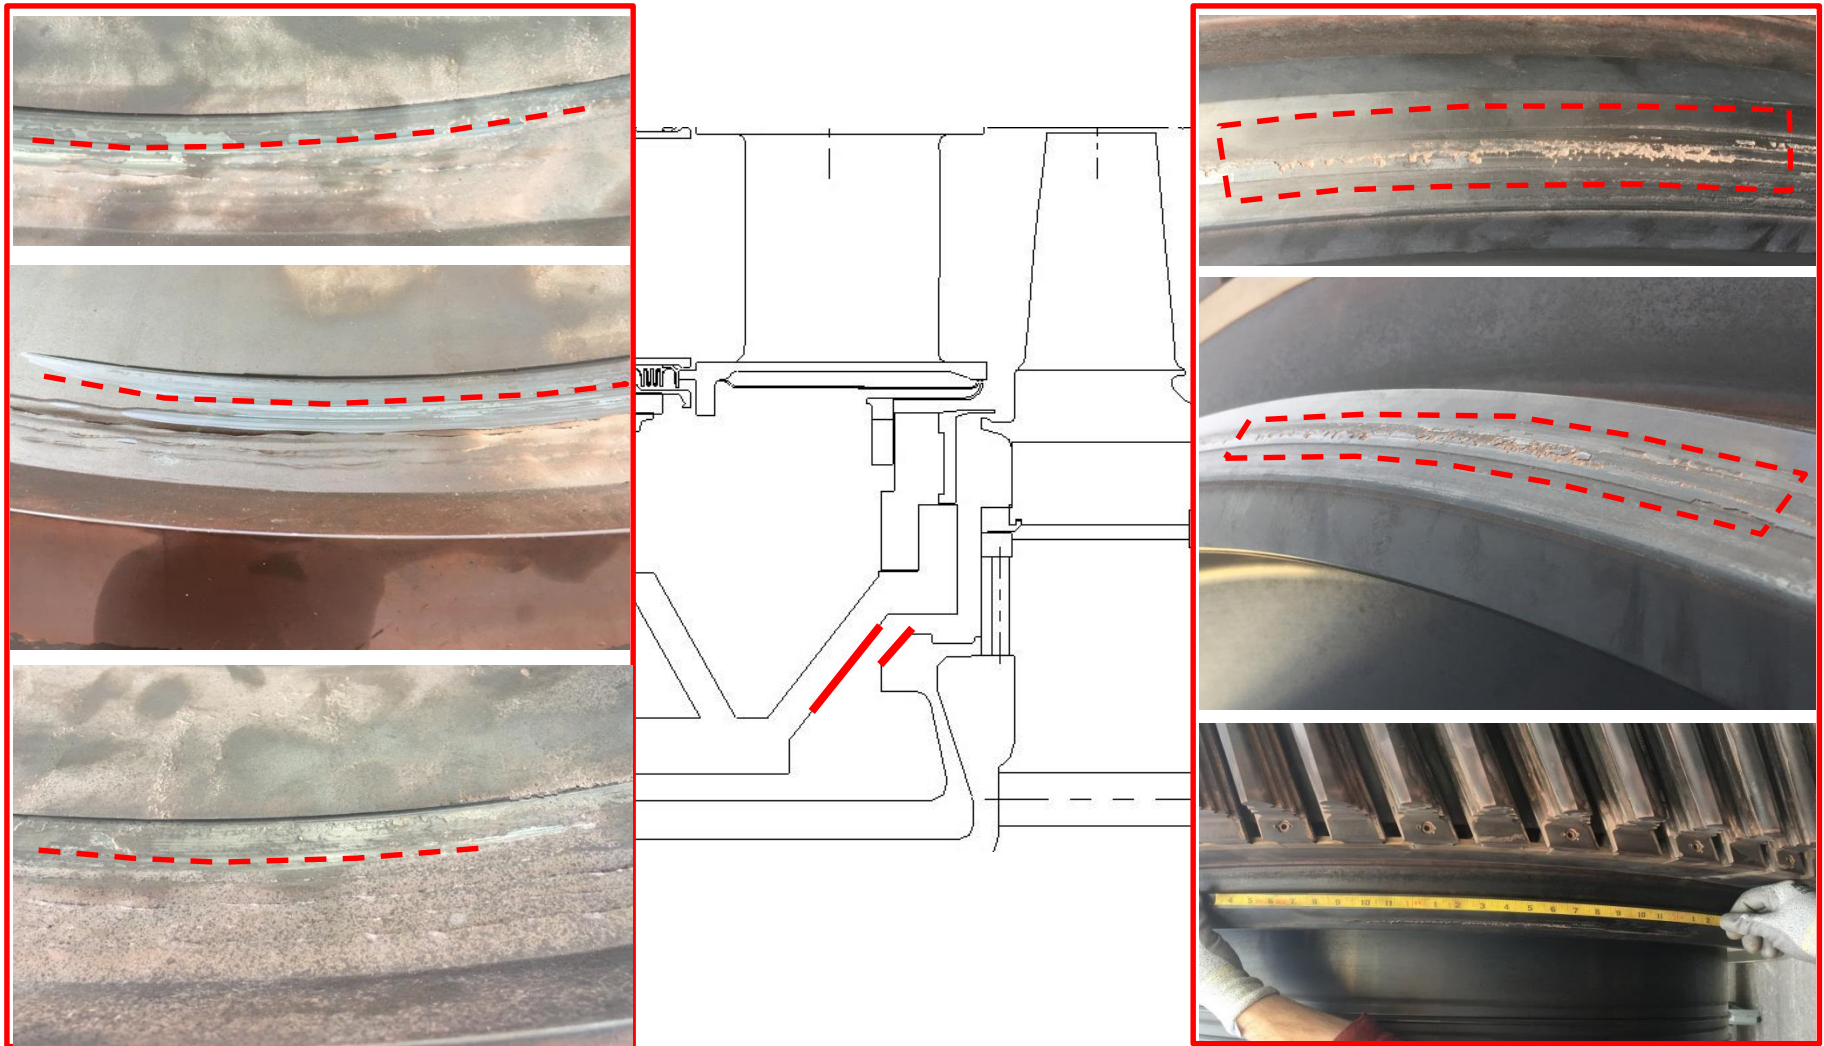
Inspect Rotating Components for Interaction with Static Structure

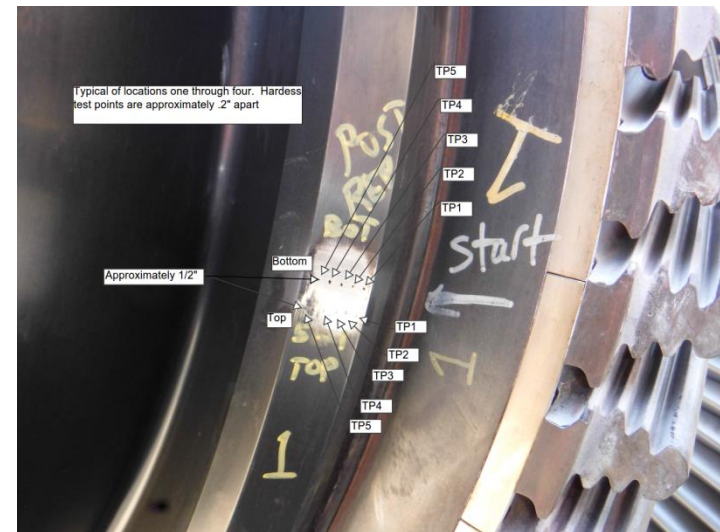
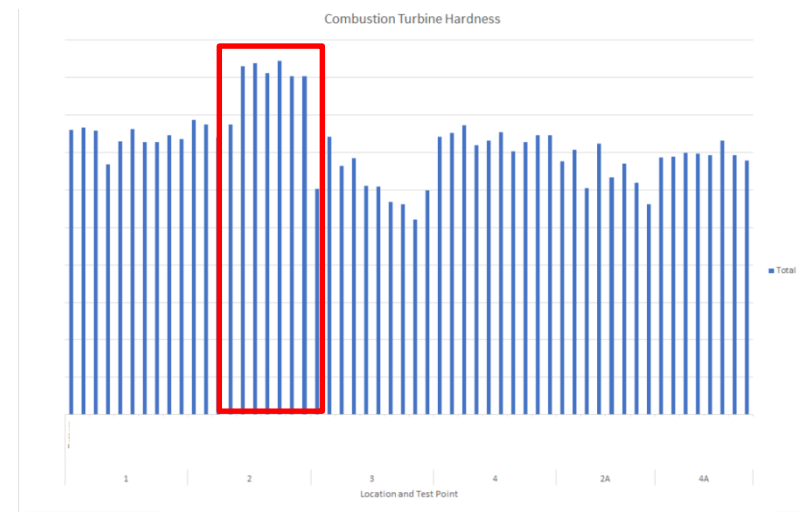
- Onsite replication and hardness measurements to understand material condition
 - Measured circumference of Hammer Head
 - Control measurements made near cooling holes
- Elevated hardness measured in locations of heavy rub
 - Signs of significant overheating
 - Potential for material embrittlement
- Proposed onsite machining

Combustion Turbine Hardness

Must Remove Hardened Material to Restore to Baseline Material Properties

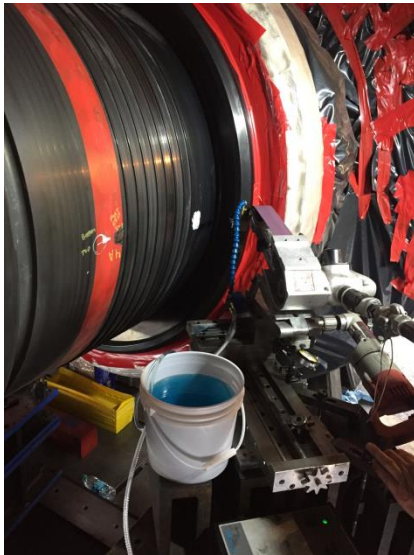
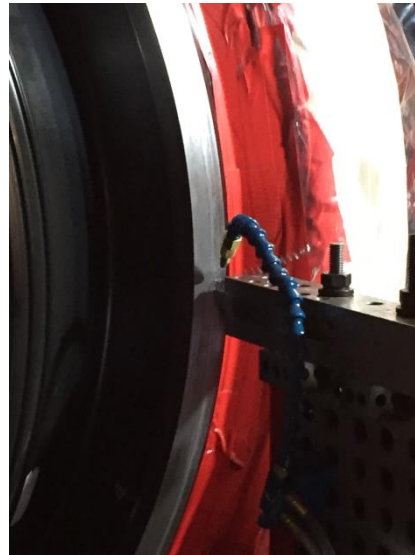
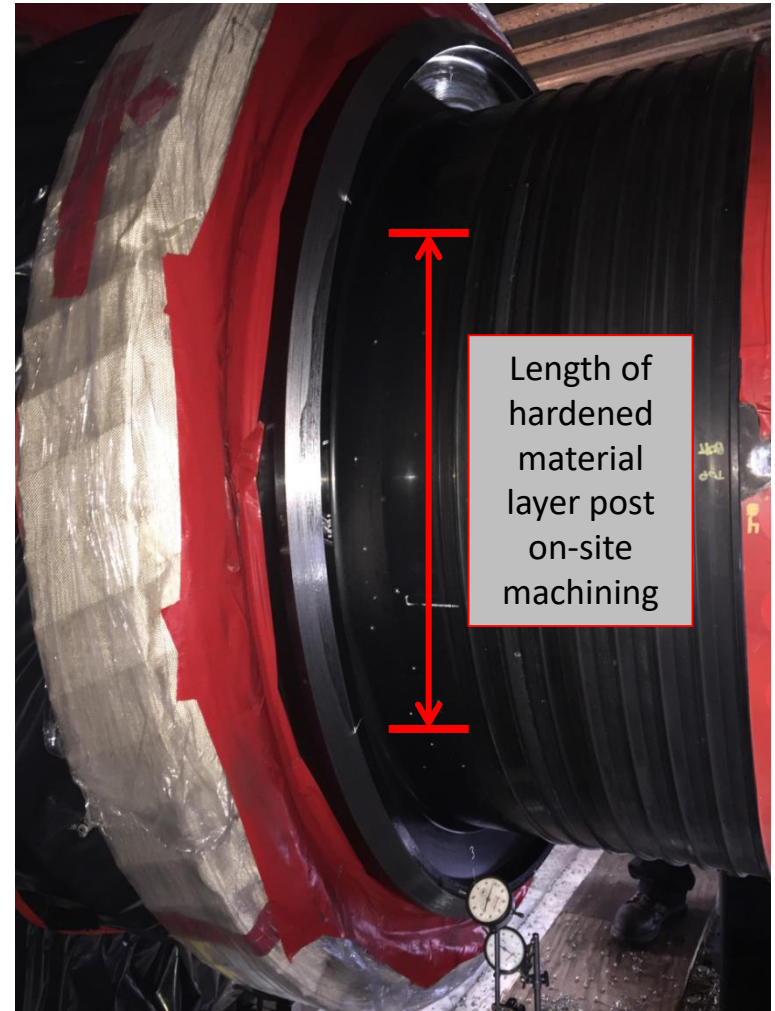
- Field lathe used to grind/machine hardened material
 - Maximum depth defined via FE analyses
 - Hardness remained elevated at maximum depth
 - High risk – customer opted to replace

Unsuccessful Onsite Material Removal Resulted in Rotor Shop Visit for LTE

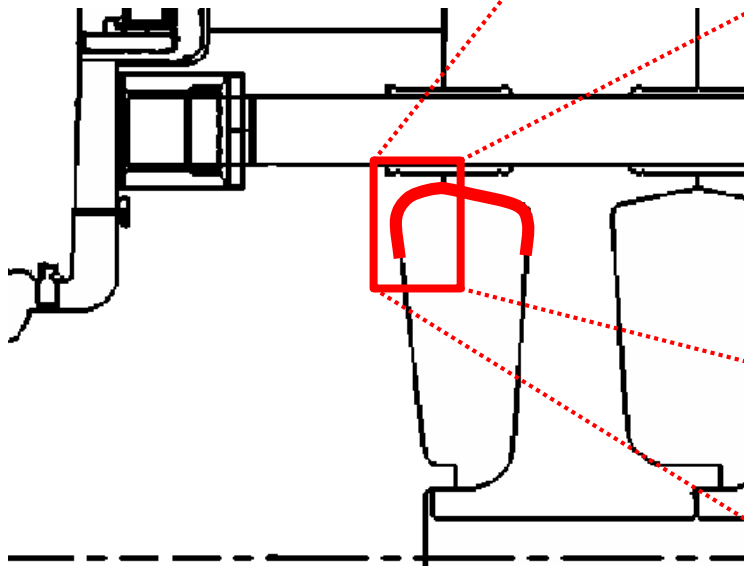
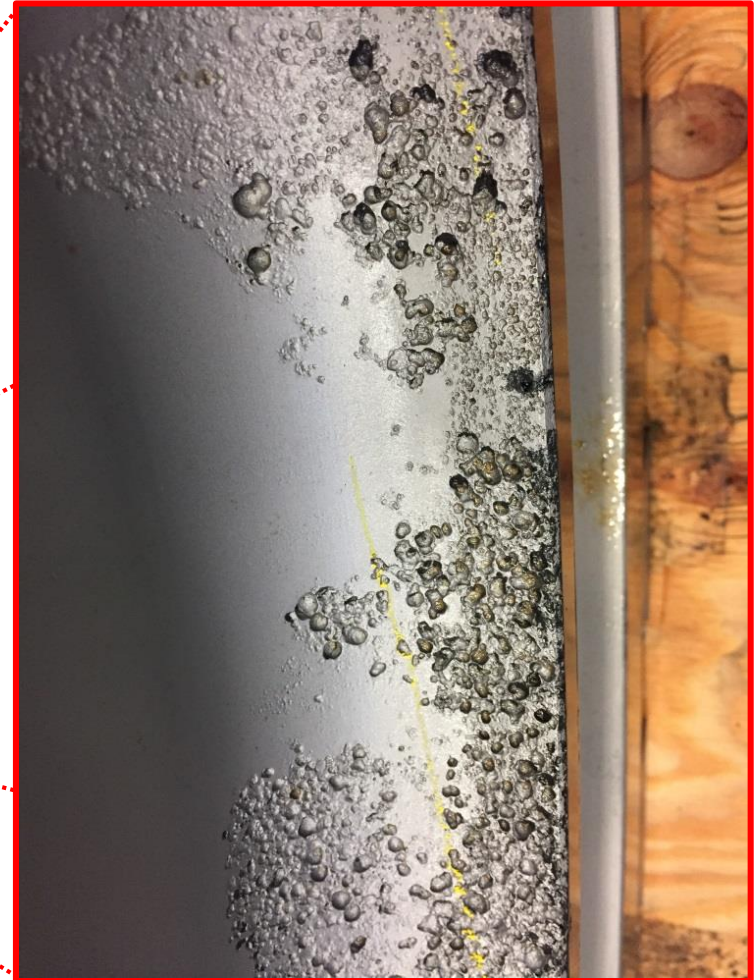
- Disk web pitting

- Pitting observed in the inner cavity of two disks near contact surface
- “Wormholing” apparent in several pits, with some near the contact faces

Extensive Wormholing Observed in a Moderately Stress Location

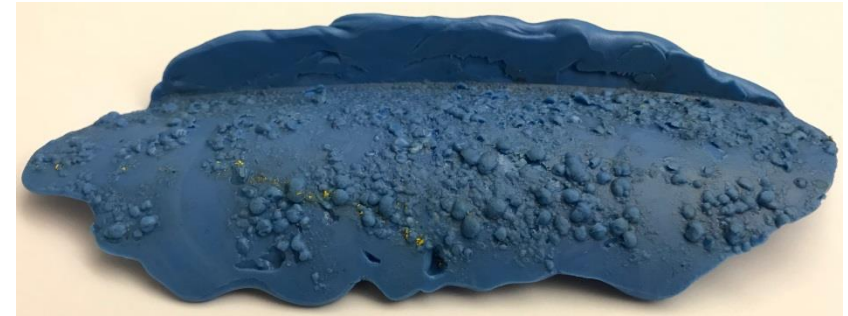
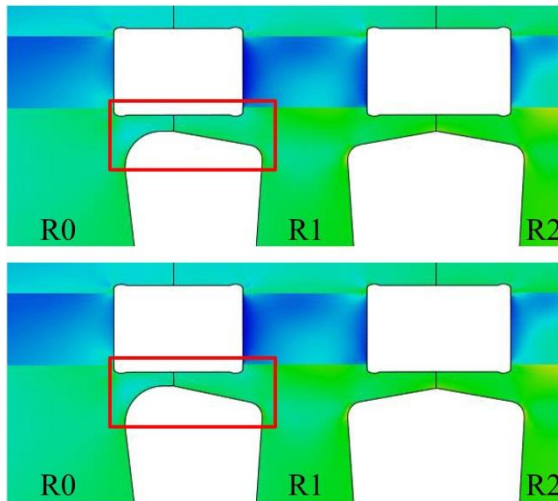
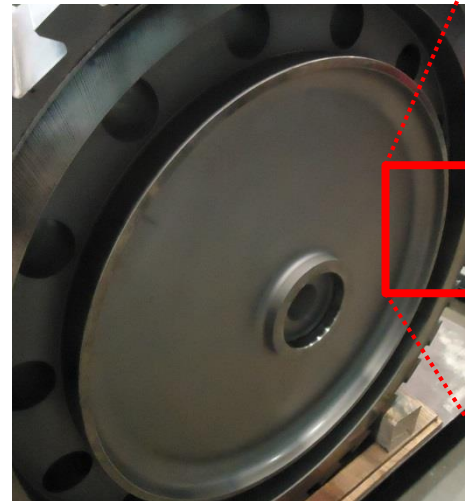
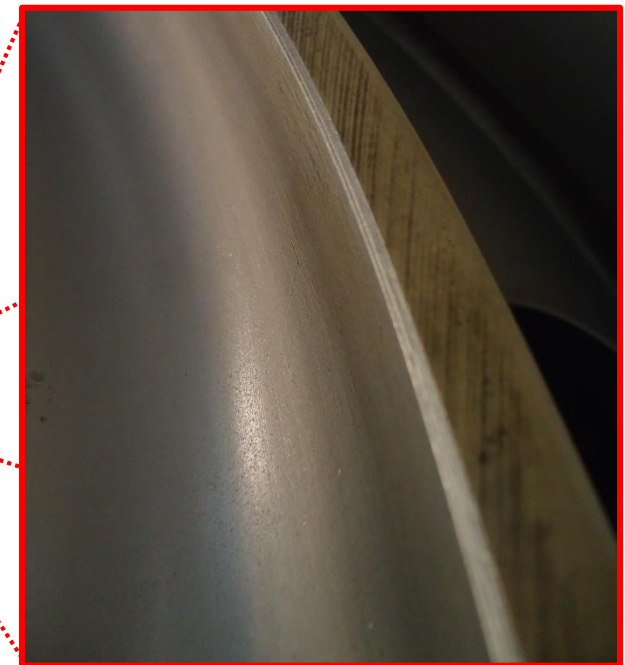
Transient Rotor Analyses Utilized to Provide Envelope for Pitting Removal

- Repaired developed to remove pitting from internal surfaces
 - Depth understood via replications
 - Transient FE analyses completed to define envelope of allowable material removal
 - Final machining based on maximum depth and re-worked to disk webbing

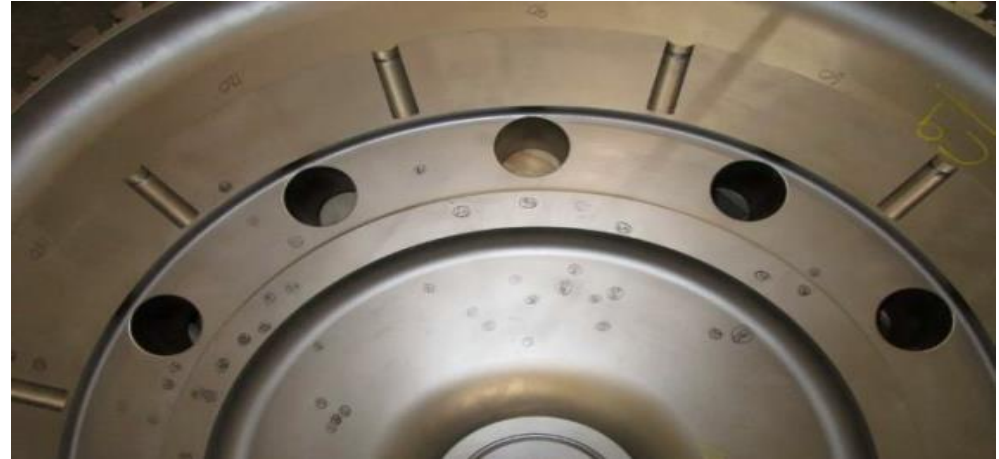
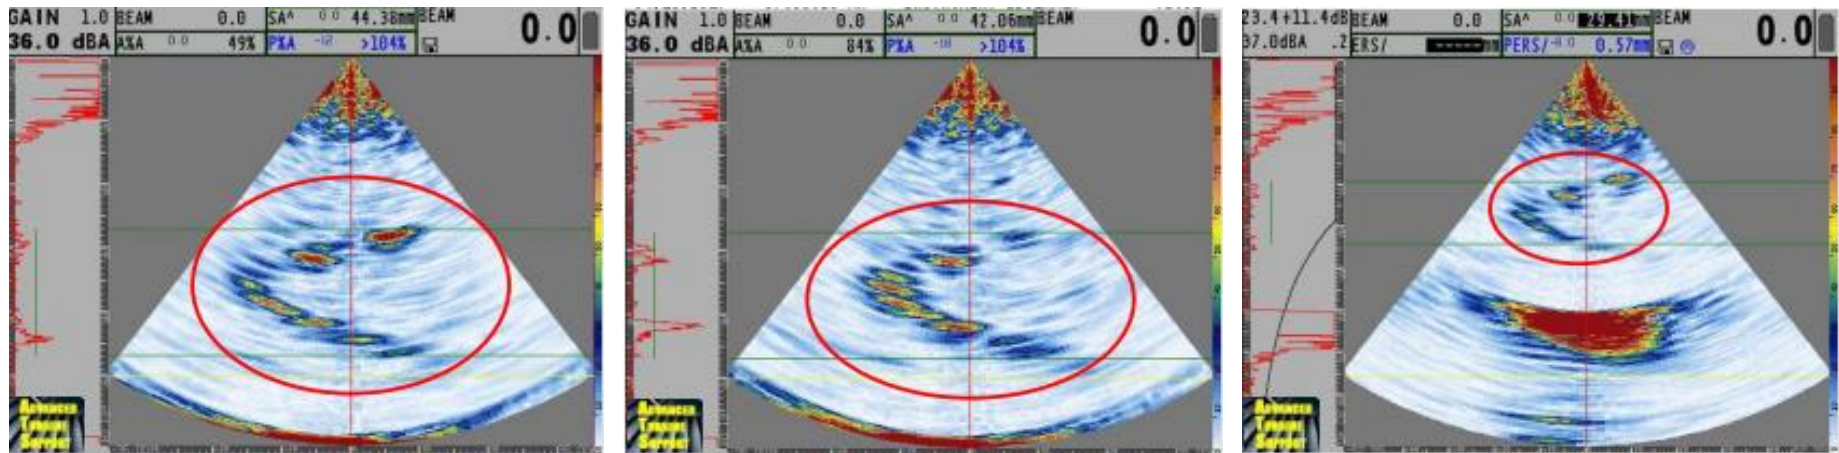
- Forgings defects discovered throughout disk
 - Over 60 indications recorded
- Linking up of multiple indications
- Total length – > 19mm

Significant Flaws Discovered in Cold End – No Visual Indications

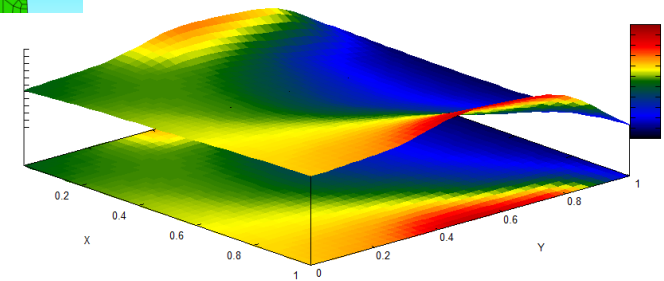
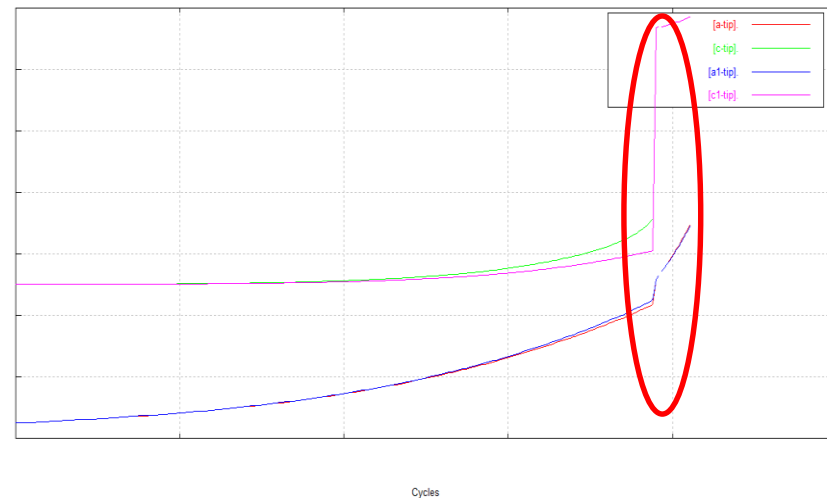
- Stresses pulled from transient rotor model
- Fracture analysis of embedded flaws via NASGRO
- Rotor life limited due to size of flaws
 - Original OEM lifetime acceptable, but...

Component Would Not Make Requested Interval – Replacement Necessary
