Hot Section Life Management Through Improved Material Property Recovery

John Scheibel
Electric Power Research Institute

Rajeev Aluru
Duke Energy

ETN Brussels, Belgium
October 11, 2018

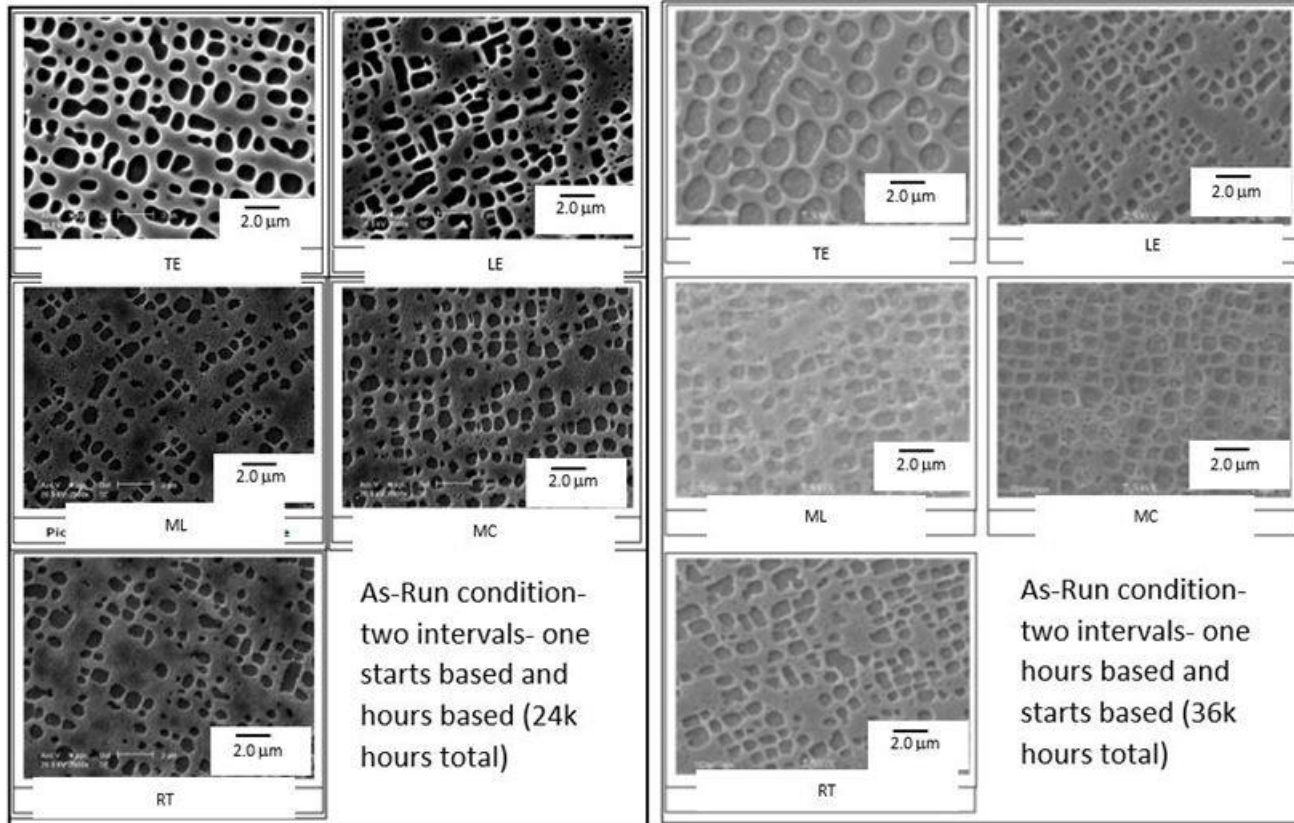
Microstructure of Specimens – As Run Condition

- Microstructures are of two intervals buckets with an unknown repair after its first cycle
- Metallurgical structure of base material (carbide and gamma prime) have coarsened, grain boundaries sensitized by presence of elongated carbides, and needle-like phases with gamma prime eutectics were observed
- Primary gamma prime had grown significantly at the inter-dendritic regions of the TE and less significantly at LE

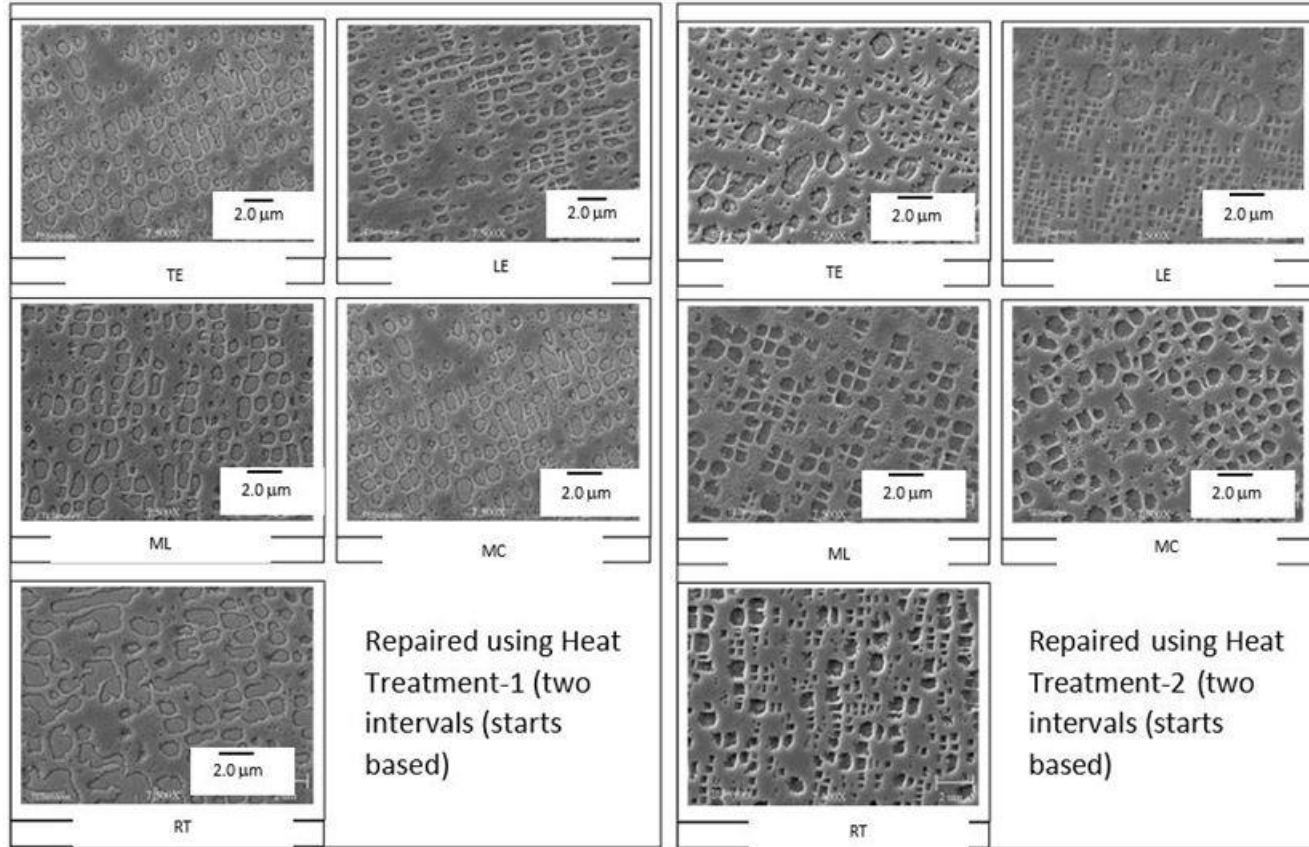
Microstructure of Specimens – Repaired Condition (Partial and Full Solution)

- Microstructures are of two intervals buckets (starts-based) repaired with partial solution (left) and full solution (right) heat treatments
- Buckets from the same set were selected for As Run and different heat treatments, so an accurate comparison of microstructures for different heat treatments can be performed
- Large rounded primary gamma prime (0.8-1.2 μm) were observed in inter-dendritic regions.

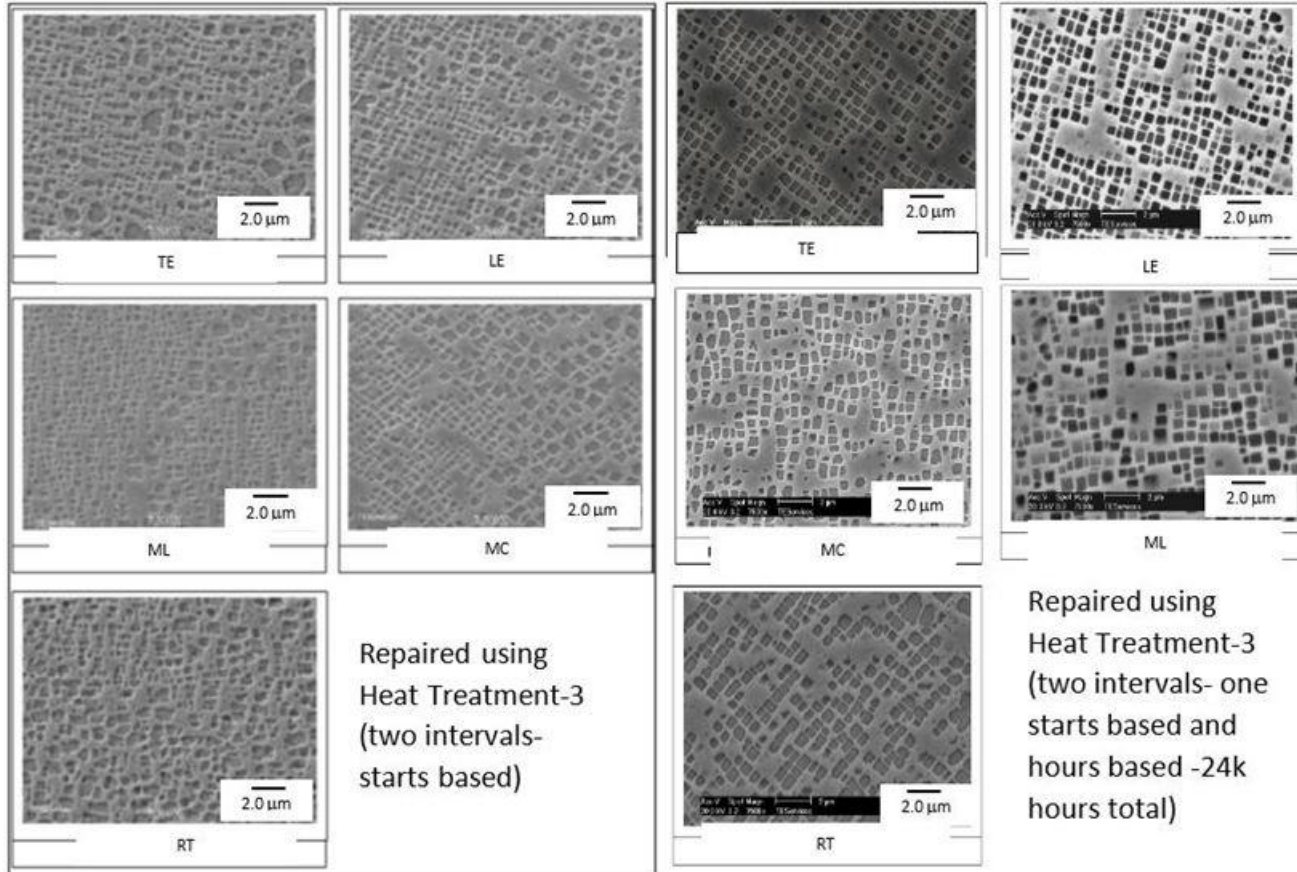
Microstructure of Specimens – Repaired Condition (HIP + Full Solution)

- Microstructures are of two intervals buckets repaired with HIP + full solution for starts-based (left) and one starts-based and one hours-based 24k total hours (right)
- Higher amounts of cuboidal primary gamma prime (0.4-0.5 μm) with some spherical shaped (0.10-0.15 μm) were observed
- The size of gamma prime in the interdendritic and dendritic locations was observed to be in the range of 0.4-0.5 μm and 0.8-1.0 μm, respectively

HIP + full solution heat treatment followed by full solution heat treatment resulted in an optimized microstructure similar to or better than original condition

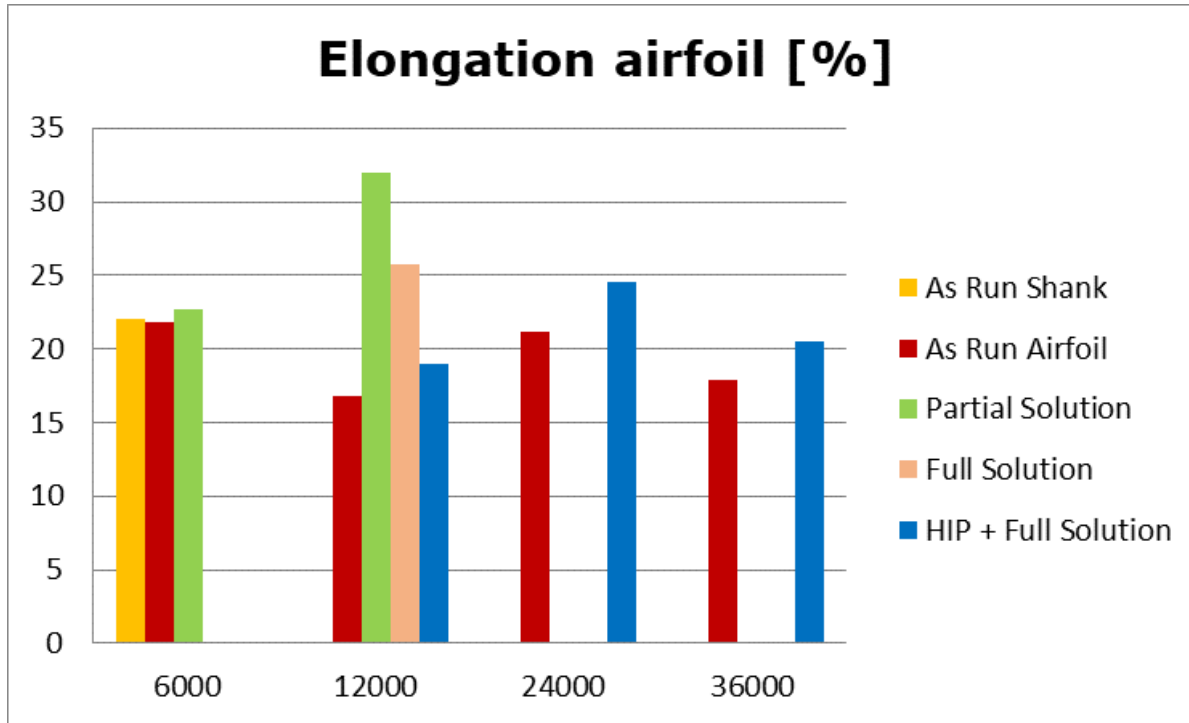
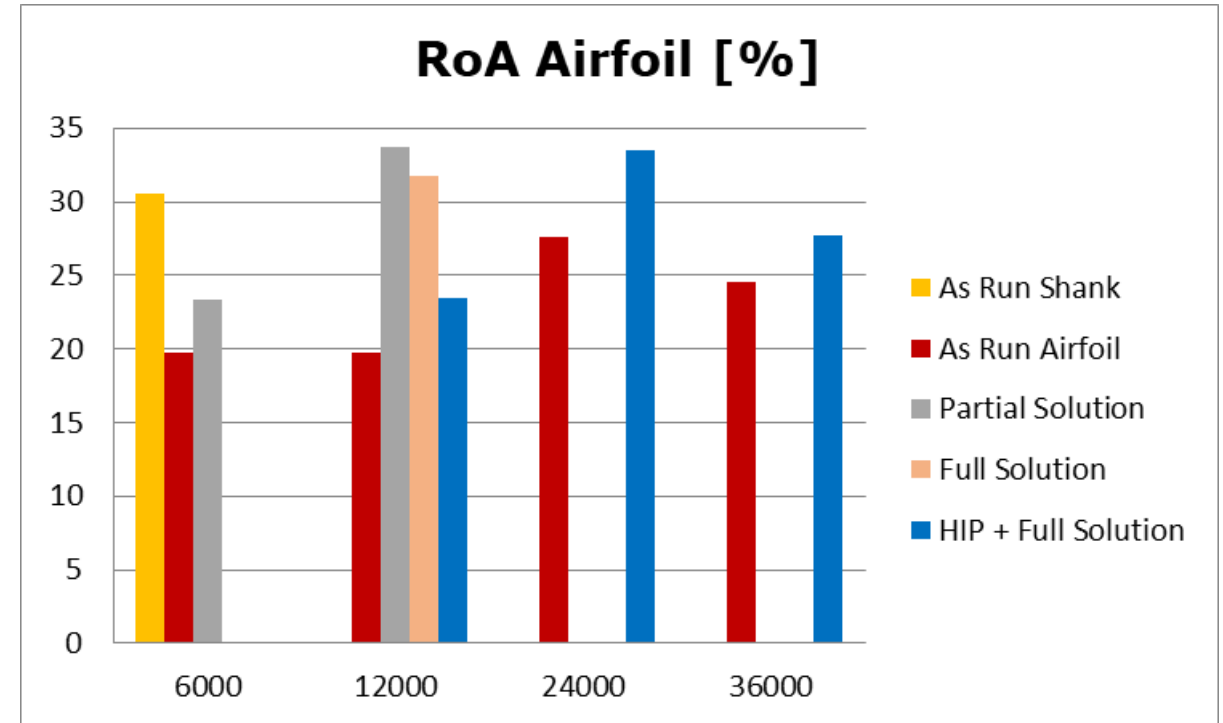
Average Elongation and Reduction of Area

- Elongation and Reduction of Area are measures of ductility
- In general, no significant differences were observed
- The Partial Solution at 12000 hours may be an exception but may also be an outlier due to low number of tests performed

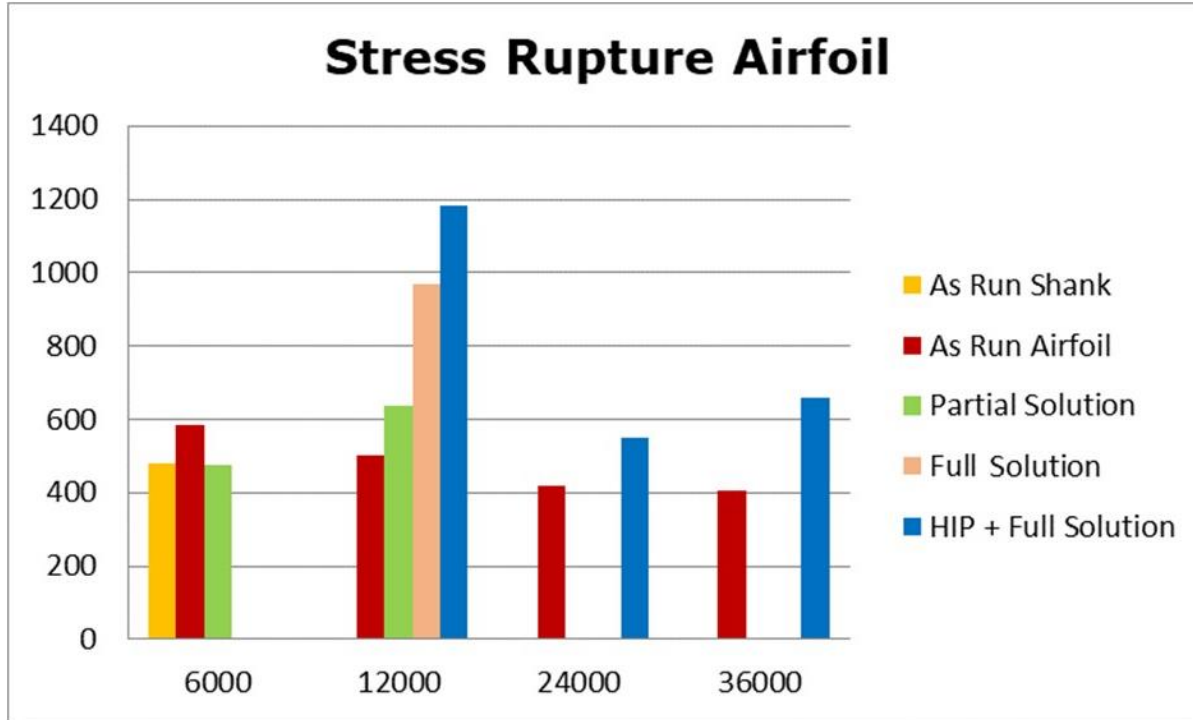
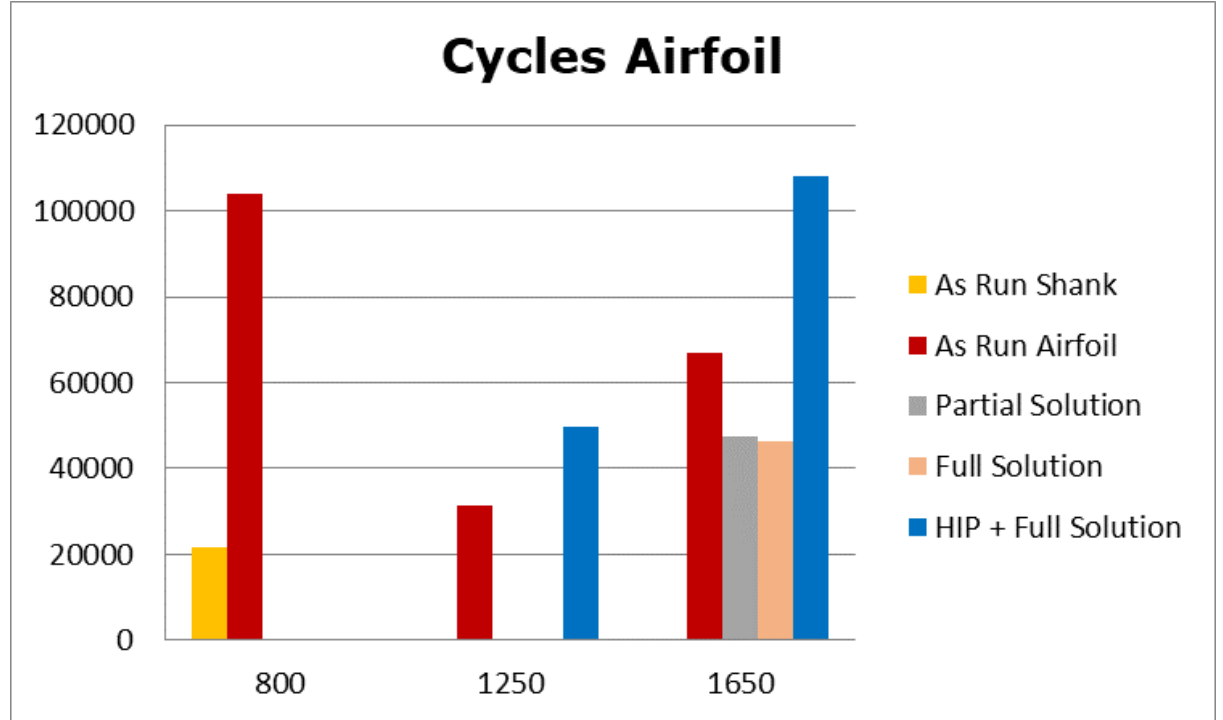
Average Stress Rupture Life and Low Cycle Fatigue Life

- At 6000 hours, stress rupture of As Run Airfoil is comparable to As Run Shank, indicating minimal degradation of strength during operation. Also, partial solution heat treatment had minimum effect.
- At 12000 hours, all three heat treatments resulted in increased stress rupture lives

- Results based on limited number of specimens
- For 800 cycle specimens, low LCF life of root compared to airfoil may be due to casting differences in root
- For 1650 cycle specimens, the partial and full solution heat treatments result in lower LCF life, while HIP + full solution increased LCF life

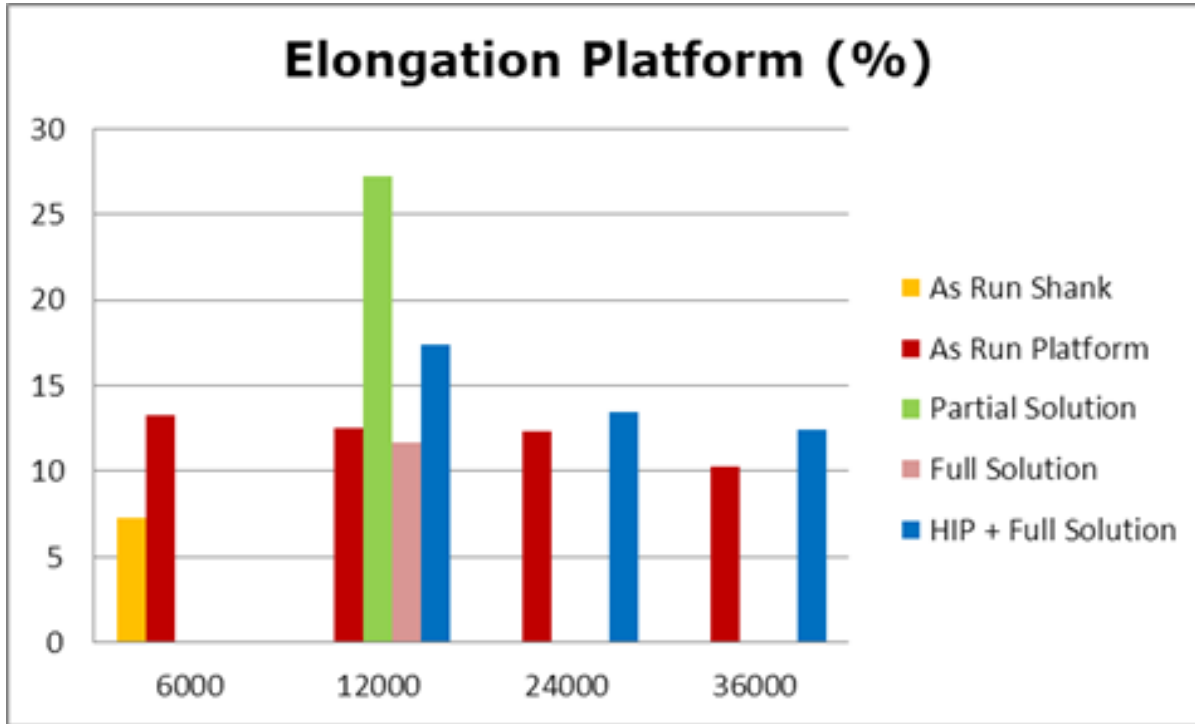
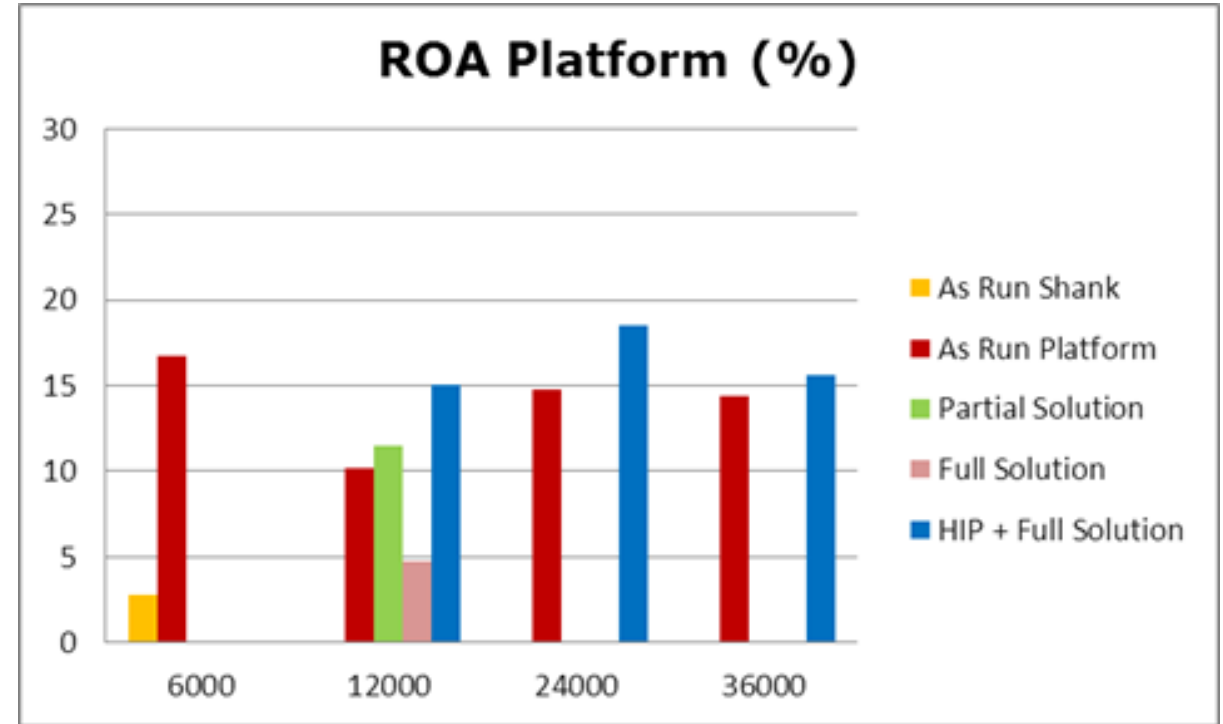
Average Elongation and Reduction of Area

- For As Run condition at 6000 hours, ductility of root is lower than platform (with equiaxed grain structure)
- No substantial differences in ductility for HIP + Full Solution and Full Solution
- High ductility (elongation) at 12000 hours with Partial Solution not observed in Reduction of Area at 12000 hours

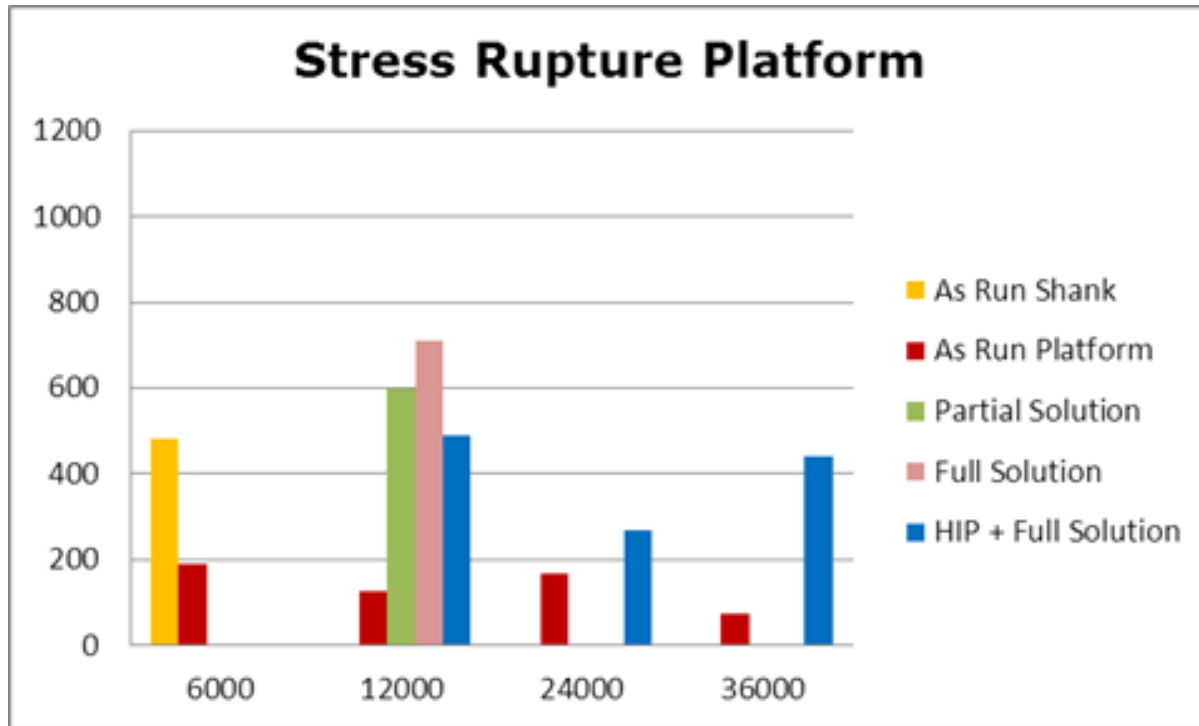
Average Stress Rupture Life and Low Cycle Fatigue Life

- At 6000 hours, low stress rupture life of platform likely due to grain structure (equiaxed with large grain in middle)
- At 12000 hours, specimens showed improved stress rupture with all heat treatments
- At 24k and 36k hours, HIP + full solution improved stress rupture

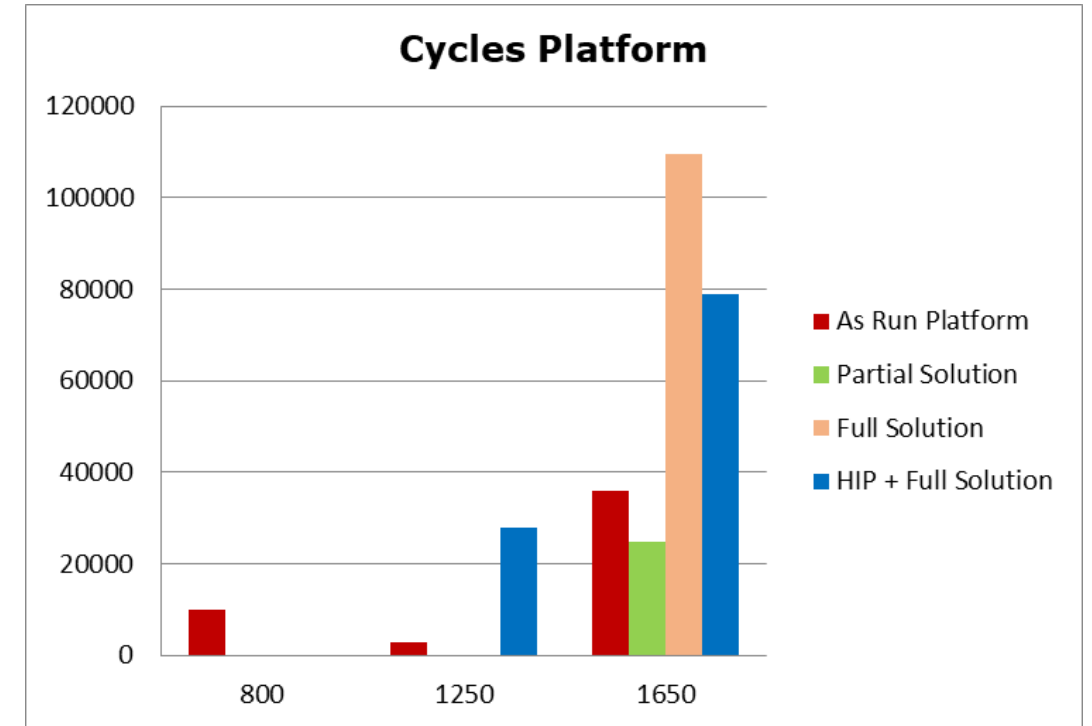
- For the 1650 cycles specimens, Full Solution resulted in the highest LCF life.

Note Partial Solution results were lower than As Run (likely due to limited number of test specimens and significant data scatter)
