## EXTENDING THE LIFE OF F-CLASS GAS TURBINE ROTORS FOR IMPROVED OPERATIONAL & MAINTENANCE LIFE CYCLE COSTS

Scott Keller, Power Systems Mfg., LLC., (PSM)  
Ansaldo Energia Group

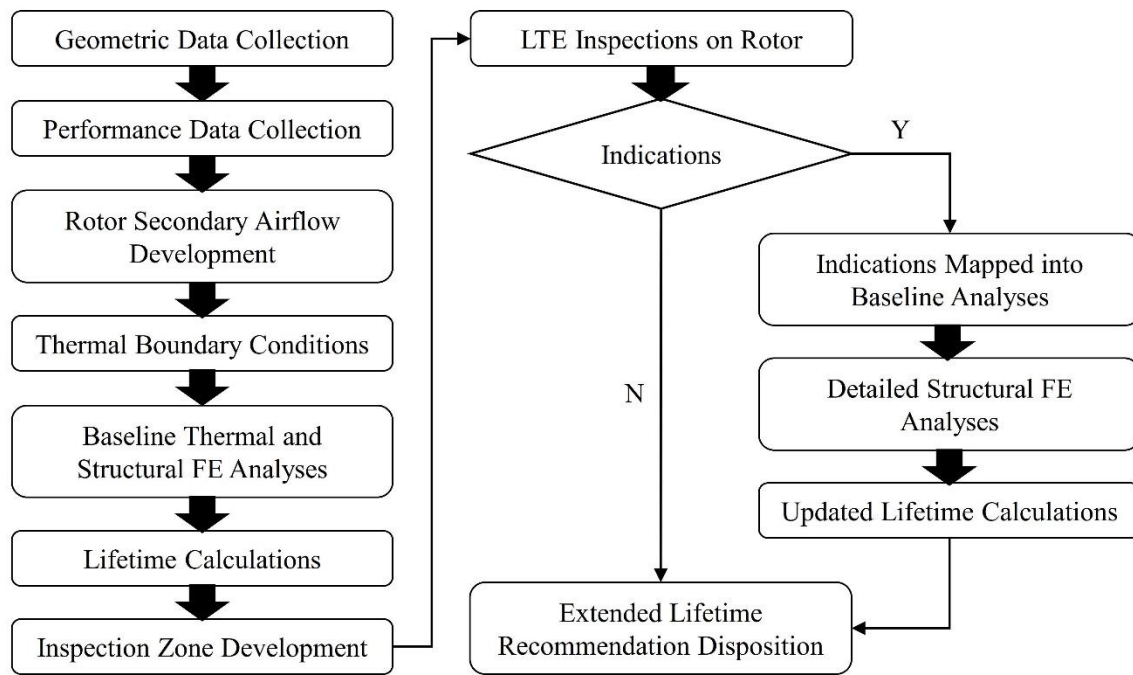
Figure 1: Rotor lifetime evaluation flow chart.

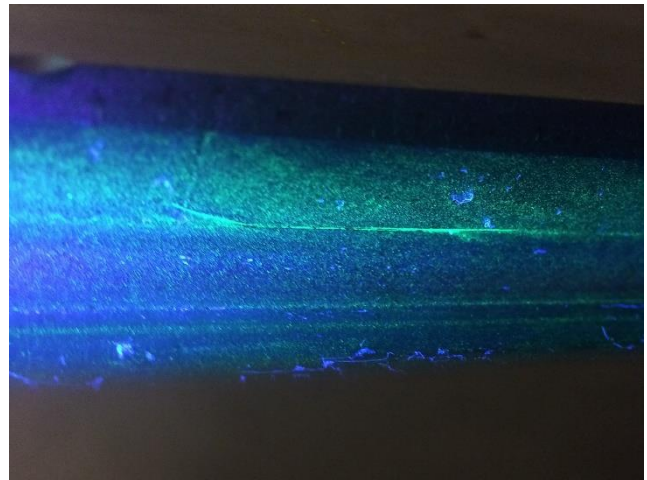
*Figure 2: Surface-exposed crack discovered in a disk attachment near the edge of contact with the blade.*

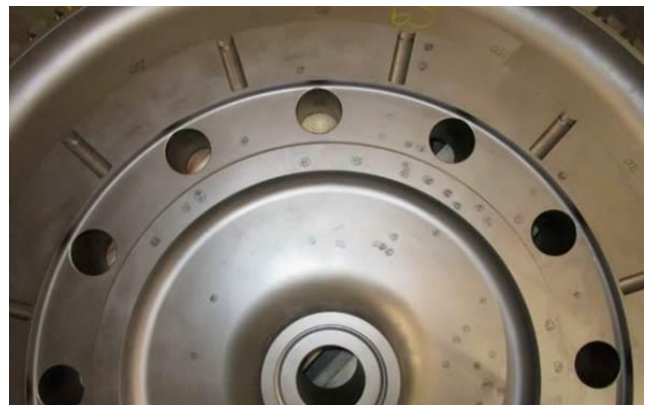
*Figure 3: Over 60 UT indications discovered in a row 9 compressor disk.*

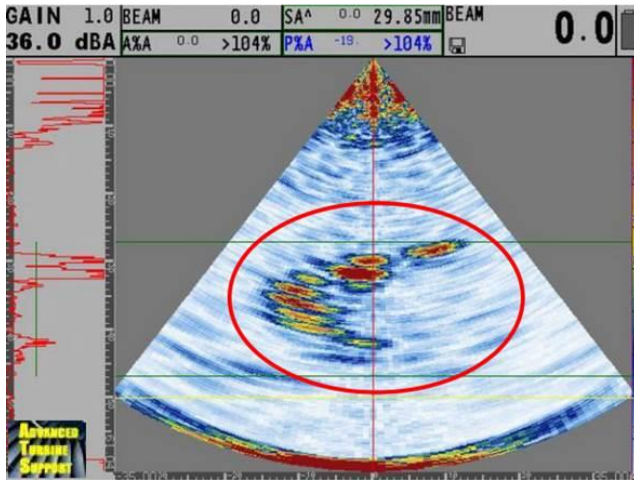
Figure 4: Large UT indication in the middle of a compressor disk web with a length of ~0.750 in (~19 mm).

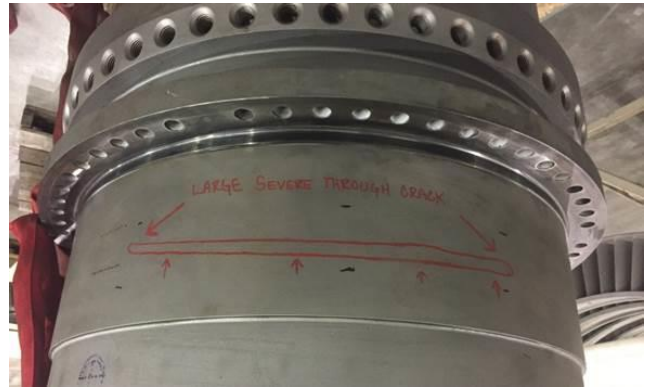
Figure 5: Large through-wall crack discovered in an intermediate shaft.

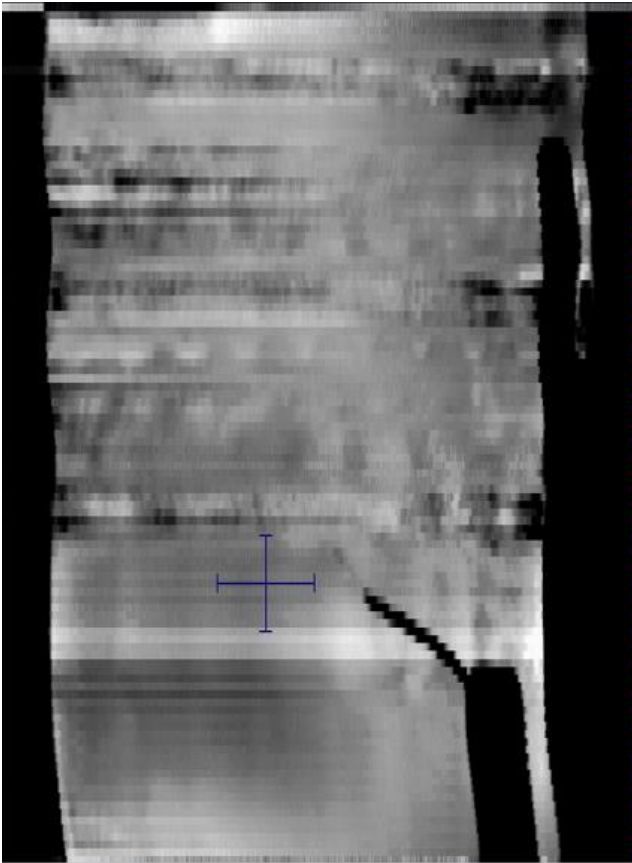
Figure 6: Eddy current response of a large crack in an IN706 turbine disk emanating from the aft cooling slot.

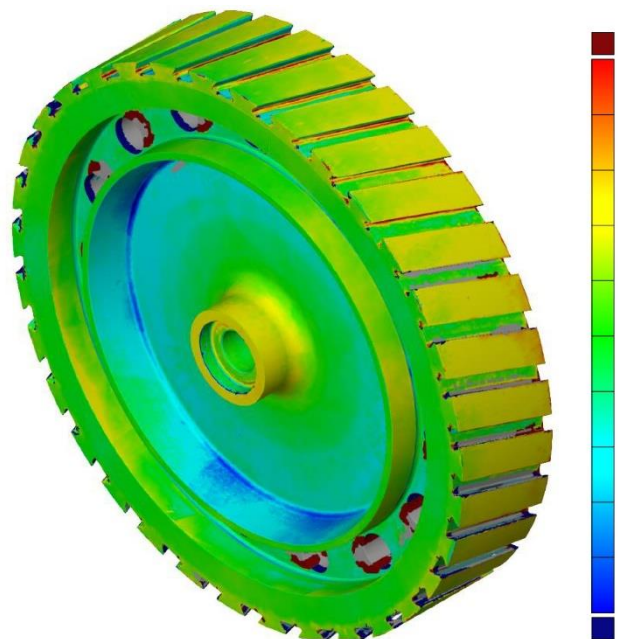
Figure 7: Overlay comparison of a retired and new compressor disk. Deviations are noted as highs (blue) and lows (red) in regards to nominal conformance (green).

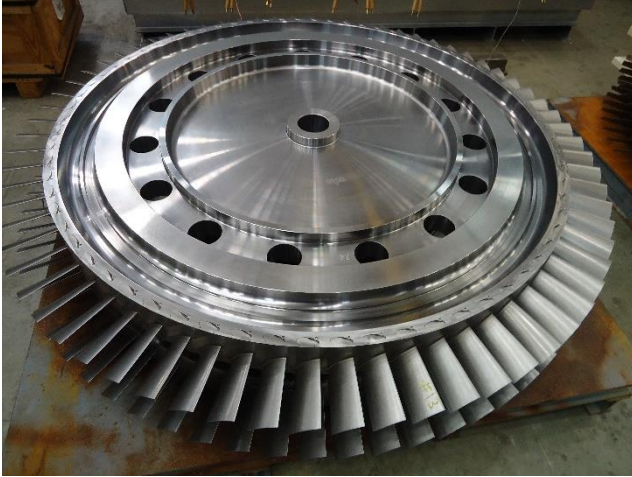
*Figure 8: New-make compressor disk used to replace a component in a rotor that had exhausted the useful operational lifetime.*
