TEMPERATURE MEMORY COATINGS FOR SHORT AND LONG TERM APPLICATIONS IN GAS TURBINES

C. C. Pilgrim, Sensor Coating Systems
J. P. Feist, Sensor Coating Systems
S. Karmakar Biswas, Sensor Coating Systems
P. Y. Sollazzo, Sensor Coating Systems
S. Berthier, Sensor Coating Systems
J.R. Nicholls, Cranfield University

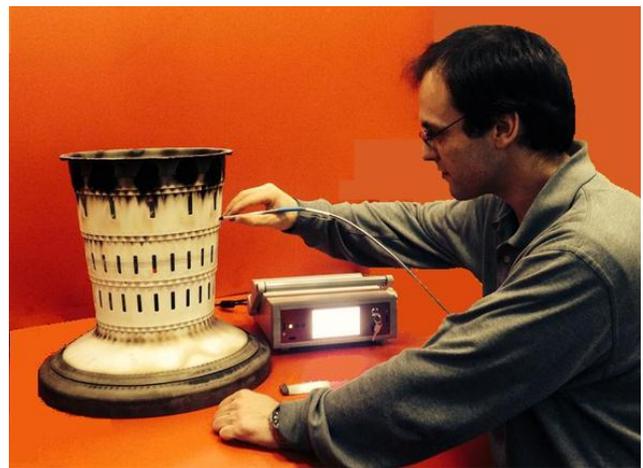
Figure 1. An operator using the measurement equipment is contained within a box with a fibre guided probe and a touchscreen for control.

The measurement equipment excites the phosphorescence, records the subsequent emission and analyses the result providing a lifetime decay value or temperature if the required calibration data is stored. The equipment is contained in a portable box with a fibre guided probe, as shown in Figure 1.

A pulsed diode pumped solid state laser, operating at a wavelength of 532nm, is directed into one end of an optical fibre. The other end of the fibre is directed at the coating. The laser light excites the phosphorescence and

the emission is collected by the optical fibre which directs it to an optical detector via a band pass filter. The light is converted to an electrical signal which is then digitized by an acquisition card.

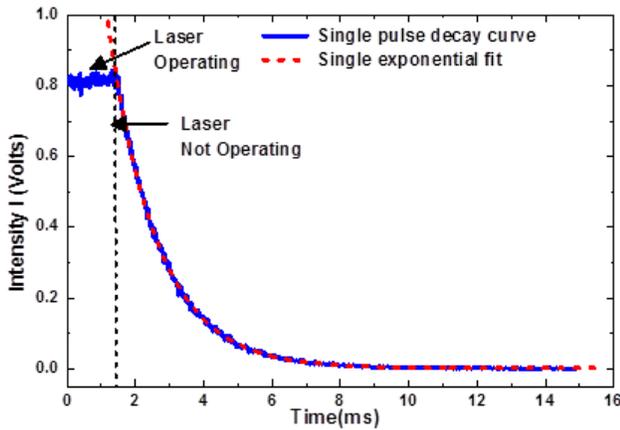
Figure 2. A typical phosphorescence decay signal with an exponential fit.

The decay data is fit to Eq. (1) using a Levenberg-Marquardt algorithm. Figure 2 shows a typical decay signal indicating when the laser is operating and the vertical dotted line shows when it is switched off. The phosphorescence decays exponentially and the result of the fit gives the lifetime decay value. The duration of this decay changes with heat treatment temperature. The data plotted in Figure 2 is from a single laser pulse and indicates the signal-to-noise ratio of the measurement.

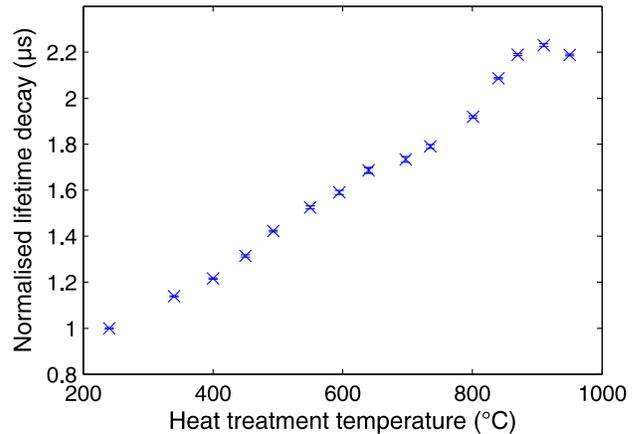
Figure 4. The calibration data for thermal history paint A for 30 minutes exposure time. The error bars show the standard deviation on 30 repeat measurements.

Figure 4 shows that the lifetime decay monotonically increases with heat treatment temperature from 240°C to 910°C. Over this range there is over a two-fold increase in the lifetime decay. The plot also shows the standard deviation on 30 repeat measurements as an error bar on

each marker. At all temperatures the standard deviation is less than 0.5% of the lifetime decay. Therefore, the variation on the measurement of lifetime decay is very low compared to the dynamic range of the decay values over the temperature range.

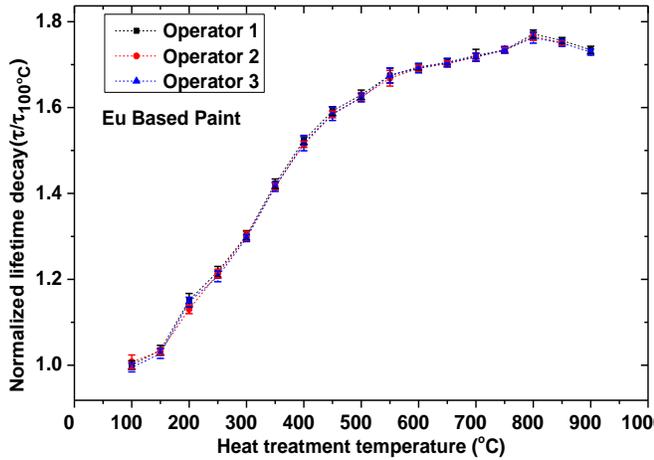
Figure 5. The calibration data for the thermal history paint B for 30 minutes exposure time. The error bars show the standard deviation on 30 repeat measurements and the different markers represent measurements by different operators.

The calibration curve for Thermal History Paint B is shown in Figure 5. Comparing this calibration curve to that shown in Figure 4, shows that the change in the lifetime decay with heat treatment temperature is dependent on the paint type. This behaviour can be used to optimize the paint selection for a particular application. The steeper the gradient of the calibration curve, the greater the precision of the measurement because for a given uncertainty in the lifetime decay there is less uncertainty in the temperature. The plot for paint B shows a steeper gradient at lower temperatures, up to approximately 500°C, as the lifetime decay increases by over 60% compared to approximately 50% for paint A. However, above 500°C the calibration curve flattens out, reaching a maximum at 800°C where the normalized lifetime decay is 1.75. Therefore, paint B is better suited to temperature measurements below 500°C compared to paint A but the overall change in lifetime decay and temperature range is lower.

The plot in Figure 5 includes measurements by three different operators, shown as different shaped and coloured markers. The different operators were free to choose the measurement location on the sample. The results show there was no difference observed for different

operators as the repeat measurements are within the error bars of an individual measurement.

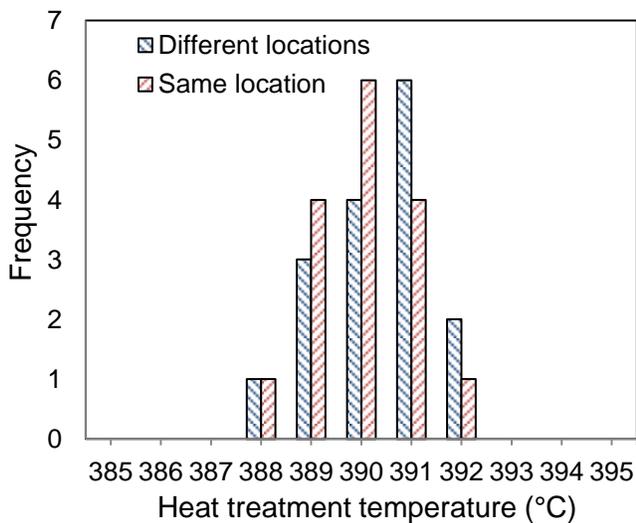
Figure 6. Histogram of the variation in 16 temperature measurements at a single location and different locations measured on a sample heat treated to 390°C for 30 minutes.

The precision analysis was conducted on three samples. A single location on the sample was measured 16 times. Then 16 repeat measurements were conducted at 16 different locations. The results for one sample, provided in Figure 6, show that the variation at a single location or different locations is similar indicating high uniformity in the sample.

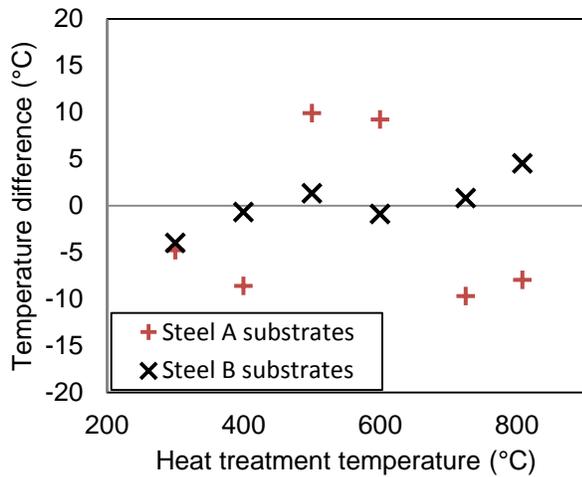
Figure 7. The temperature difference recorded on paint samples applied on different composition steel substrates to the calibration samples.

Thermal History Paint A was applied to two different sets of substrates composed of different steel compositions, referred to as steel A and B. This was done at a later date than the application on the stainless steel calibration samples. The samples were heat treated in the same way as described for the stainless steel calibration samples between 300°C and 810°C. After heat treatment, the measurement equipment was used to record the lifetime decay from the samples. The lifetime decay was converted to temperature using the calibration curve shown in Figure 4. The difference between the recorded temperature and the heat treatment temperature of the new steel substrate samples was calculated. The result is plotted against the heat treatment temperature in Figure 7.

For both sets of steel samples the temperature difference is less than ±10°C over the full temperature range. The result demonstrates the repeatability of the technique. The combination of different application and heat treatment times and different substrates results in an error of within ±10°C. This provides an indication of the accuracy of the technique.

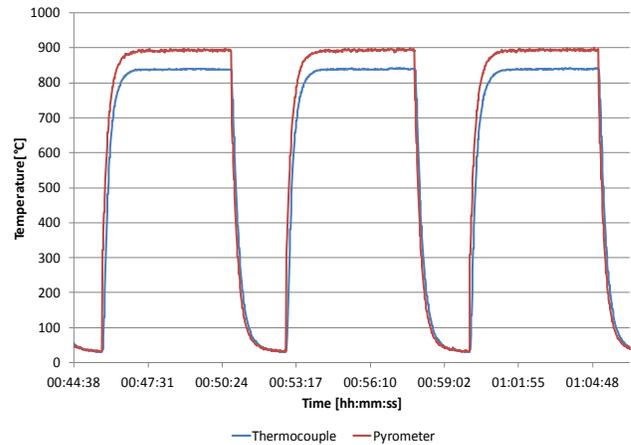
Figure 8. Temperature trace of 3 cycles on the thermal gradient testing rig. The blue line is the thermocouple data and the red line is the pyrometer data.

Thermal History Paint and the commercial Thermal Paint was applied to different Nimonic 90 alloy button samples. The button samples were tested in the gradient test rig for 2.5 hours with cycling periods of 7 minutes; 5 minutes heating to 900°C and 2 minutes cooling reaching room temperature. Figure 8 shows three typical cycles recorded with the surface temperature recorded by a pyrometer and the substrate temperature recorded using an embedded thermocouple. A thermal gradient was generated by heating the front and actively cooling the back of the substrate. Such a test is considered to be representative of operating conditions in harsh environments in gas turbines or in similar applications with cooled components.

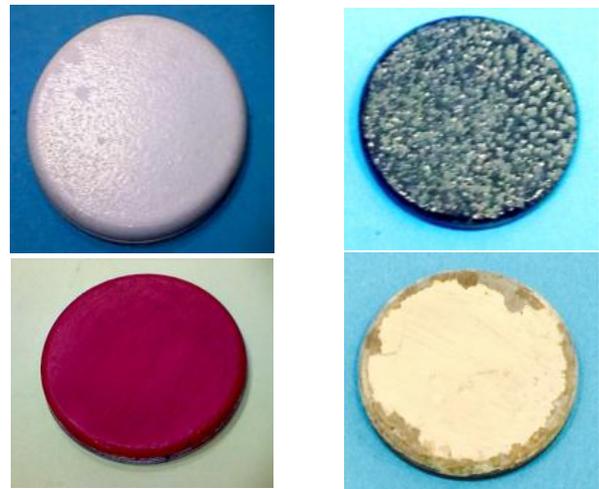
Figure 9. Photographs of the Thermal History Paint before testing (top left) and after testing (top right) alongside the Thermal Paint before testing (bottom left) and after (bottom right).

The photographs in Figure 9 show the paint samples before and after testing. The Thermal History Paint remained adherent to the surface with a dark mottled appearance after testing. No flaking or loss was observed. Despite the dark appearance it was possible to measure the lifetime decay on the coating surface. Conversely, the commercial Thermal Paint became brittle with delaminations and cracks observed at the edge of the sample. Furthermore, the colour of the paint was compared to the calibration colour chart and no match was found, therefore, it could not be used to determine the exposure temperature.

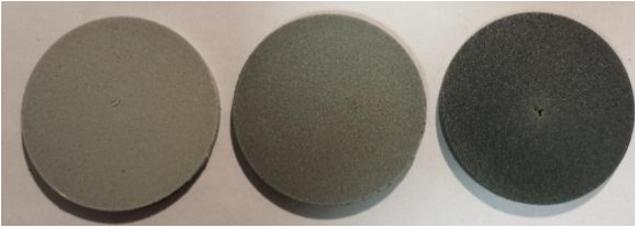
Figure 10. Samples of paint applied to Inconel substrates then heated at 800°C (left), 900°C (middle) and 990°C (right) for 30 minutes.

As a further test of the paint durability, samples were heat treated under isothermal conditions. Thermal History Paint was applied on Inconel substrates which are often used in high temperature applications due to its oxidation and creep resistance. The samples were exposed at 800°C, 900°C and 990°C for 30 minutes in a tube furnace. A photograph, in Figure 10, shows that the paint was adherent on all the samples after heating and the decay time could be measured on all samples. This result gives further evidence of the durability of the paint at high temperatures.

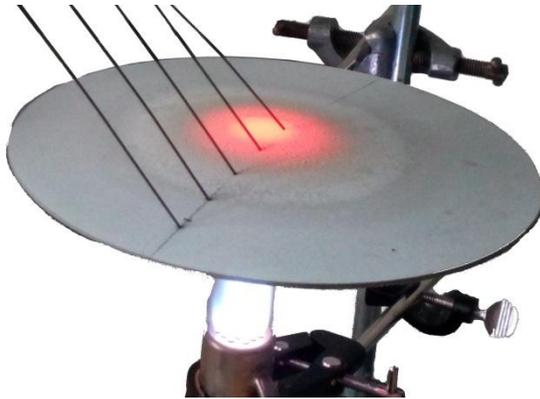
Figure 11. A photograph of the painted disc during heating showing the five thermocouples on the surface and the red hot centre of the disc.

Thermal History Paint A was applied to the surface of a 200mm diameter stainless steel disc to provide a demonstration of how the Thermal History Paint can be used to record two-dimensional temperature profiles. The disc was heated in the centre using a propane-oxygen flame to reach a stable temperature for 30 minutes. As shown in Figure 11, five thermocouples were placed into 1mm deep indentations in the disc. The first indentation was in the centre of the disc and the rest were spaced 20mm apart towards the edge of the disc.

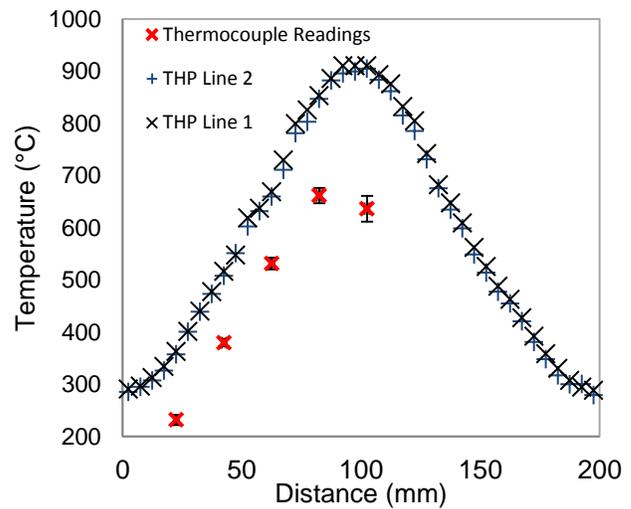
Figure 12. The results taken from the thermocouples and Thermal History Paint (THP) along two parallel diametric lines. The thermocouple data is averaged over the 30 minute heating period and the error bar indicate the standard deviation.

After heating, measurements were taken from the paint along two parallel lines either side of the diametric line on which the thermocouples were placed. The recorded lifetime decay was converted into temperature using the calibration curve presented in Figure 4. The data are plotted in Figure 12 along with the thermocouple readings.

There is very good agreement between the temperature measurements recorded with the Thermal History Paint along the two parallel adjacent lines. The temperature profile across these lines are expected to be very similar due to their proximity. The consistency in the results provides further evidence of the repeatability of the measurement system.

There are two notable differences between the results recorded using the thermocouples and that recorded with the paint. Firstly, the central thermocouple shows a lower temperature than the thermocouple at 80mm. This does not correlate to the expected temperature profile and the observed colour of the plate during heating, as shown in Figure 11. Secondly, there is a consistent offset between the outer four thermocouple readings and the temperature recorded with the paint. The lower temperature provided by the thermocouple is thought to be caused by poor thermal contact of the thermocouple with the disc surface. During testing it was observed that while the disc was glowing red hot the thermocouples did not. Furthermore, the maximum temperature recorded by the thermocouples is 660°C which is not consistent with the glowing colour of the disc during heating.

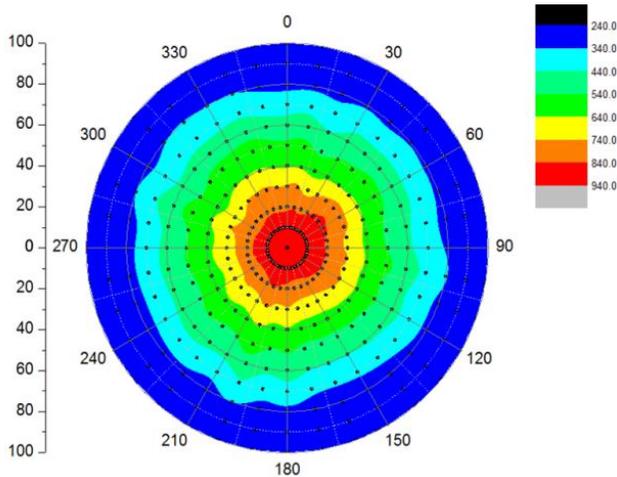
Figure 13. A contour plot of the temperature measurements recorded on the disc. The black dots represent measurement locations.

To generate a two-dimensional temperature profile the disc was measured at 360 locations which took approximately 1.5 hours. The probe of the measurement equipment was aligned at the edge of the disc, a measurement was recorded then the probe was translated 20mm along a diametric line. The disc was then rotated 10° and the process was repeated. The results are shown as a contour plot in Figure 13.

The plot shows the hot spot in the centre of the disc with concentric rings indicating the temperature drop to the outer edge. The heat was expected to dissipate evenly over the disc resulting in circular contours. However, the contours are not circles but exhibit wavy profiles. This is due to slight misalignments which occurred between rotations of the disc during the measurement procedure. The thermal gradient along the radii of the disc was calculated to be 7.3°C/mm, therefore, slight misalignments

of several millimetres cause a significant change in the measured temperature. As a result, in some locations the recorded temperature is higher or lower than expected causing deviations from the expected circular contours. The effect can be observed along the 20° diametric line. Above the centre, the contours along this line show a slightly lower value while below the centre they show a slightly higher value. This indicates that the measurement location was closer to the top edge than thought.

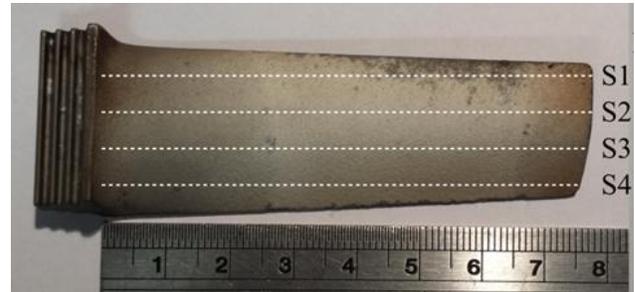
Figure 14. The suction face of the coated turbine blade after testing with the four scan lines shown.

A yttrium aluminium garnet (YAG) based Thermal History Coating was applied to a turbine blade of a Rolls-Royce Viper engine owned by Sensor Coating Systems and operated at Cranfield University. This was done using production line facilities as part of a larger programme which is described in detail elsewhere (Feist, et al. 2013, Feist, et al. 2012). The coated turbine blade was installed and the engine was operated over the full working range from 5,000 to 13,500 RPM. The cumulative operating time was approximately 70 hours. A photograph of the suction face of the blade after testing is shown in Figure 14. There is some slight damage to the leading edge of the blade however the entire coated surface remains intact.

The blade was scanned along the four lines shown in the figure to record the lifetime decay, measurements were taken every 5mm. The results are plotted as a contour plot in Figure 15. No samples were available to perform the calibration therefore the results are presented as lifetime decay rather than temperature. The low decay times at

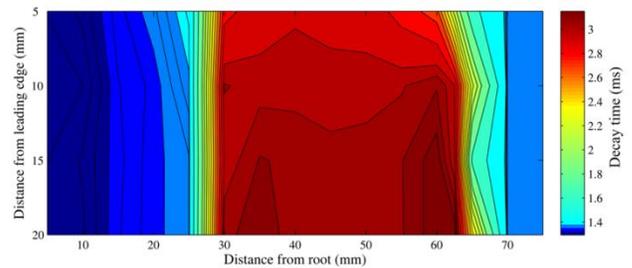
Figure 15. The contour plot showing the result of the lifetime decay measurements on the suction face of the turbine blade.

either end of the blade indicate that the coating was cooler in these regions. This is because the turbine blade is cooled at the ends during operation by a flow of air from the compressor. The tip of the blade has a higher decay time compared to the root because the flow of cooling air was less at the tip.

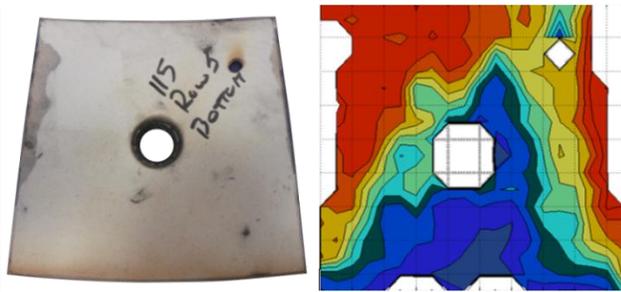
Figure 16. (Left) A photograph of the combustor tile with the composite coating after operation for 4,500 hours. (Right) The profile of the luminescence decay time where red represents higher values and blue lower values.

A similar YAG based Thermal History Coating material has been embedded into TBC by mixing it with 90 wt.% YSZ (Feist, et al. 2006). Composite coatings have been produced which comprised a base layer of YSZ and a top layer of the YSZ/YAG:Dy mixture. These coatings have shown the same or increased durability compared to reference YSZ samples during thermal cycling testing (Feist and Nicholls 2008, Feist, et al. 2014b). Furthermore, this coating construction was applied to a combustor tile which was subsequently operated in Didcot powder station in the UK for 4,500 effective operating hours. Reference YSZ coatings were applied to adjacently installed tiles. The composite coating exhibited less degradation compared to the reference coatings. In addition, the decay time was recorded across the surface of the coating. The profile, shown in the right of Figure 16, indicates that the thermal history effect can be observed after operation. The higher decay times, depicted in red are thought to indicate higher temperatures. This observation corroborates with

micrograph analysis of the thermally growth oxide layer beneath the ceramic coating which suggested a higher operating temperature by $\sim 15^{\circ}\text{C}$ at the top of the tile compared to the bottom. The profile also matches the expected cooling air flow over the tile.
