## RSE activities on microturbines (MT)

F. Armanasco, A. Cavaliere, F. Cernuschi, S. Concari

RSE Spa Via Rubattino, 54, 20134 Milano, Italy

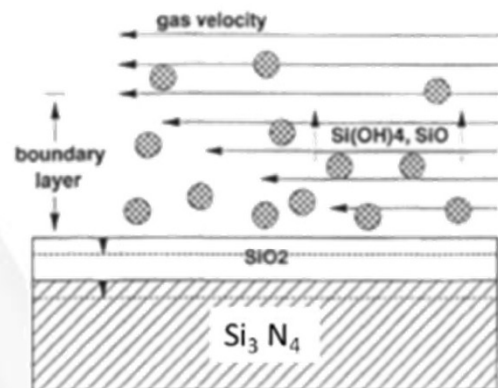
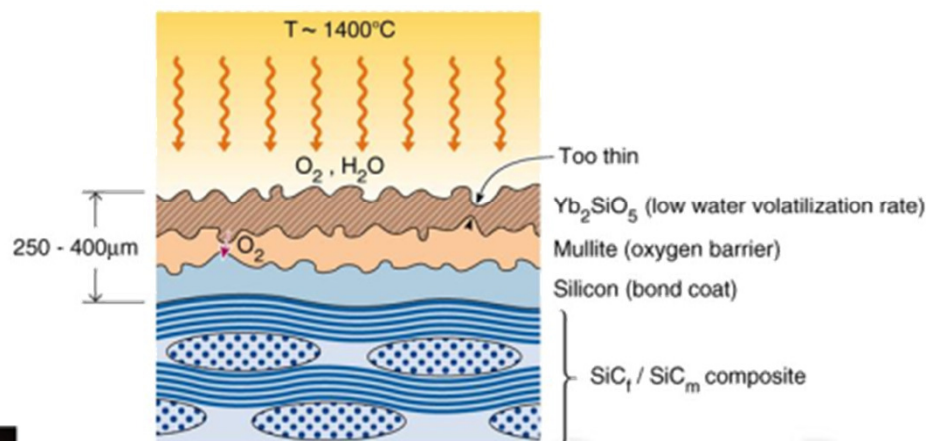
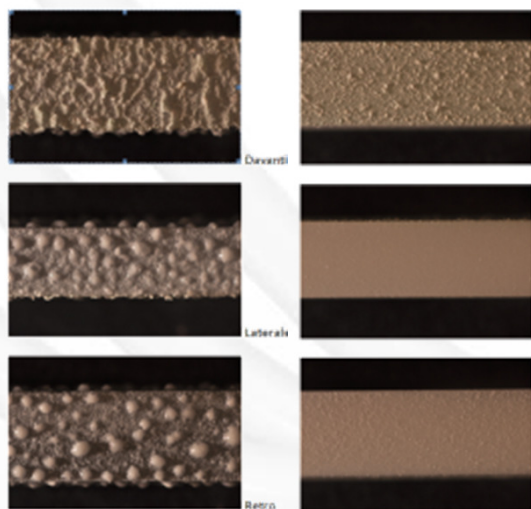
### Recession of non oxide ceramics at temperatures higher than 1150°C

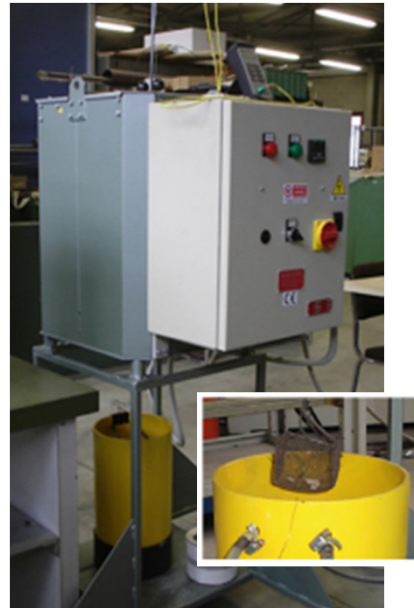
RT and HT 4 point bending test  
ASTM C1161-13&C1211-13

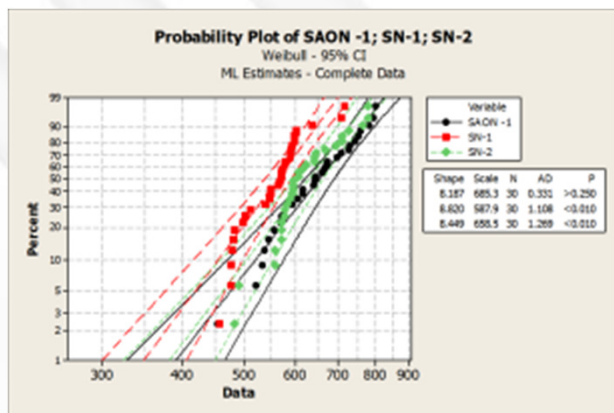
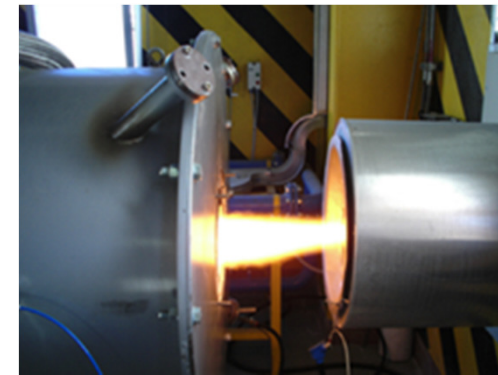
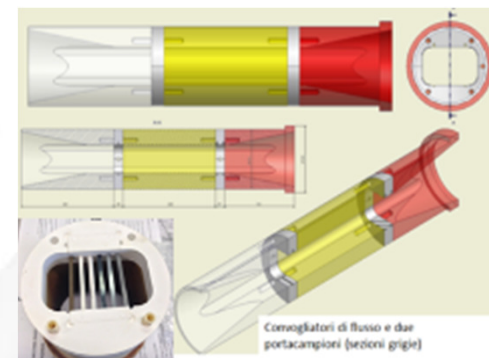
Thermal shock ASTM  
C1525-04

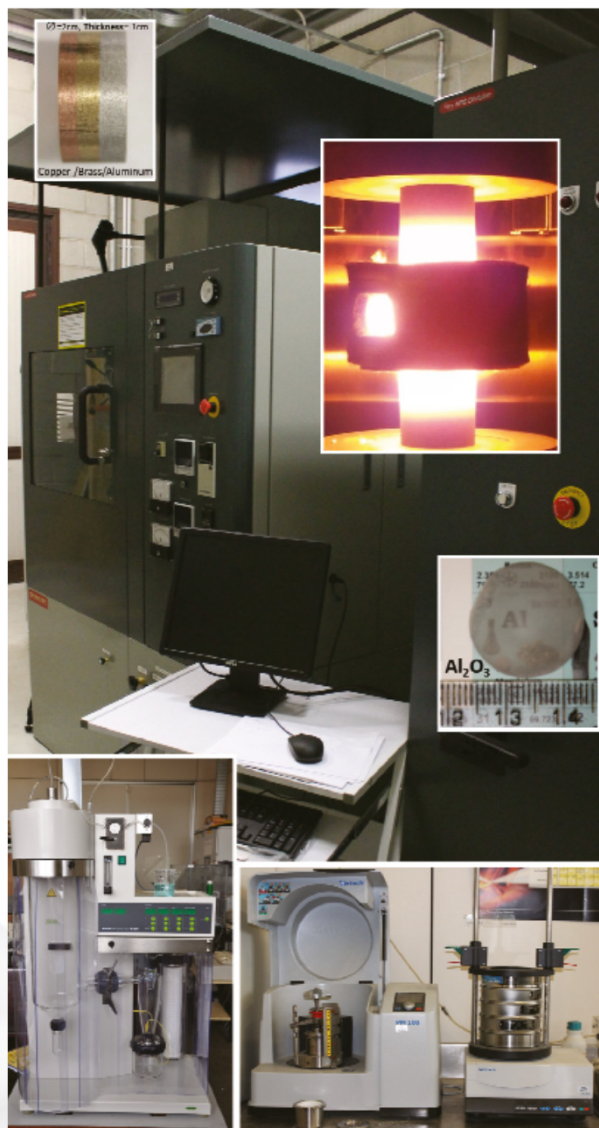
Spark Plasma Sintering for sintering advanced ceramics, metallic, and composite components

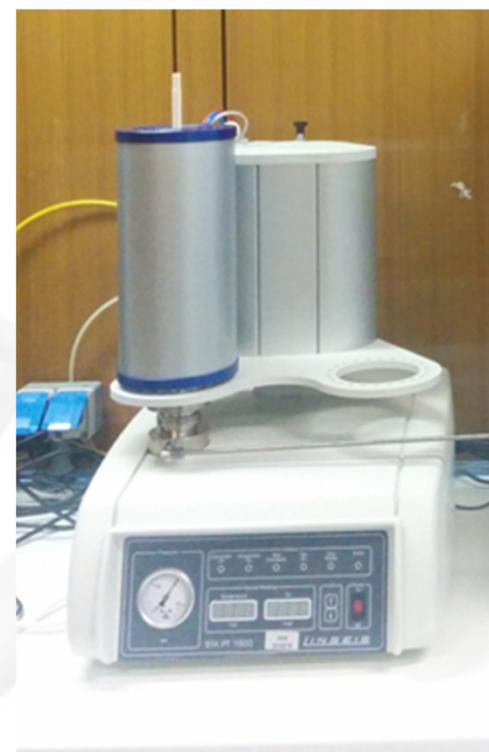
TGA for oxidation/corrosion kinetics studies

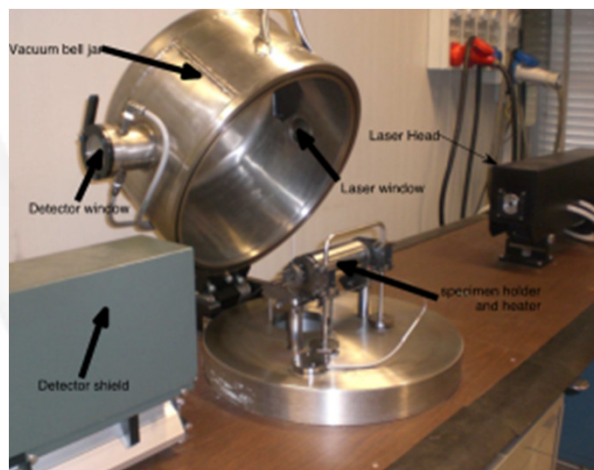
Laser Flash for thermal diffusivity measurement

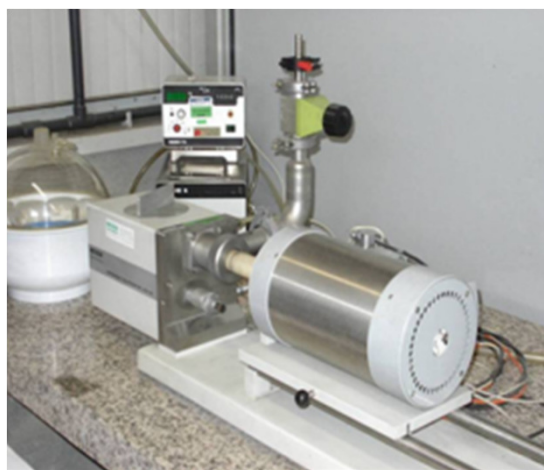
Differential Dilatometer for TEC

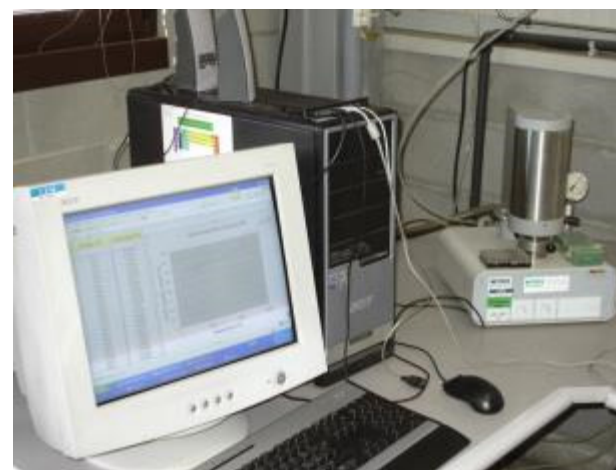
Differential Scanning Calorimeter for  $C_p$

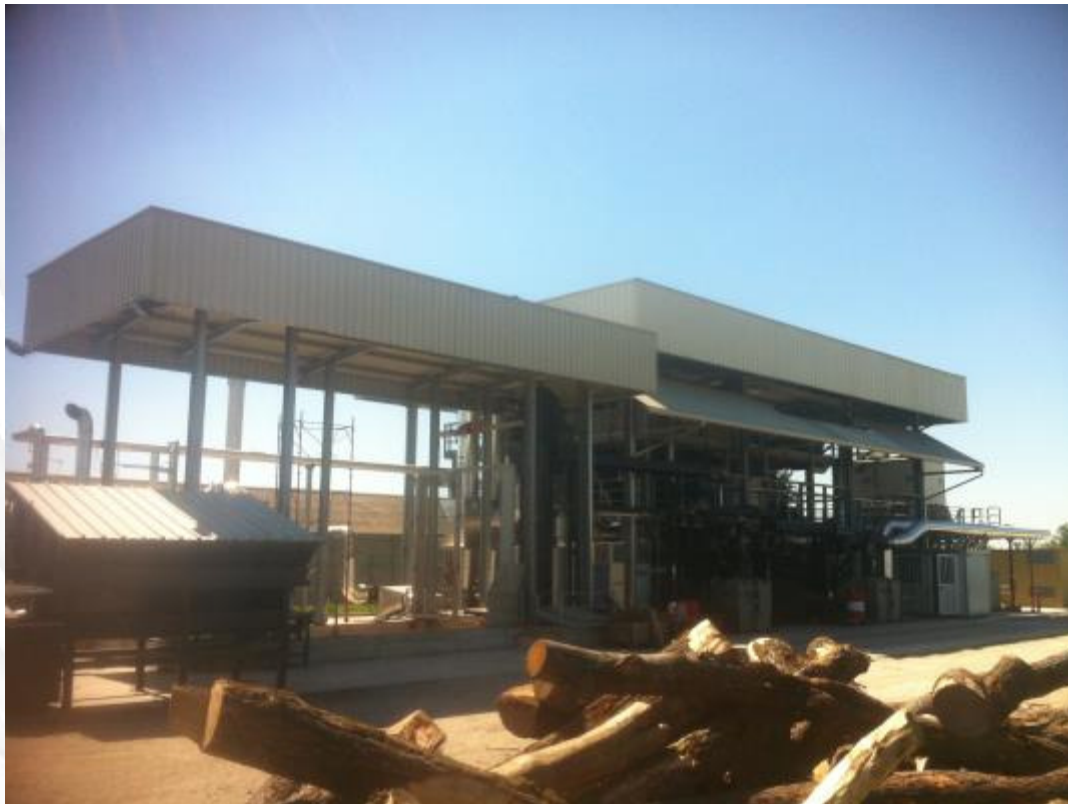
To extend fuels for MT to solid biomass and waste, external combustion is an option

Two  $80\text{kW}_{\text{el}}$  MT+ $110\text{kW}_{\text{el}}$   
Rankine organic Fluid cycle  
fuelled by wood chips located  
in Zibello (PR-Italy)

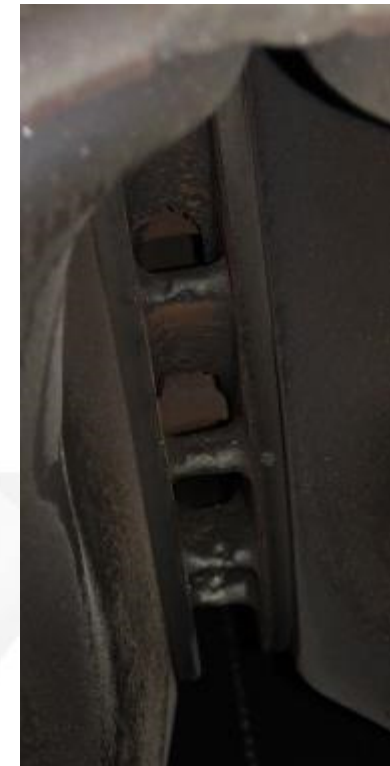
SPE erosion of MT  
vanes

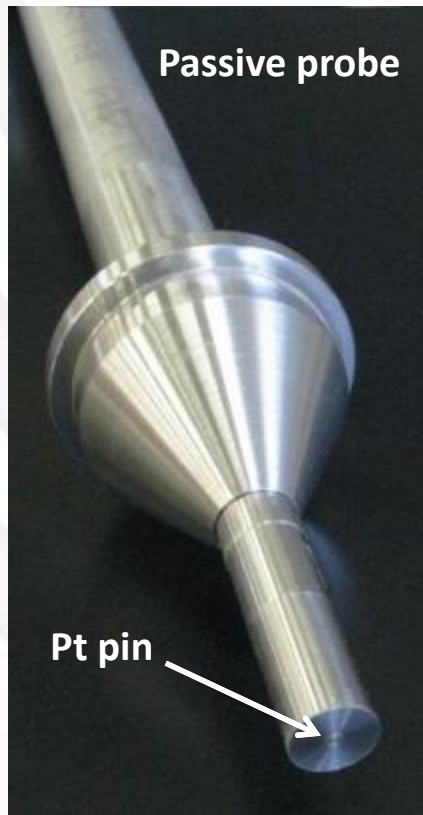
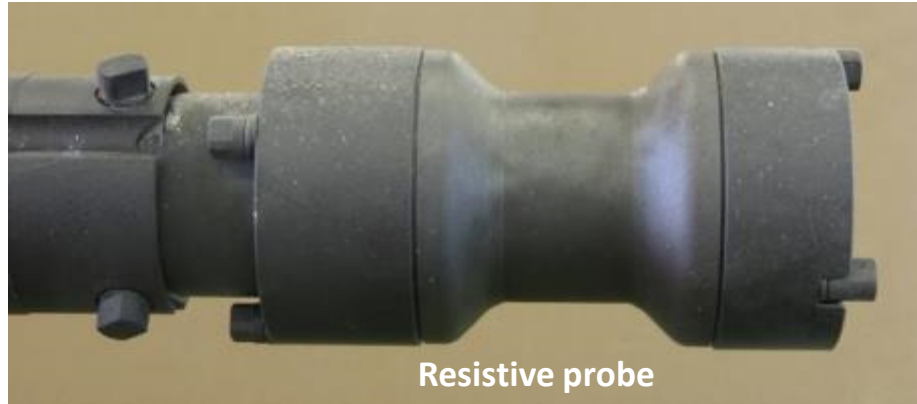
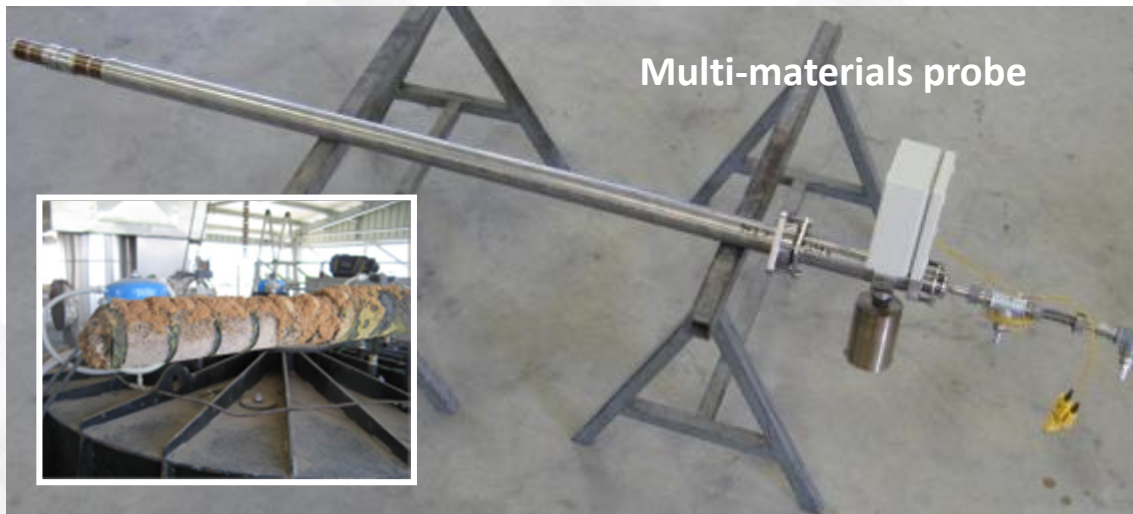
Cooled probes for hot corrosion and high temperature oxidation monitoring to be installed in plants

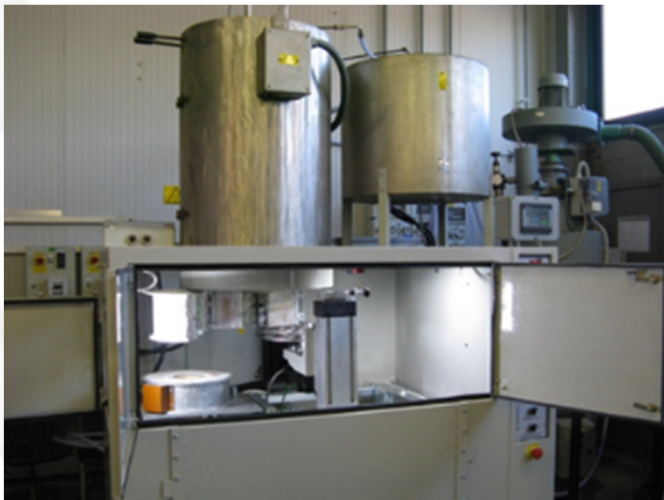
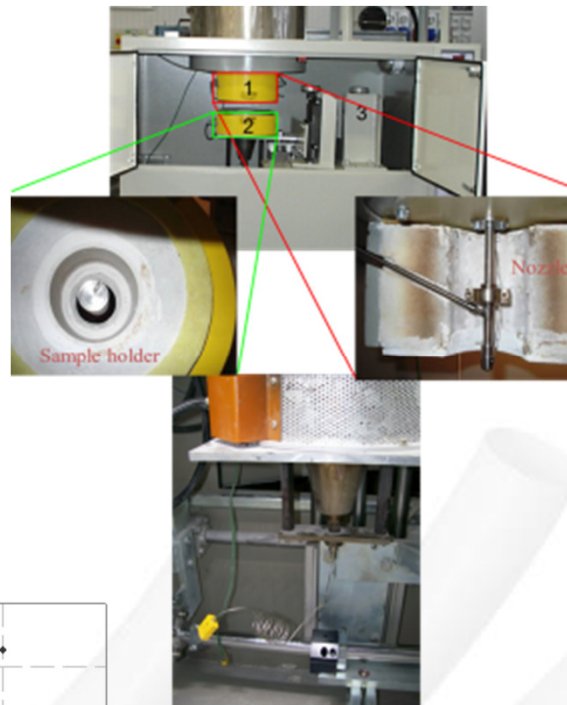
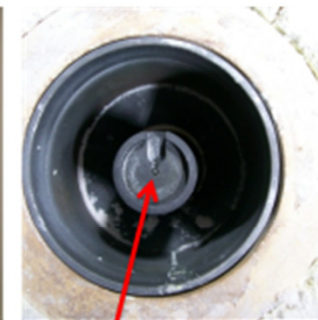
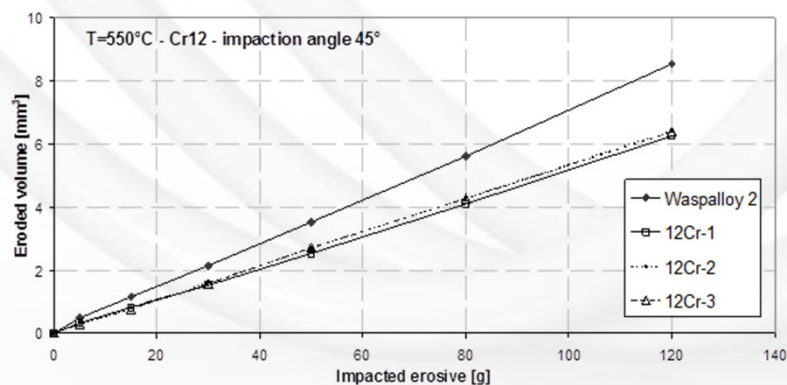
### High temperature solid particle erosion Jet Tester according to ASTM G211-14

Thermocouple in contact with the rear face of the sample

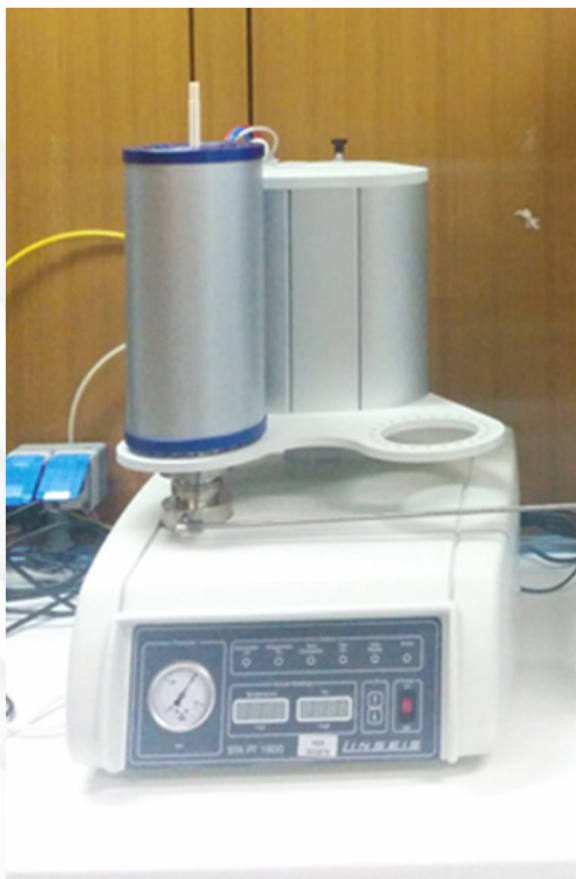
TGA for oxidation/corrosion  
kinetics studies
