Investigation of hot salt corrosion at a land-based gas turbine installation

F. Starr, N. Wood⁽¹⁾ and R. Robertson⁽²⁾

⁽¹⁾ British Gas plc, Research and Technology, Gas Research Centre, Ashby Rd, Loughborough, U.K.

⁽²⁾ British Gas plc, St. Fergus Gas Terminal, Peterhead, Aberdeenshire, U.K.

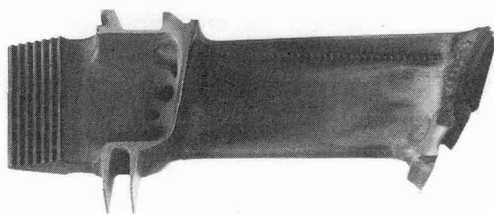
Visual examination of the blades (Plate 1) revealed a large amount of corrosion on the underside of the blade shrouds, an unusual location for hot corrosion.

Plate 1. — Photograph of RB211 turbine blade. The blade length is 15 cm.

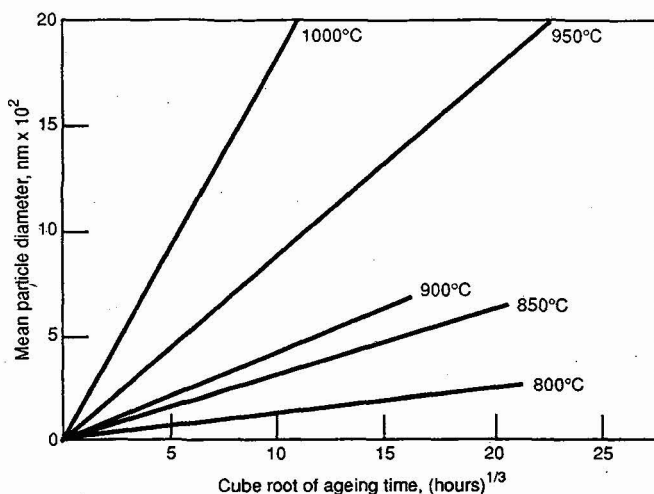
Fig. 1. — Growth curves of λ' particles in nimonic 105-solution-treated 4 h/1150 °C, air cool (nimonic 108 is very similar to nimonic 105 [2]).

To evaluate the service history of the blades from the RB211 engines, we carried out some heat treatments of our own, with an unused turbine blade, and then made a comparison. The heat treatment times and temperatures were chosen by making use of the data in figure 1 [2].

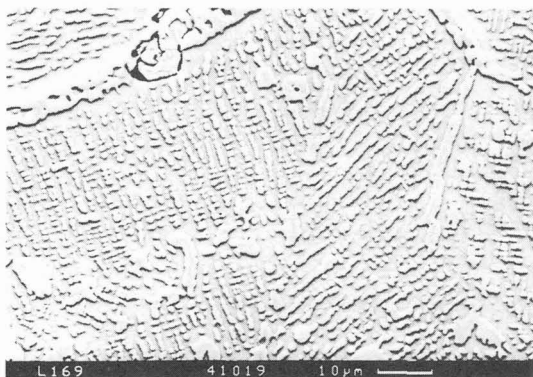
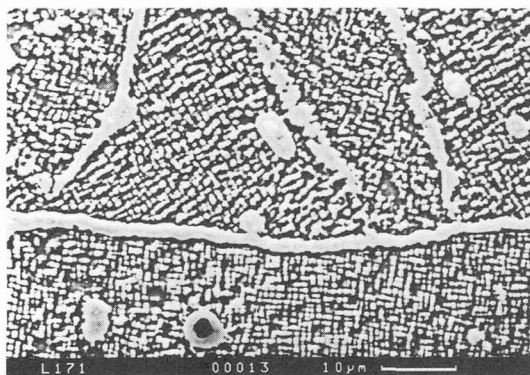
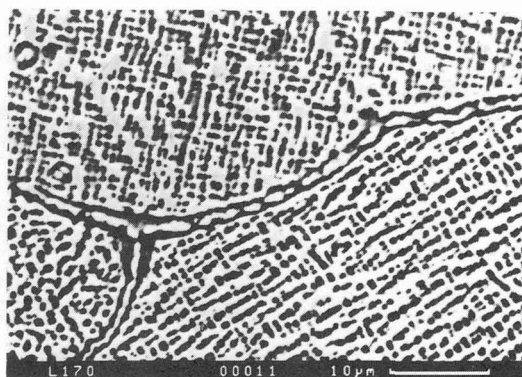
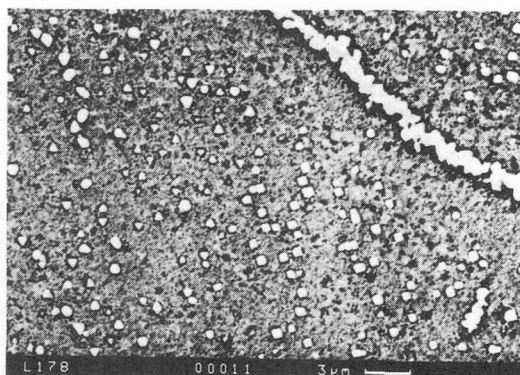
One of the turbine blades that had been in service at St. Fergus for about 8000 hours, was sectioned into six parts, and examined in the SEM, in order to check the microstructures. Their micrographs are shown in plates 2a-c. They show how much the γ' particles had coarsened. We estimated the section in plate 2a to have run at 925-950 °C, and the sections in 2b and 2c at 900 °C. For comparison, plate 2d shows an "as-received" structure of nimonic 108.

Plate 2. — a) Large γ' particles in blade section 1 — nearest the shroud. Some possible void coalescence is also visible. b) γ' particles on section 2 of the turbine blade. The particles appear dark in this micrograph as marbles reagent was used. c) Large γ' particles on section 3 of the turbine blade. d) γ' particles in the "as received" nimonic 108 alloy.

The size of the γ' particles and the degradation of the aluminide coating, near the trailing edge of the blade tip, suggests that this section of the blade ran hot, thus accelerating corrosion.

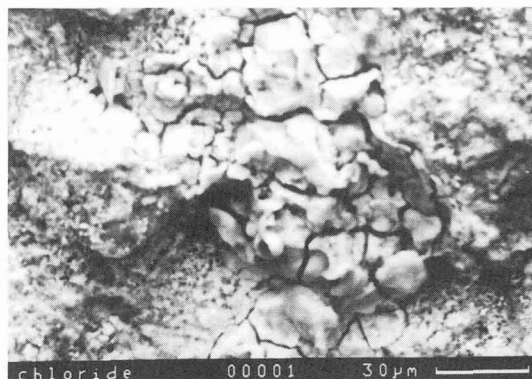
In plate 3, crystals which appeared to have been formed by the deposition of a "foreign species", could be seen. The analysis of them showed a high chlorine level. There was no evidence of sodium, and only very low levels of potassium or sulphur. The levels of aluminium

were generally very low, considering the turbine blade was aluminised. Other parts of the blade tip, away from obvious areas of attack, showed higher aluminium levels.

Plate 3. — Close-up of a large chlorine-containing particle close to the edge of the turbine blade platform.

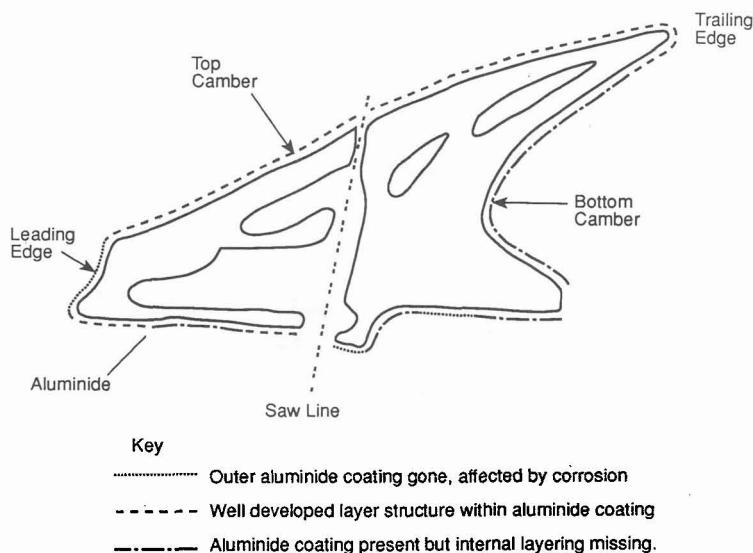
An enlarged diagram of that section is shown in figure 2. The principal features are the leading edge, the trailing edge, and the internal cooling channels.

The surface of the blade was traversed carefully, so we could see where the aluminide coating had degraded. Figure 2 suggests that much of the blade surfaces retained an integral coating of aluminide, with a two-layer structure in evidence. At some places, there was considerable attack e.g. at the leading edge (Plate 4a).

Fig. 2. — Sketch diagram of the cross-section through the turbine blade showing the distribution of the aluminide coating. The section was sawn in half during sample preparation.

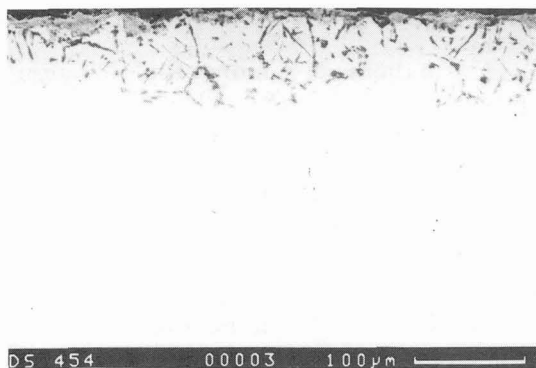
The alloy underlying this attack showed internal nitridation, which contained high levels of titanium, and aluminium.

Plate 4. — a) Area of attack on the surface of the blade. EDA showed a lack of aluminium to protect the blade. b) Internal attack close to the leading edge of the turbine blade. The dark-coloured, angular phase within the light band is a titanium, aluminium nitride. The grey particle with a white dot is sulphide.

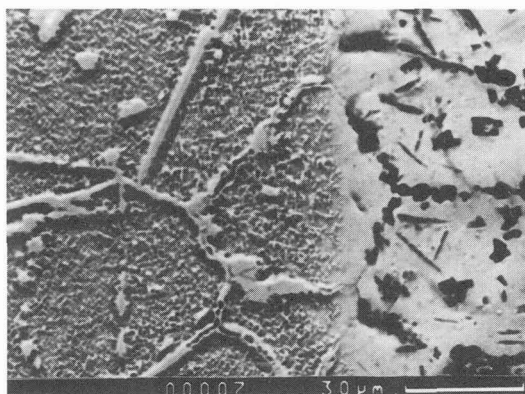
b)

Scanning the alloy just below this internal attack revealed a thin band of material, plus a few particles, high in sulphur (Plate 4b). The sulphur was present as chromium-rich sulphide inclusions, and must have originated from the CaSO_4 in the sea salt. Sulphidation beneath oxidation has been reported by Hossain *et al.* as characterising hot corrosion [3]. The extent of sulphidation was very limited, however, and it should not be given too much significance. The very apex of the leading edge was also examined. The thick scale present was aluminium-rich, it too containing nitrides, as well as oxides.

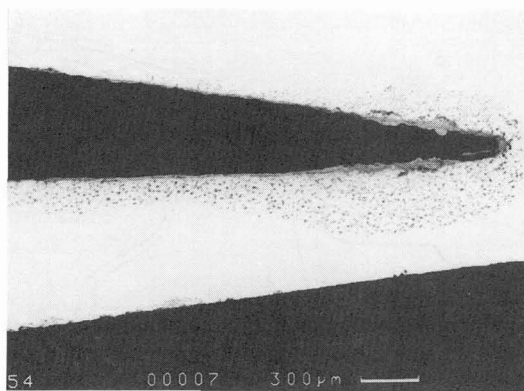
The cooling channels within the section nearest to the blade shroud were examined. The channel nearest the training edge of the blade, showed corrosion, plus attack of the surrounding material to a depth of 300 microns (Plate 5). Analysis of this internal attack showed

angular-shaped particles, they were aluminium and chromium-rich nitrides. There was no sign of sulphur here. The high levels of corrosion, and the presence of nitrides suggest local metal temperatures around 1000 °C.

Plate 5. — Internal corrosion at the apex of the turbine blade cooling channel.
