H₂-IGCC Project Deliverable

Grant Agreement number	239349
Project acronym	H ₂ -IGCC
Project title	Low Emission Gas Turbine Technology for Hydrogen-rich Syngas
Funding Scheme	FP7-ENERGY-2008-TREN-1
Subproject	2 Materials
Work Package	2.2 Performance of state-of-the-art materials/coatings in novel operating conditions
Delivery number - name	D 2.2.6
Lead Beneficiary	
Dissemination level	Limited
Delivery month	43
Name, title and organisation of the scientific representative of the project's coordinator	Christer Bjorkqvist Managing Director, European Turbine Network (ETN) Tel: 00 32 2 646 1577 Fax: 00 32 2 646 15 78 E-mail: cb@etn-gasturbine.eu Project website address: www.h2-igcc.eu

Subject Mechanical characterisation of materials.

Notes Deliverable D 2.2.6

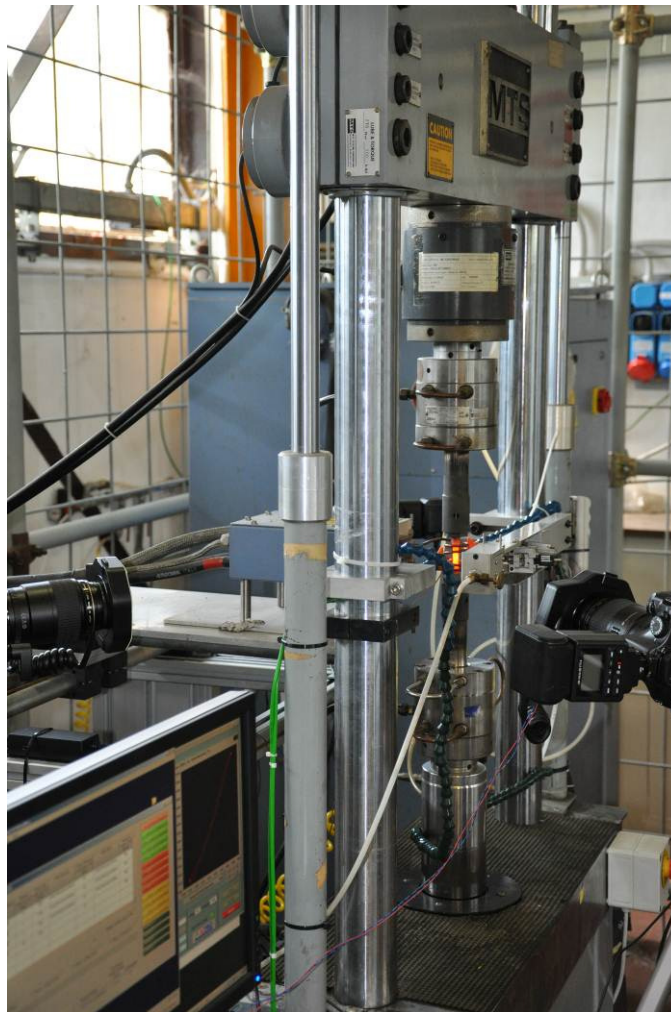
RSE rig for thermo-mechanical fatigue tests is based on a 250 kN servo hydraulic machine made by MTS, controlled by a “Trio Sistemi e Misure srl” system; an Aetron induction furnace with coil for cylindrical shape allows specimen to be heated, while an electro valve blowing air improves cooling rates at low temperatures. A digital camera system, made by three Canon EOS 1100 D equipped with Canon EF 100 2.8 Macro USM and Sigma EM140 DGNA annular flash lights, enables crack surface monitoring in specimen gauge length from three different point of view, covering the whole sample. A picture of the complete rig is shown in Figure 1, while a still picture sample captured by one of the cameras is shown in Figure 2, where calibration thermocouple wires with 0.6 mm diameter are detectable.

Figure 1 – RSE Thermo-Mechanical Fatigue Machine

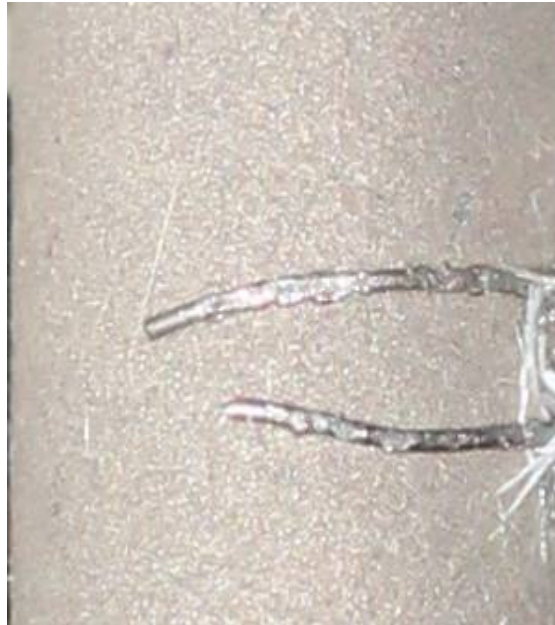
Figure 2 –TMF specimen surface with \varnothing 0.6 mm thermocouple wires

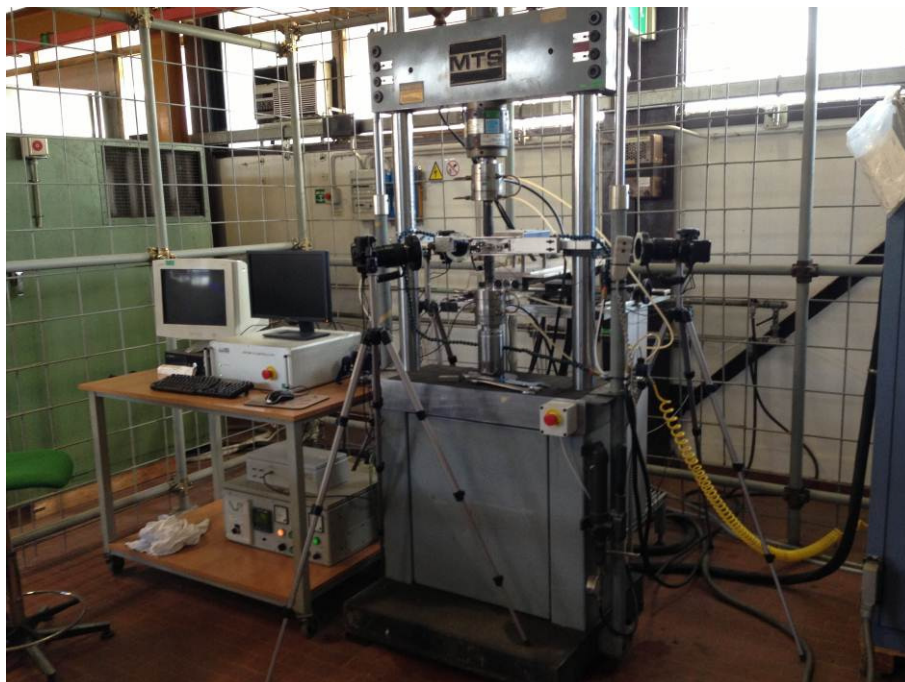
Test rig is based on hydraulic machine MTS 312.31, electronically and software revamped by “RT3” system provided by “Trio Sistemi e Misura S.r.l.”, allowing a simultaneous mechanical (force, strain and displacement feedbacks) and thermal control (induction coil driven by one thermocouple, with a second one reading another specimen point). A strong synergy was adopted with the producer, in order to accomplish test standards and to optimize the testing strategy.

Figure 3 – Thermo-Mechanical test rig

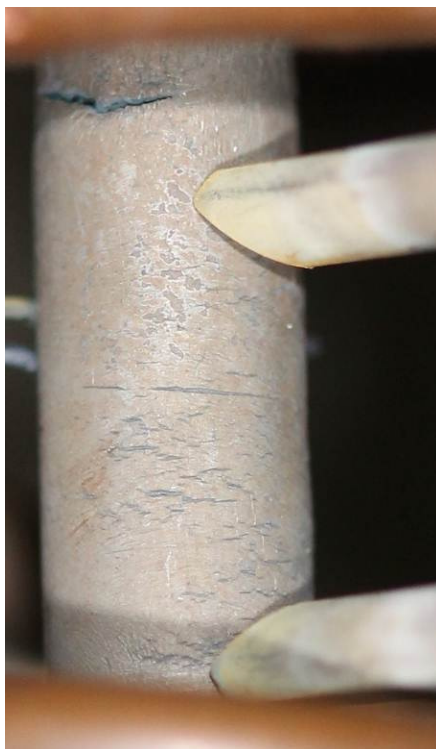
Figure 5 – Example of cracks in detail shown by front camera

Coated samples can be monitored by an automated photographic system controlling superficial cracks developing during TMF tests. No commercial system was found on market, in fact there was the need of something monitoring the whole specimen and periodically acquiring photos; a solution by analogic VGA cameras was proposed, but low quality image output pushed to build a self-developed multi-camera system, using three 12 Megapixel Canon EOS 1100D set at 120° to cover every specimen angle, each one with macro lens and annular flash (see Figure 4 and an example of collected picture in Figure 5).

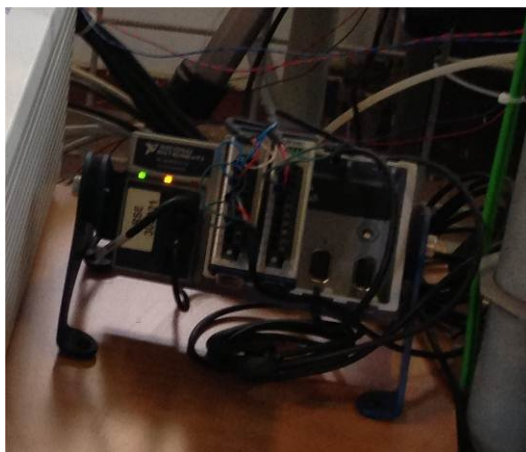
Figure 6 - National Instruments relay card

The management of programmed shooting was made possible thanks to the input of the manual remote control of each camera provided by the manufacturer: finding information on contacts' wirings, a National Instruments relay card (see Figure 6), switched by an internally developed software, allows the automated capture of still images (see Figure 7).

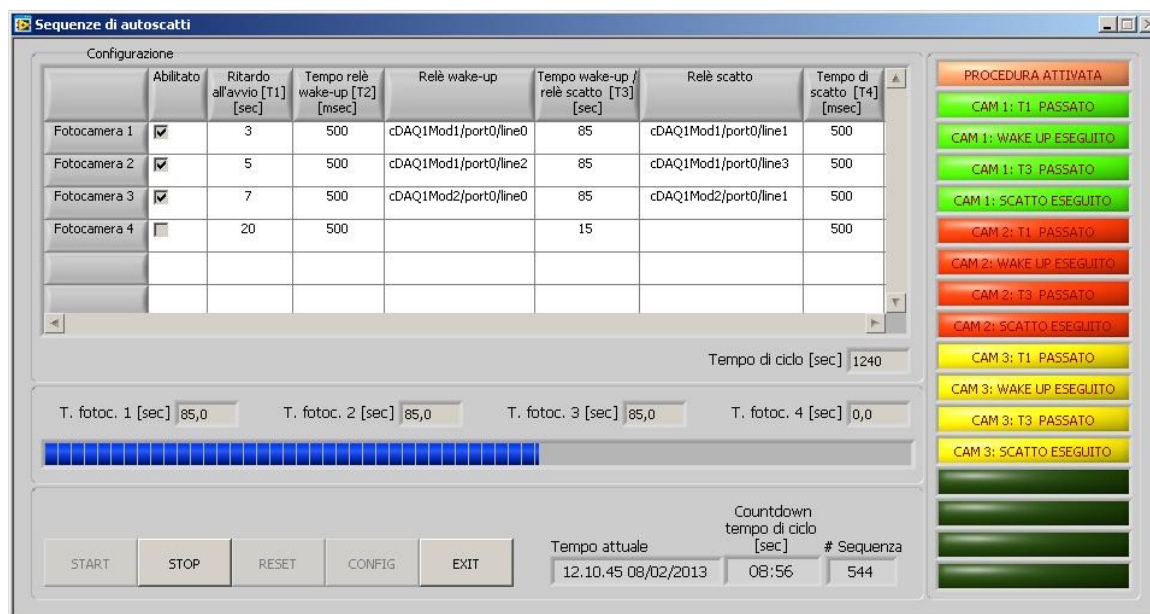
Figure 7 – Automated photo capture interface

Photos are taken in the "cold" phase of the cycle in order to get the superficial cracks, because specimens are very bright at high temperatures and geometry can't be properly distinguished. A physical shield to the objectives was initially taken into account to protect the optical reflex system from the long-time exposition to radiation emitted by high temperature samples; any camera producer recommended to adopt such a protection on our concerns, but it was thought an excessive caution was taken in order to avoid warranty issues. Investigating the topic with camera experts, a polarizing filter on the objectives was instead mounted, and after many tests and trials no damage was found on the optics. Each machine has been equipped with an annular flash balancing brightness in day and night conditions, so that cracks can be better highlighted.

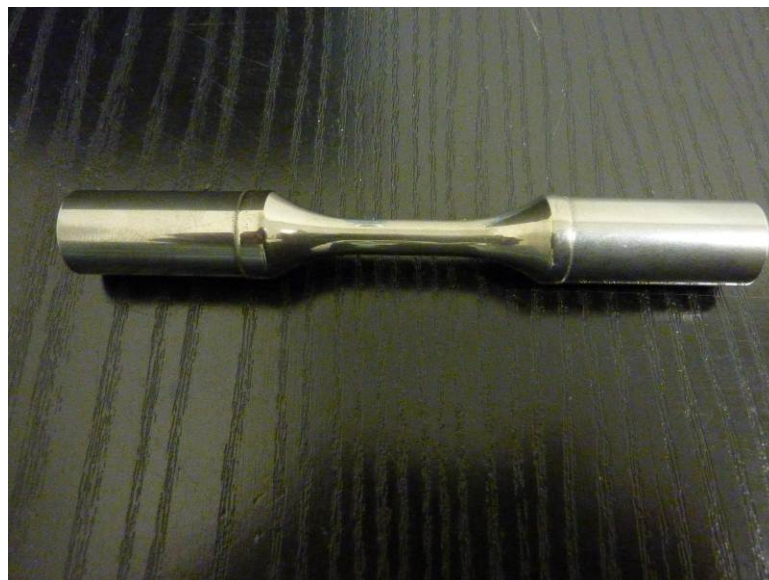
Figure 10 - TMF specimen after polishing up to 0.2 Ra in gauge length

Specimens surface is then polished along the gauge length up to the final roughness $R_a < 0.2 \mu\text{m}$ (according to standard requirements for fatigue testing), as showed in Figure 10.

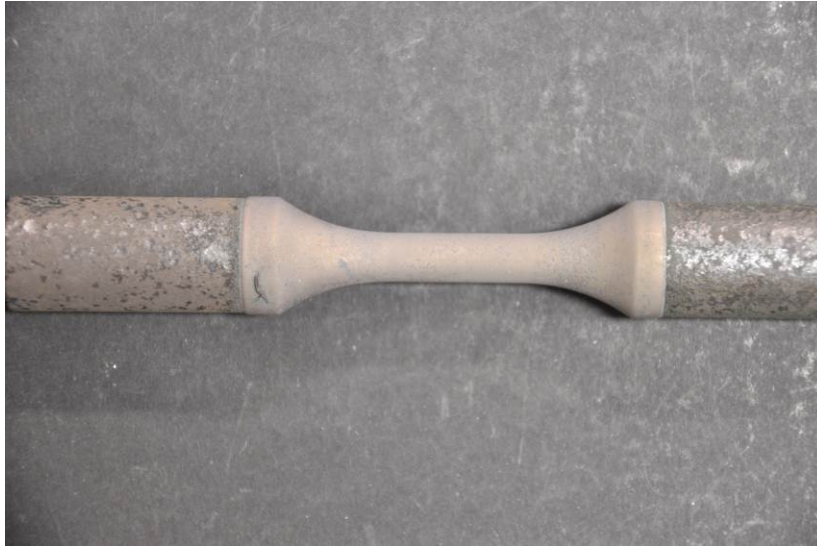
Figure 11 - TMF specimen after ageing in air

Aspect of a specimen after ageing in air for 1000 hours at 1000°C is shown in Figure 11, where the effect of oxidation is more evident in the uncoated grip heads (re-machined before testing) but can be detected in gauge length too.

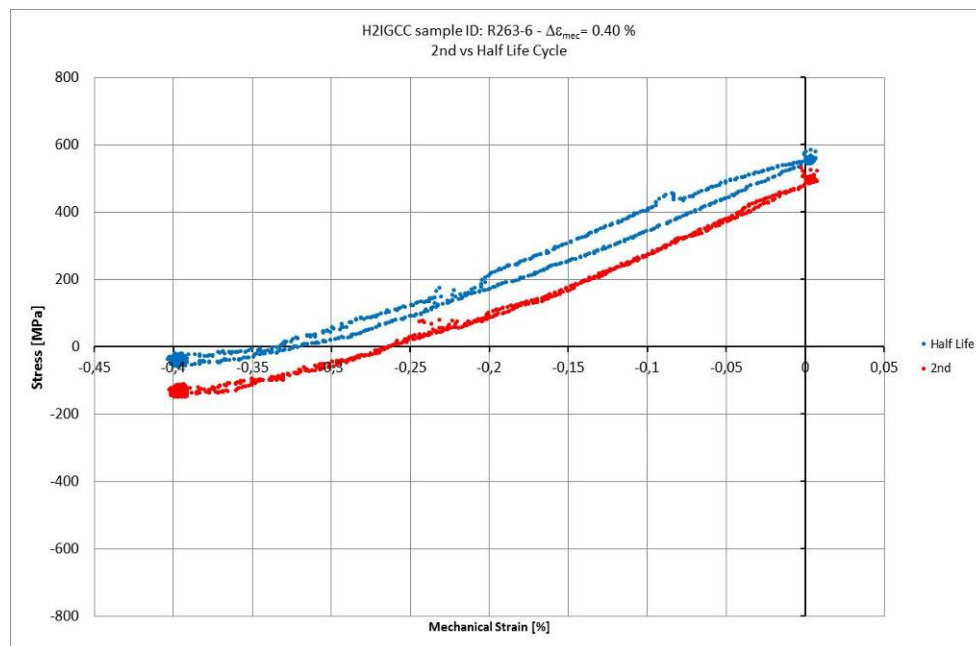
Figure 14 shows the hysteresis strain cycles during test comparing the initial condition (second cycle) and the half-life cycle. Some minor perturbations can be detected during cooling phases corresponding to intervention of additional air cooling for getting in line with required high cooling rate. Modification of air cooling system and valve opening program has been tested after this test in order to minimise strain cycle perturbations and results have been transferred to successive tests on coated specimens or repeated ones.

Figure 14 – Strain/stress hysteresis loop at second and half life cycles for R263-6 test

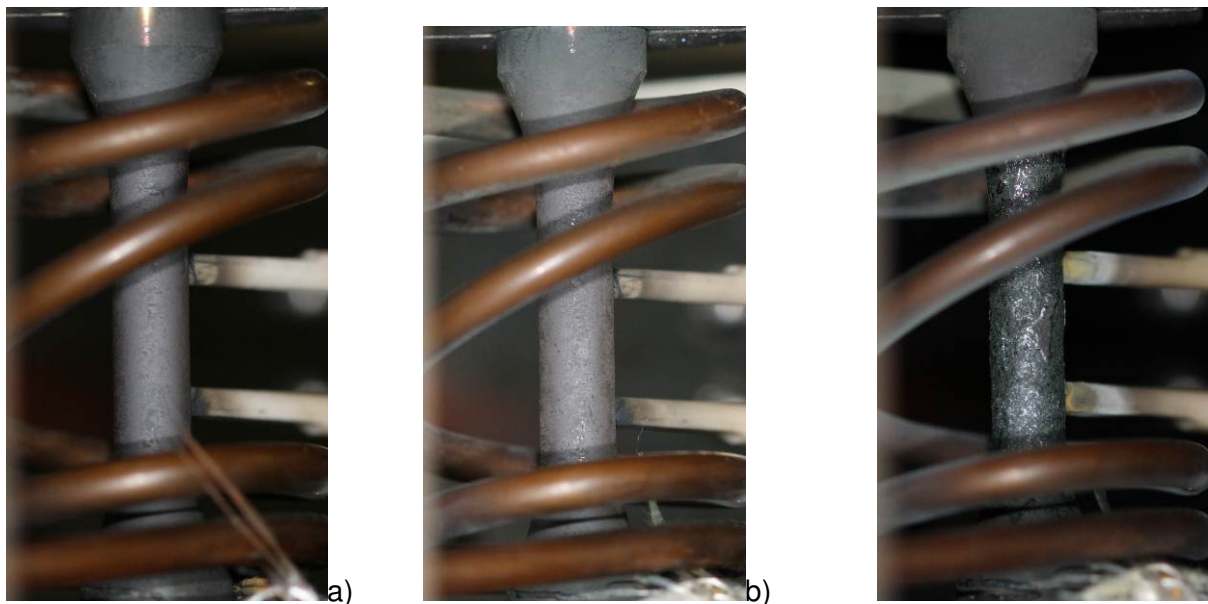
Detection of crack surface in gauge length is hindered by the oxidation of metal surface as shown in Figure 15. The surface oxidation starts to be detectable at 400 cycles and became very relevant after 1000 cycles.

Figure 15 - Aspect of gauge length surface: a) at initial cycle, b) after 400 cycle with initial oxidation, c) close to final cycle with relevant oxidation

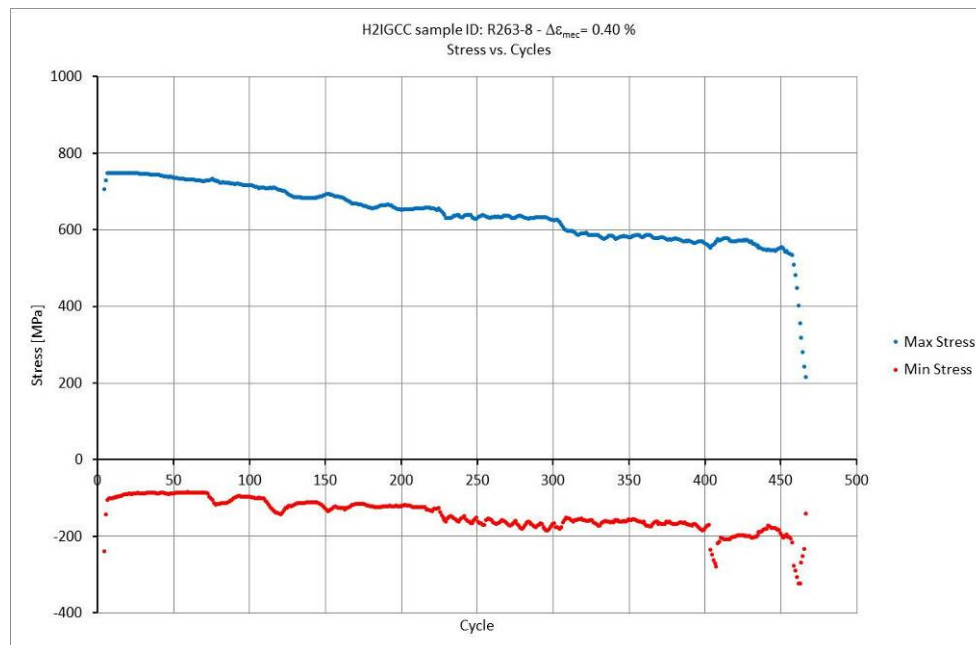
The maximum and minimum stress applied at each cycle after an initial increase show a trend of regular decreasing with sudden drop in the final phase as shown in Figure 16.

Figure 16 – Minimum and maximum stress at each cycle during R263-8 uncoated Rene 80 completely heat treated

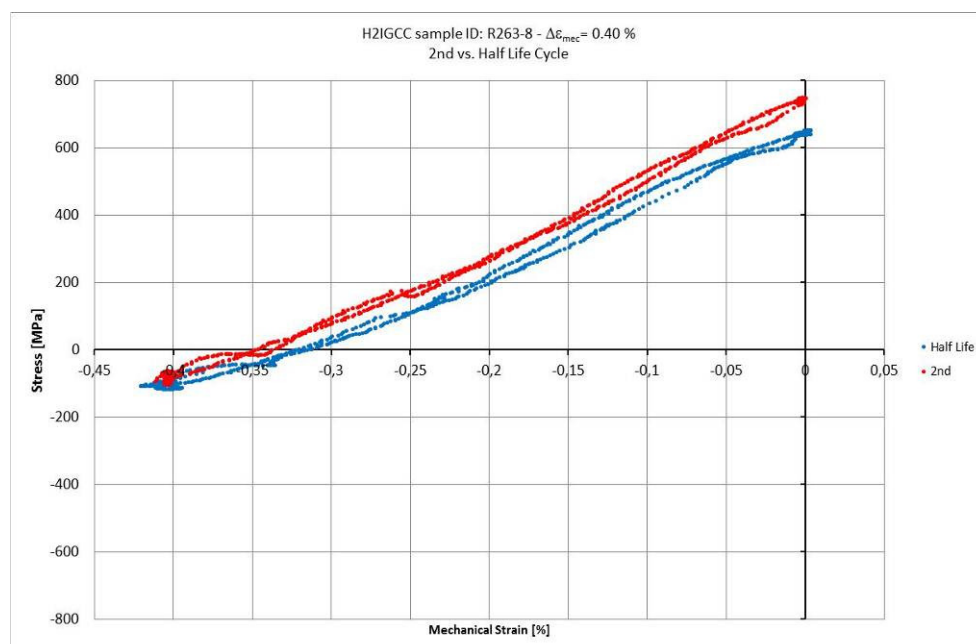
Figure 17 shows the hysteresis strain cycles during test comparing the initial condition (second cycle) and the half-life cycle..

Figure 17 – Strain/stress hysteresis loop at second and half life cycles for R263-8 test

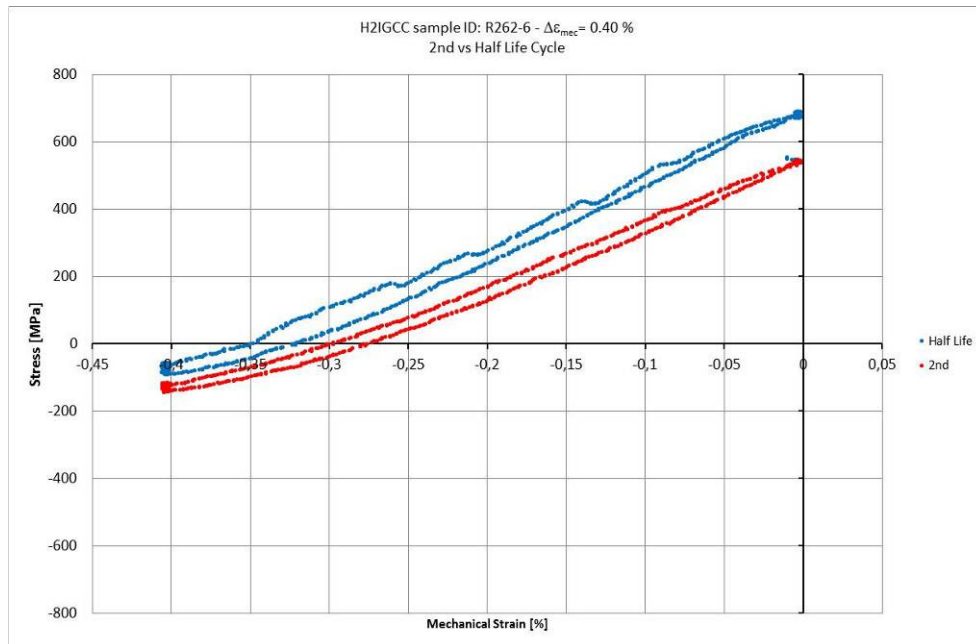
Figure 19 shows the hysteresis strain cycles comparing initial phase (second cycle) and half-life cycle.

Figure 19 – Strain/stress hysteresis loop at second and half life cycles for R262-6 test (coated Rene 80)

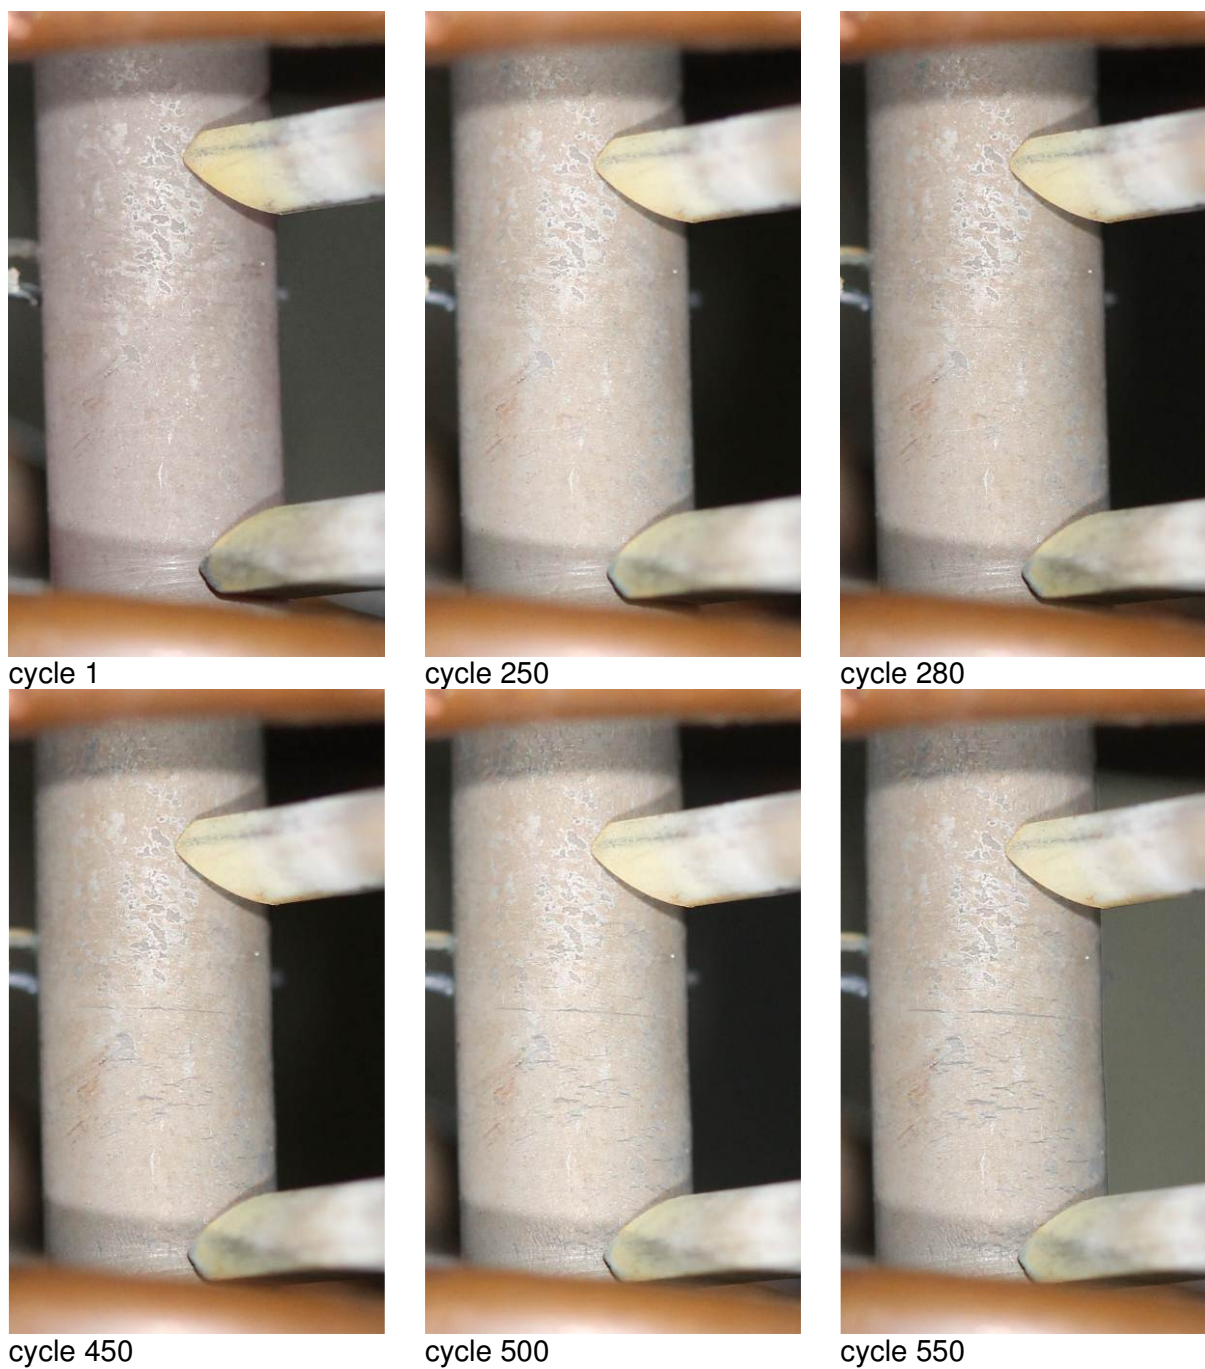
The first surface cracks in gauge length can be detected in between cycle 250 and 290, while the crack leading to failure can be detected after cycle 500. Figure 20 and Figure 21 show a sequence of some significant pictures with crack surface formation and growth during test.

Figure 20 – Pictures taken at different cycles showing the formation and growth of some surface crack in the central part of gauge length for specimen R262-6 (coated Rene 80)

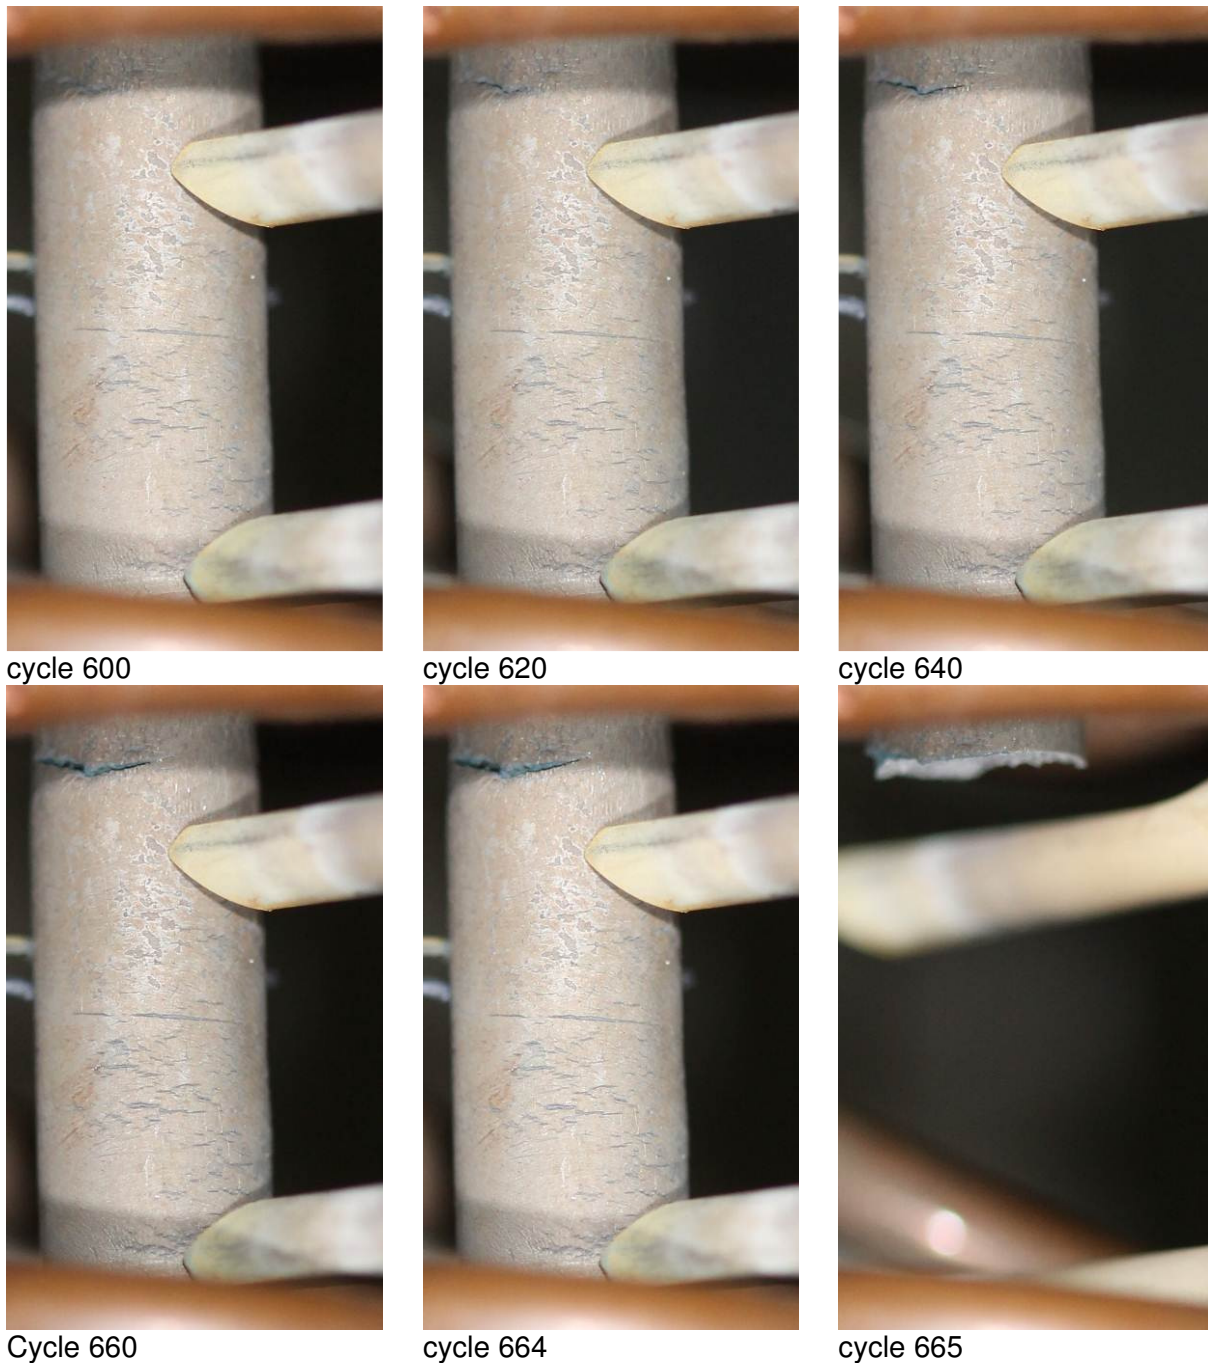
Cycle 660

Figure 21 – Pictures taken at different cycles showing the growth of surface crack leading to final failure in the upper part of gauge length for specimen R262-6 (coated Rene 80)

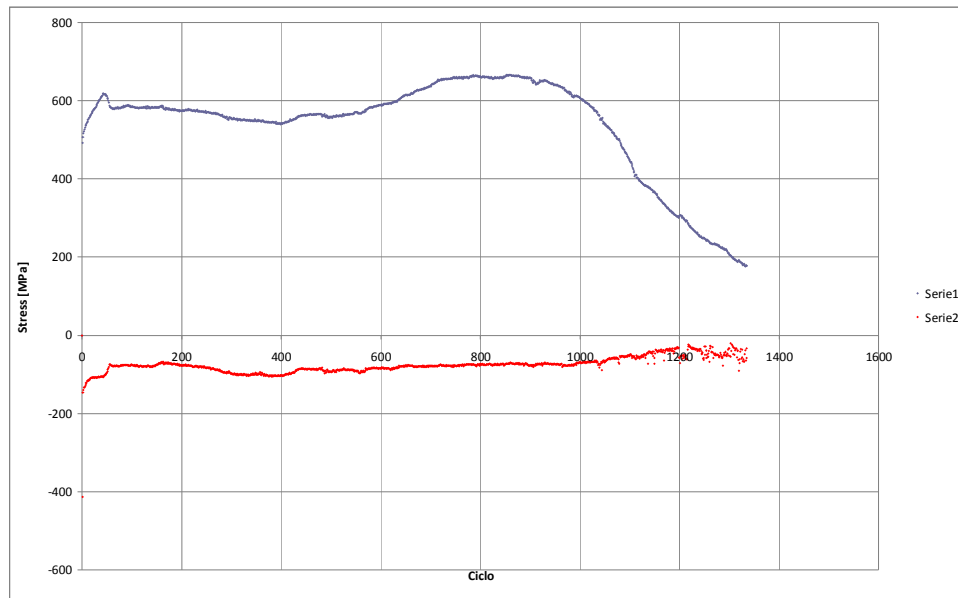
A second test has been performed on specimen R262-5 (always Rene 80 coated with SiCoat 2464 and aged in air 1000 h at 1000 °C) applying the same parameters of R262-6, except a reduced mechanical strain (reduced to - 0.35%). This test showed the formation of several cracks on specimen coated surface with a progressive increase of drop load. Test has been stopped after 1335 cycles matching a boundary limit for security of the machine on drop load. Post-test estimation assuming as end of life criteria (25% drop of maximum stress) showed this condition has been reached after 1079 cycles. First crack on gauge length surface can be detected in the range between cycle 570 and 630. The maximum and minimum (applied at each cycle) stress trend during test is shown in Figure 22.

Figure 22 – Minimum and maximum stress at each cycle during R262-5 coated Rene 80 aged in air tested with 0.35 % mechanical strain

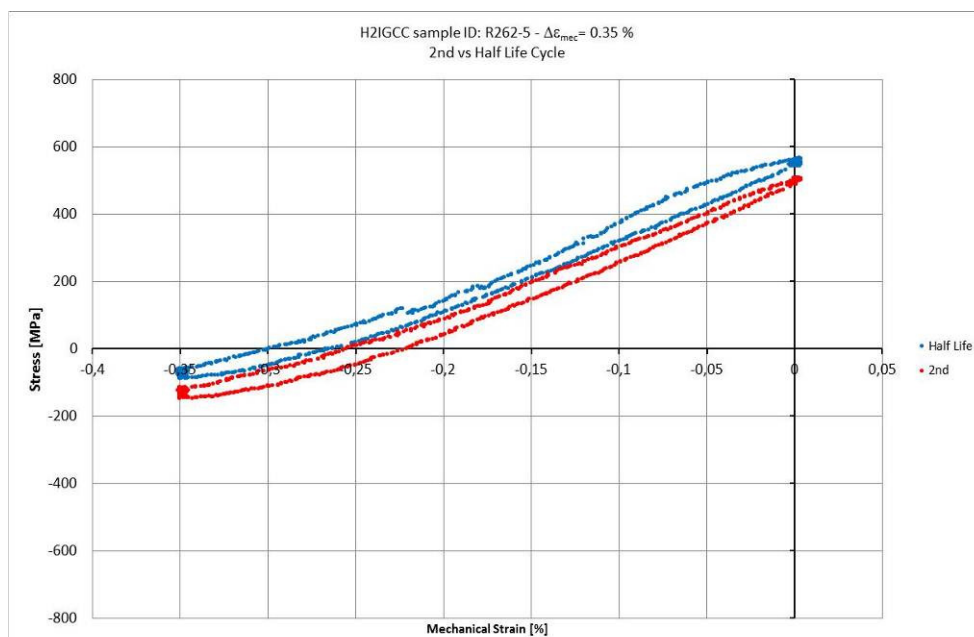
The hysteresis strain cycles comparing initial phase (second cycle) and half life cycle is shown in Figure 23.

Figure 23 – Stress/strain hysteresis loop at second and half-life cycles for test on specimen R262-5

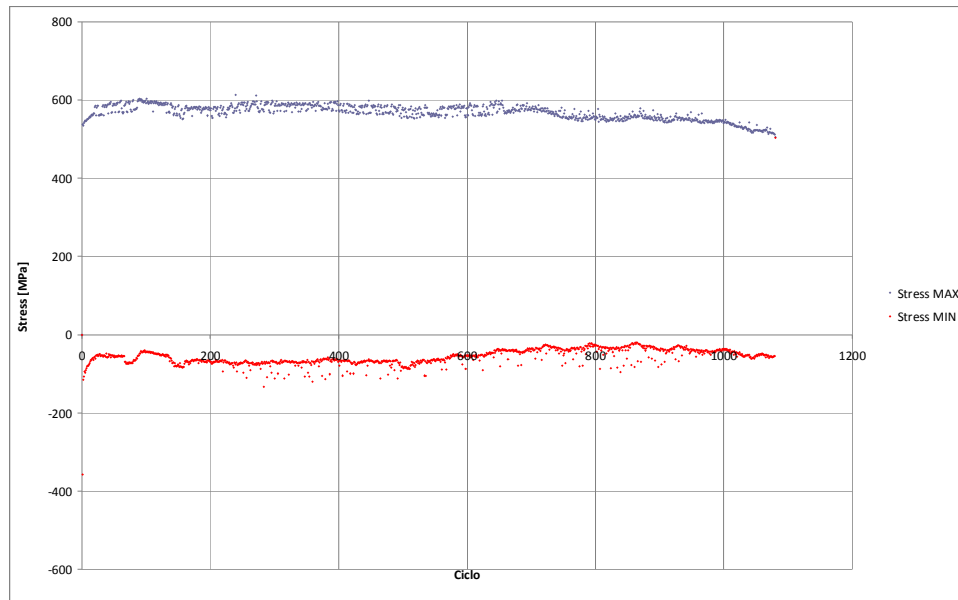
A third test has been started on specimen R262-4 (always Rene 80 coated with SiCoat 2464 and aged in air for 1000 h at 1000 °C) repeating the test on R262-5 with programmed stop after 1079 cycles (the number of cycles where end life criteria was matched in previous test) unless a quicker matching of end criteria on load drop would be obtained. Test has been completed with detection of several cracks in gauge length; the first crack can be detected in the range between cycle 250 and 300. The maximum and minimum (applied at each cycle) stress trend during test is shown in Figure 24. At the end of cycle 1079 (pre-defined stop) the drop load of maximum stress was approximately 18% showing a condition close to usual end criteria (25% drop load) and

Figure 24 – Minimum and maximum stress at each cycle during R262-4 coated Rene 80 aged in air tested with 0.35 % mechanical strain and stopped at cycle 1079

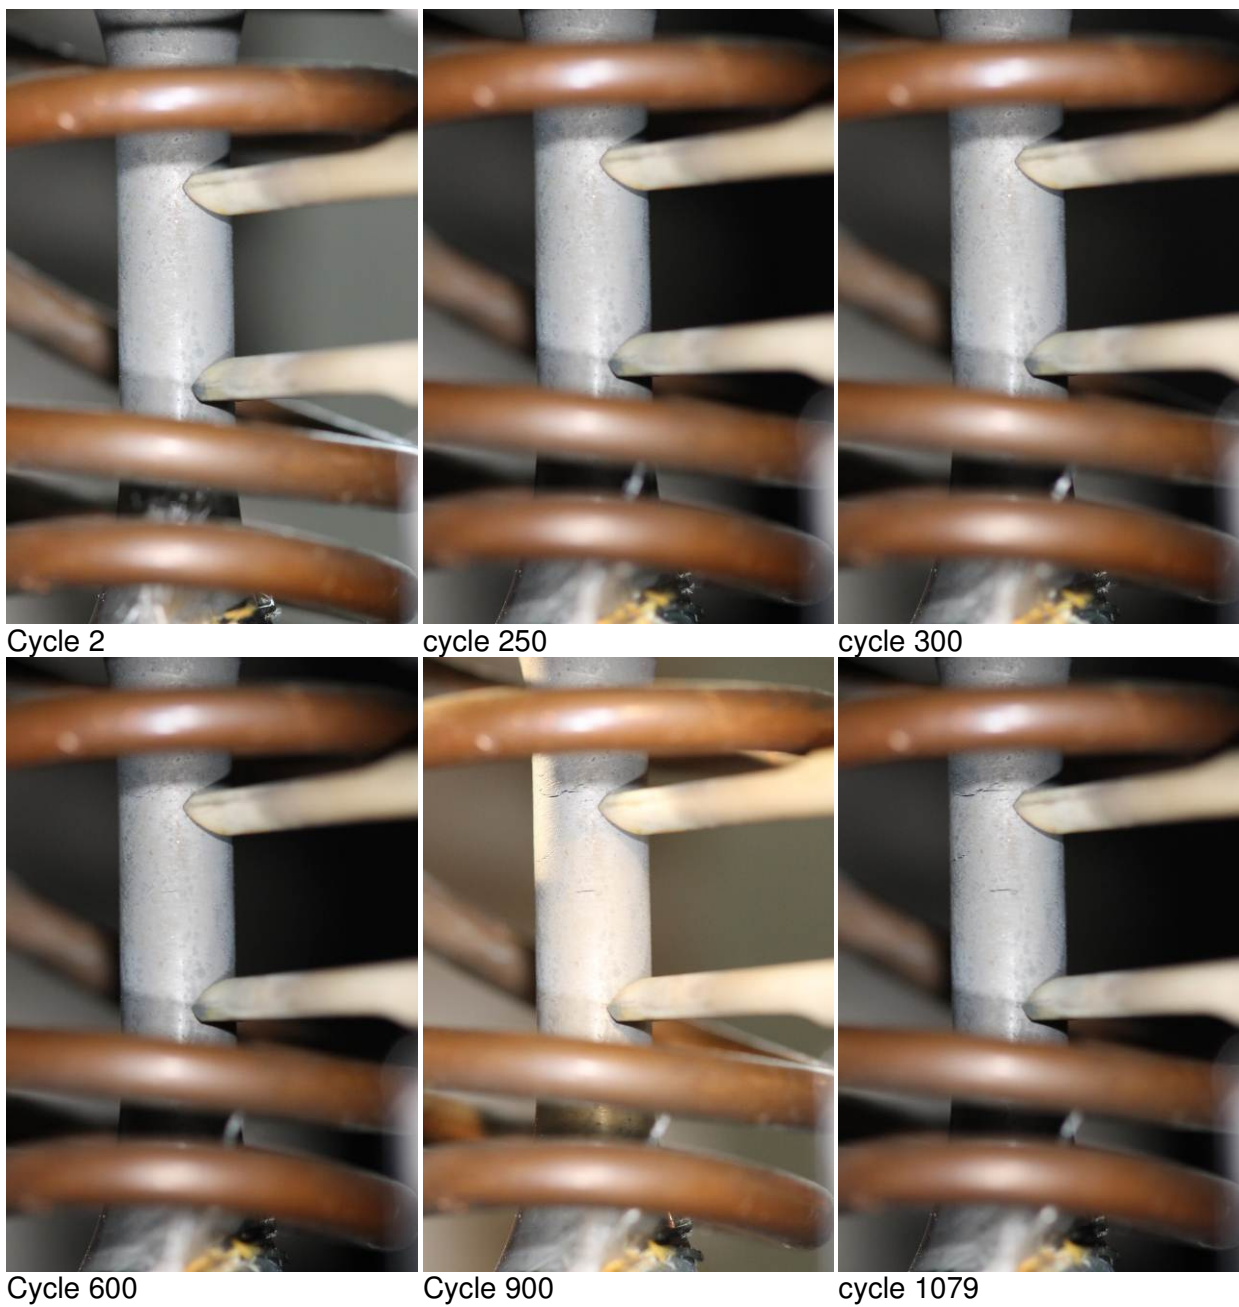
A sequence of some significant pictures acquired during test at significant steps for crack surface formation and growth is presented in Figure 25.

Figure 25 - Pictures taken at different cycles showing the growth of surface crack in gauge length for specimen R262-4 (coated Rene 80)

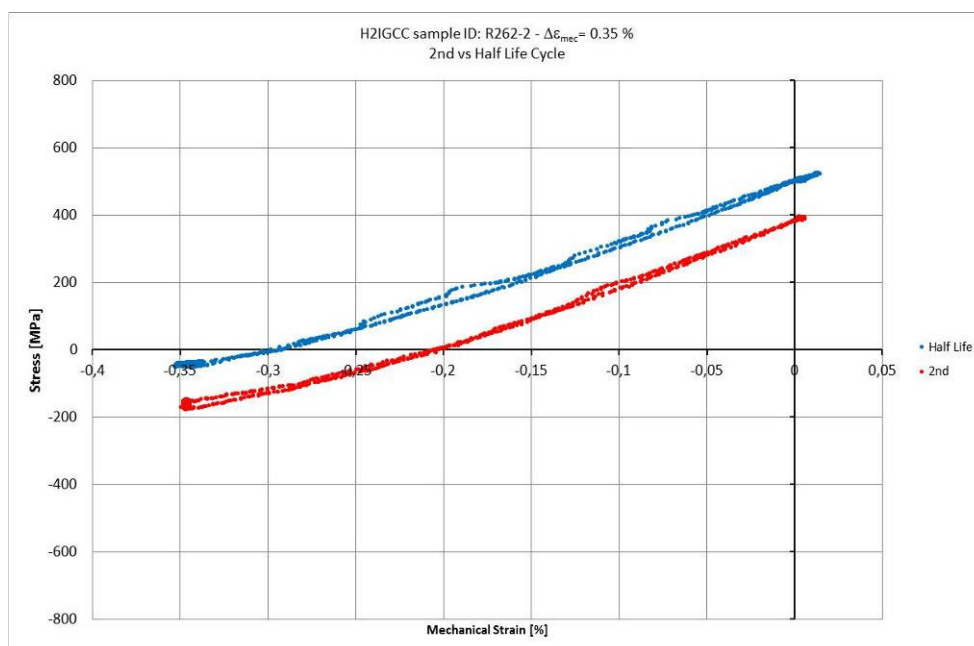
The hysteresis strain cycles comparing initial phase (second cycle) and half life cycle is shown in Figure 27

Figure 27 - Stress/strain hysteresis loop at second and half-life cycles for test on specimen R262-2

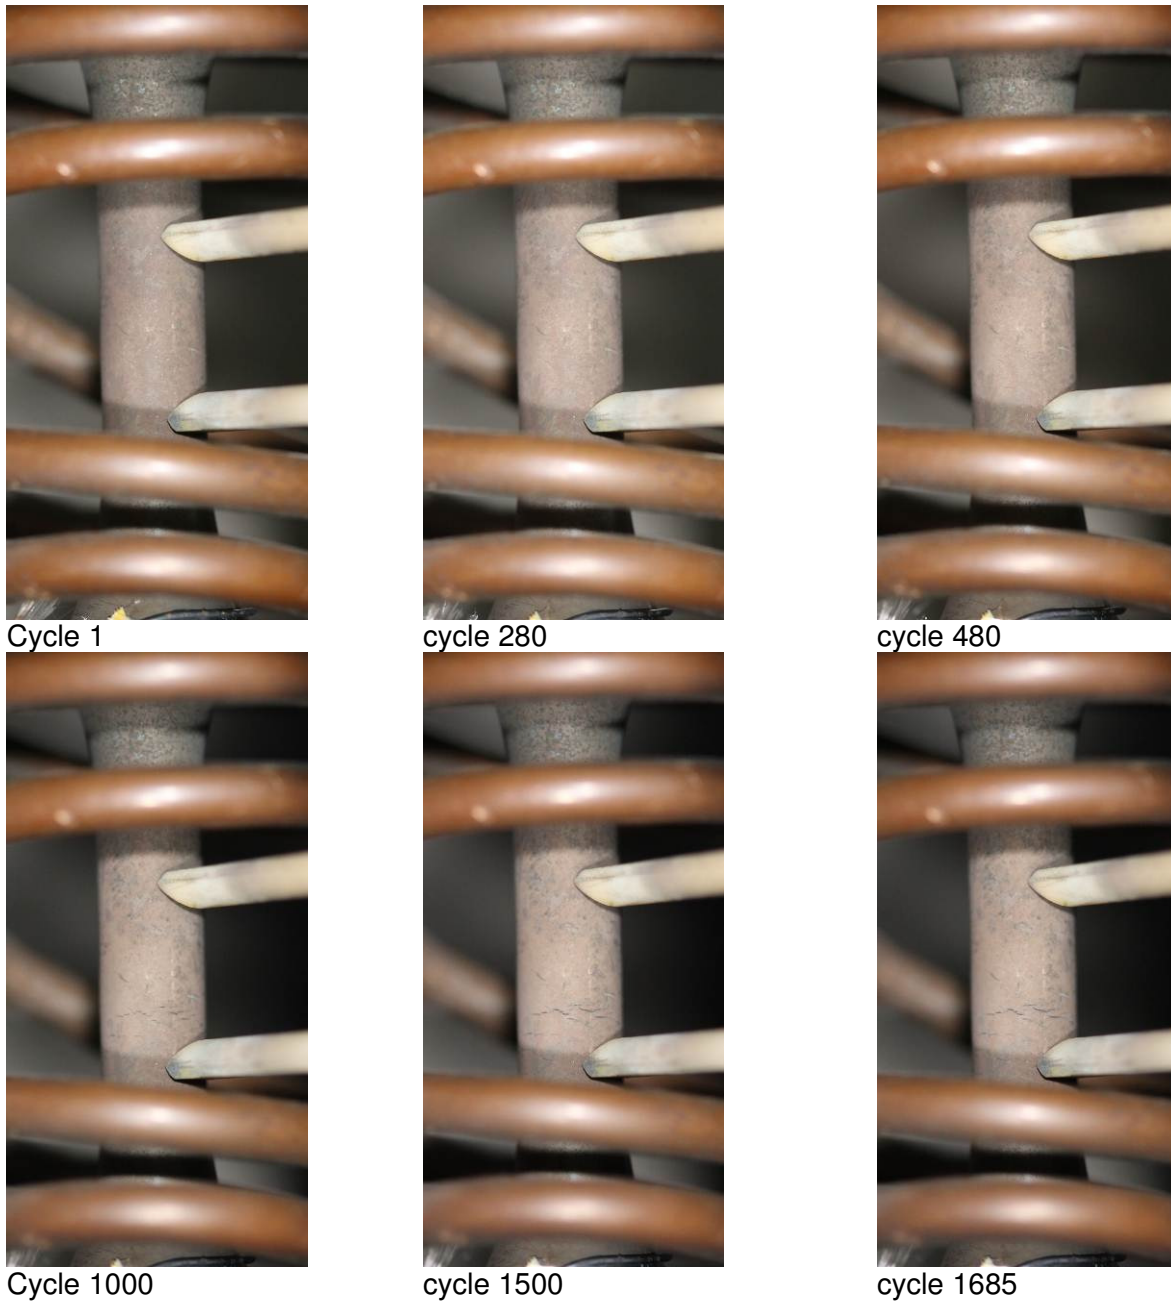
Pictures representative of surface crack evolution acquired during test are presented in Figure 28

Figure 28 - Pictures taken at different cycles showing the growth of surface crack in gauge length for specimen R262-2 (coated Rene 80)

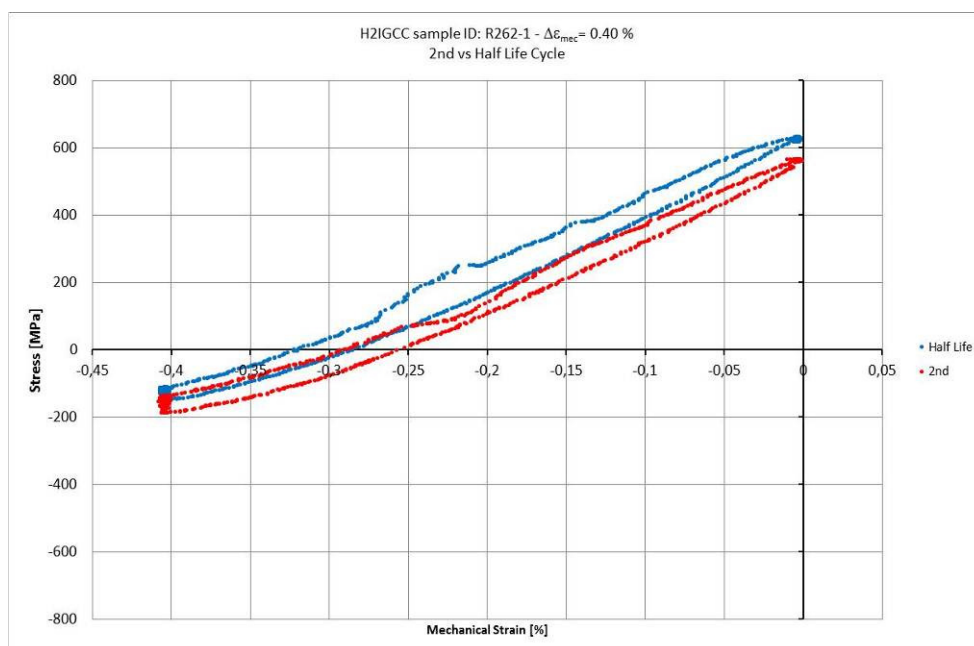
The hysteresis strain cycles comparing initial phase (second cycle) and half life cycle is shown in Figure 30.

Figure 30 - Stress/strain hysteresis loop at second and half-life cycles for test on specimen R262-1

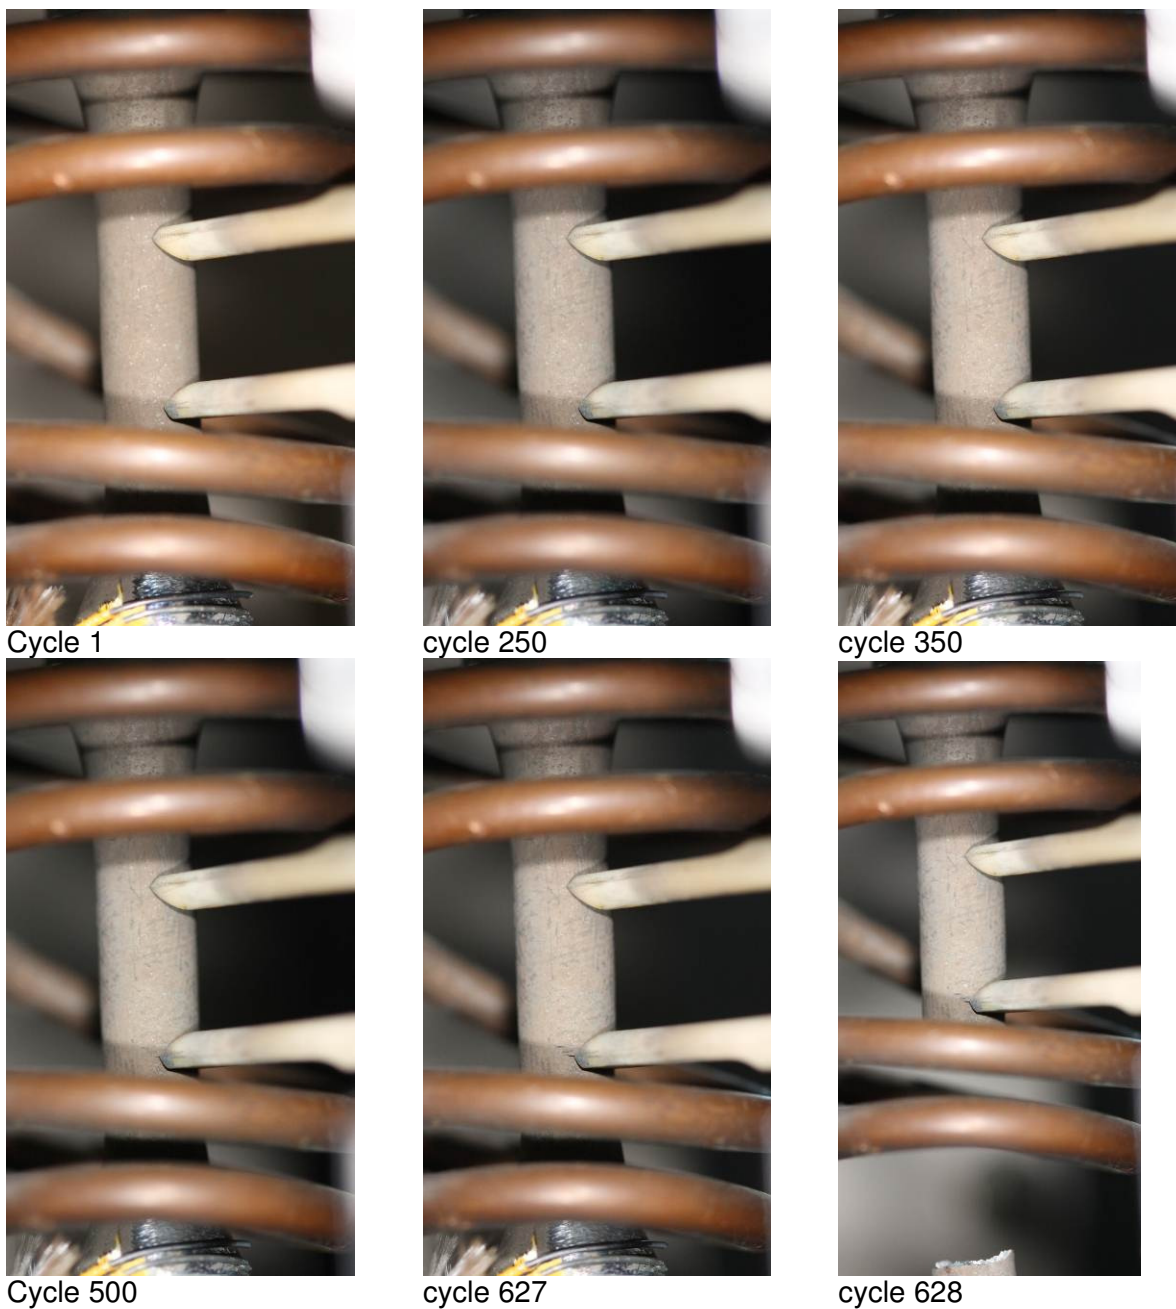
The images of some surface cracks evolution during test are collected in Figure 31 representing some relevant step of damage evolution.

Figure 31 - Pictures taken at different cycles showing the growth of surface crack in gauge length for specimen R262-1 (coated Rene 80)

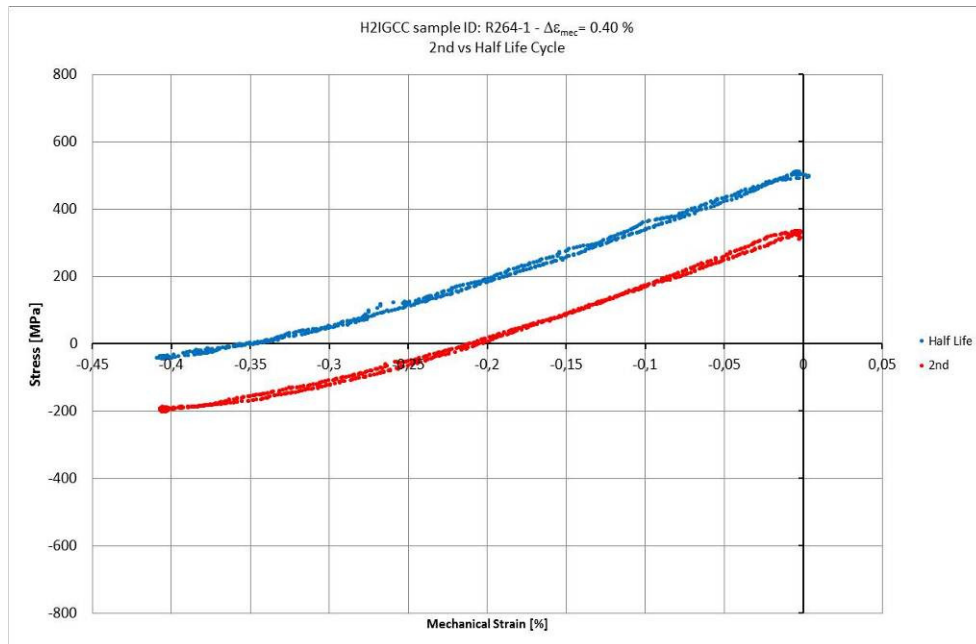
The hysteresis strain cycles comparing initial phase (second cycle) and half life cycle is shown in Figure 37.

Figure 37 - Stress/strain hysteresis loop at second and half-life cycles for test on specimen R264-1

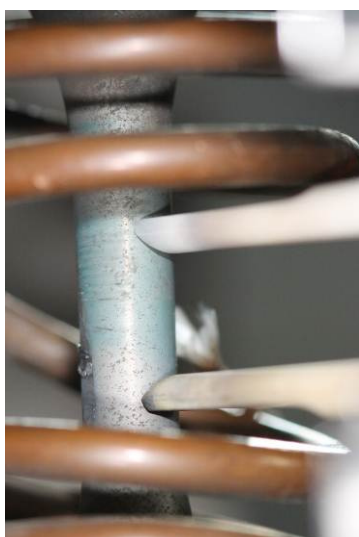
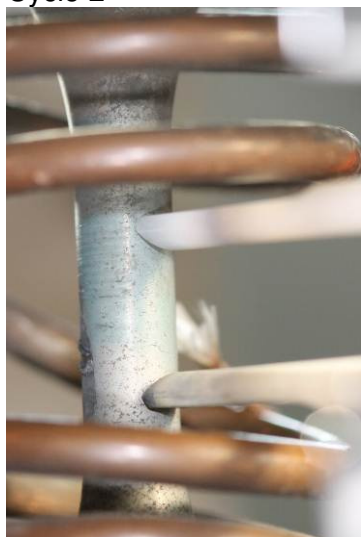
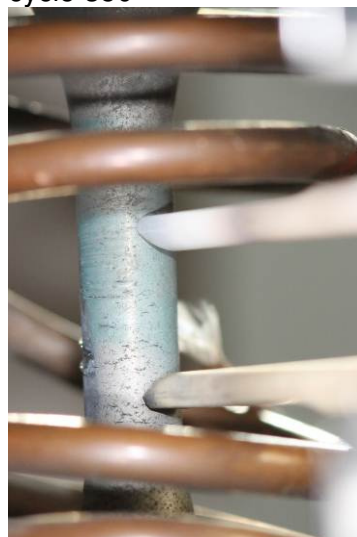
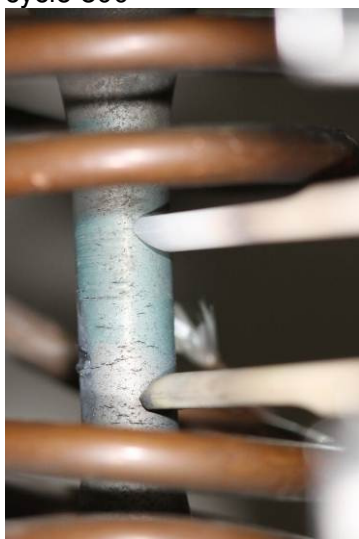
cycle 200

Cycle 400

cycle 1100

cycle 1300

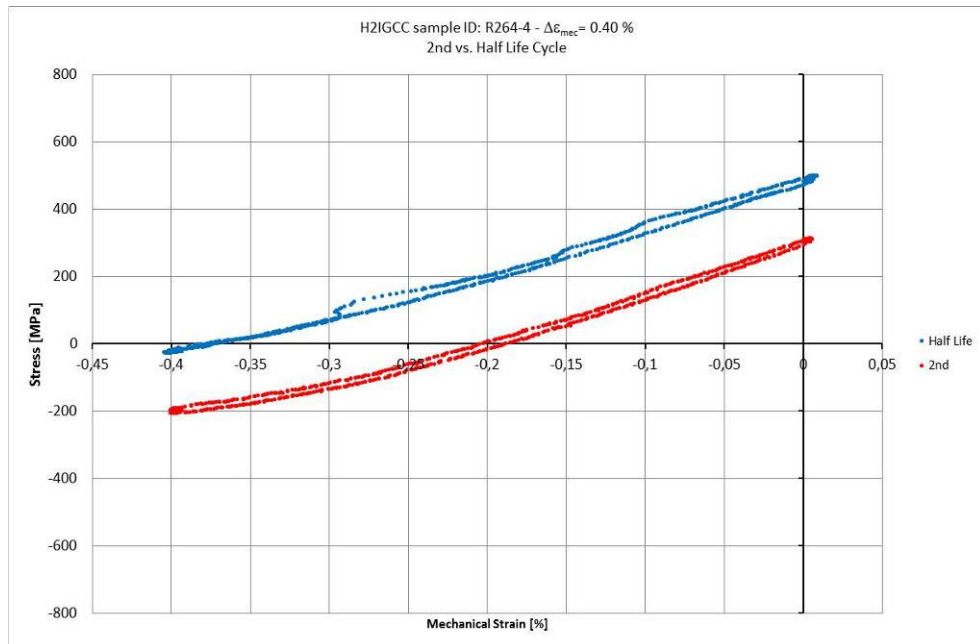
Figure 41 - Stress/strain hysteresis loop at second and half-life cycles for test on specimen R262-4
