H₂-IGCC Project Deliverable

Grant Agreement number	239349
Project acronym	H ₂ -IGCC
Project title	Low Emission Gas Turbine Technology for Hydrogen-rich Syngas
Funding Scheme	FP7-ENERGY-2008-TREN-1
Subproject	2 Materials
Work Package	2.2 Performance of state-of-the-art materials/coatings in novel operating conditions
Delivery number - name	D 2.2.6
Lead Beneficiary	
Dissemination level	Limited
Delivery month	43
Name, title and organisation of the scientific representative of the project's coordinator	Christer Bjorkqvist Managing Director, European Turbine Network (ETN) Tel: 00 32 2 646 1577 Fax: 00 32 2 646 15 78 E-mail: cb@etn-gasturbine.eu Project website address: www.h2-igcc.eu

Subject Mechanical characterisation of materials.

Notes Deliverable D 2.2.6

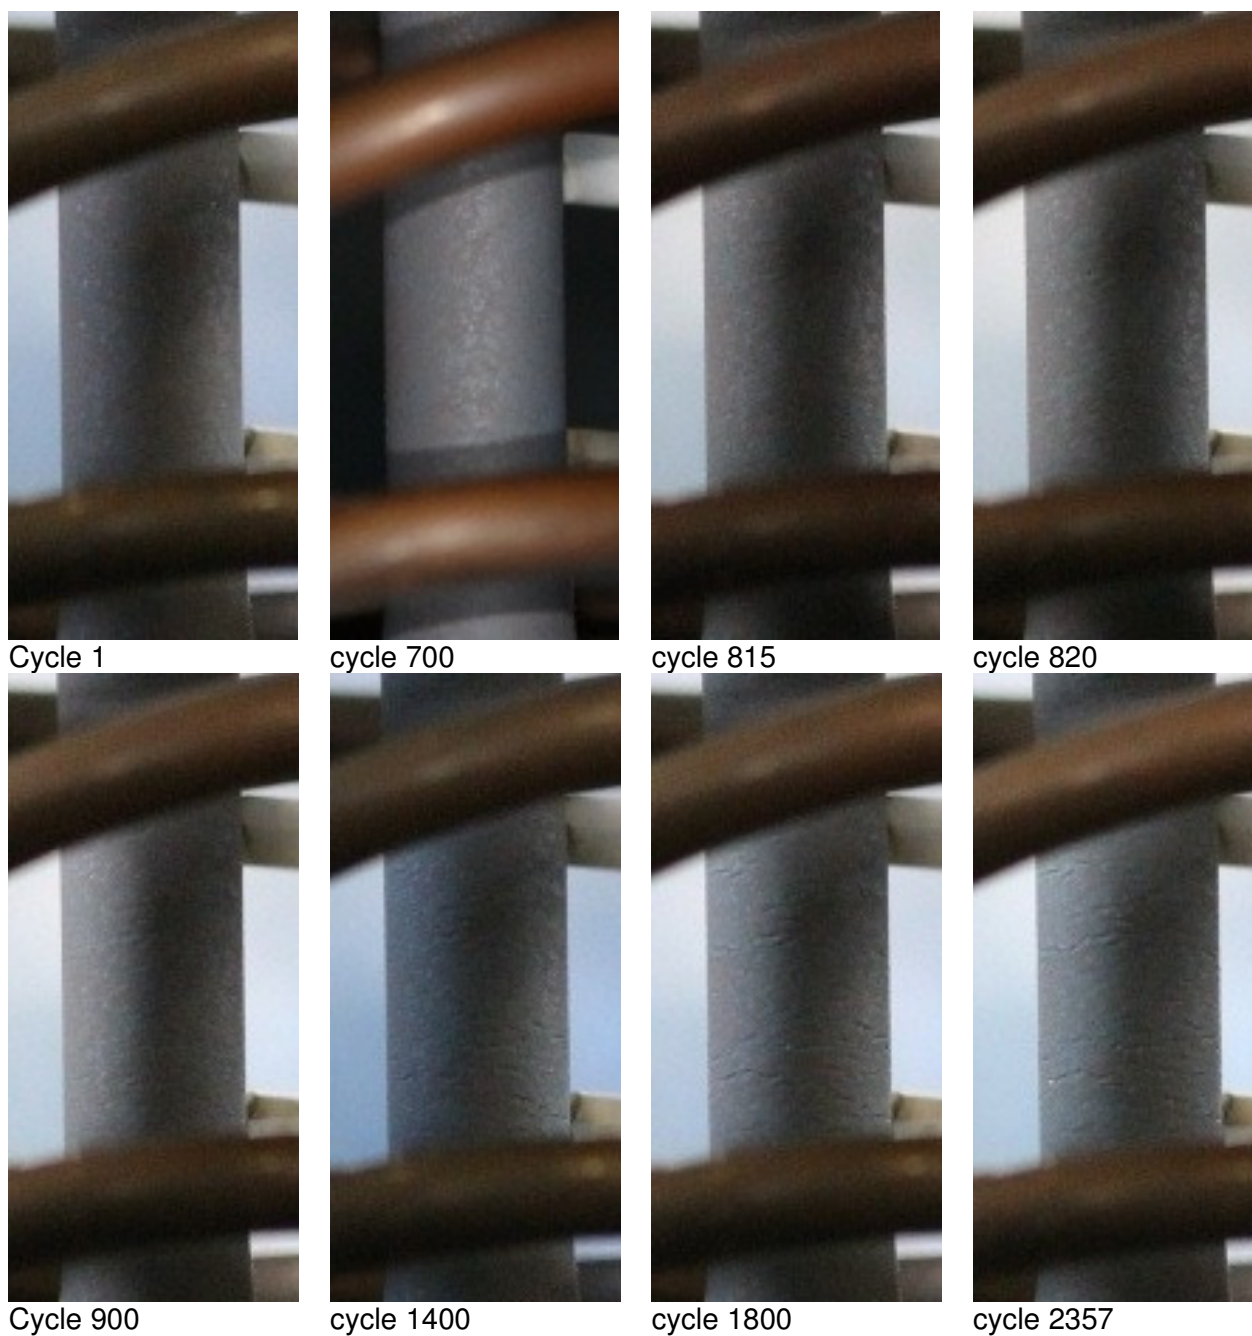
First cracks surface in gauge length can be detected after about 820 cycles as very limited penetration in coating material. Pictures of most significant steps in crack development are summarised in Figure 42.

Figure 42 - Pictures taken at different cycles showing the growth of surface crack in gauge length for specimen R262-4 (coated PWA 1483 aged air+ steam)

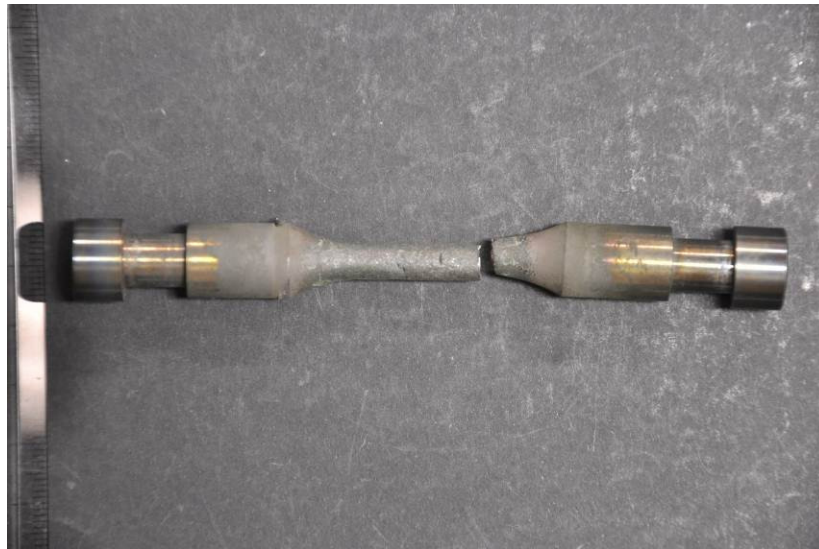
Figure 43 – R263-6 broken specimen after 1284 cycles in TMF test

Specimen went to rupture after 1284 cycles without any relevant variation in max and min stress applied at each cycle as previously shown in Figure 13. The aspect of broken specimen disassembled from TMF test machine is presented in Figure 43.

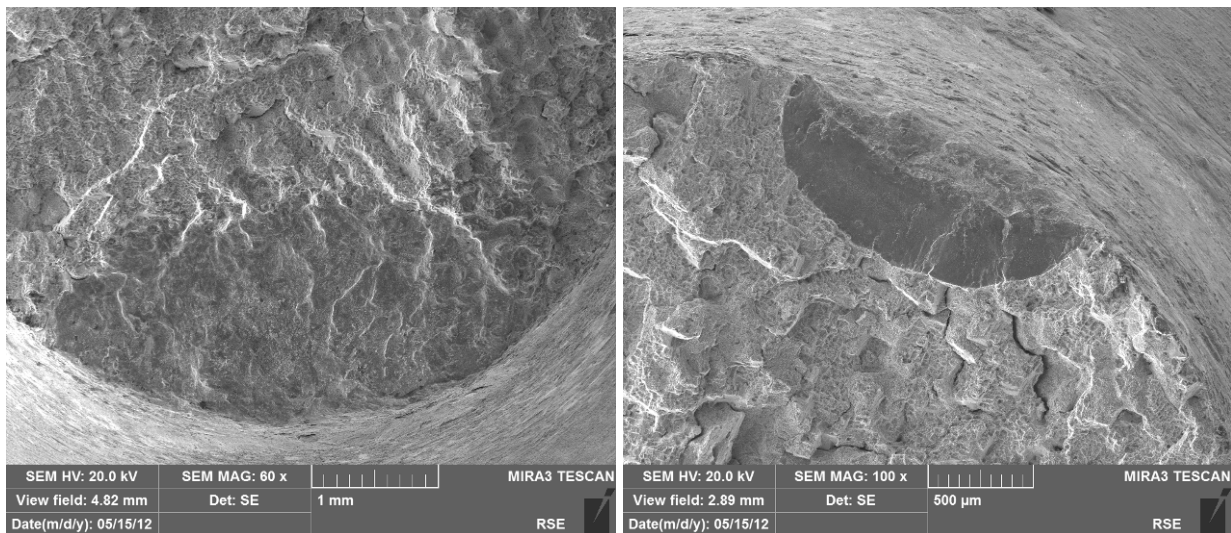
Two separated areas of crack initiation and growth can be observed, easily detectable due to surface oxidation and smoother aspect. Details at large magnification of the two areas are presented in Figure 45.

Figure 45 – View of the two separated areas with crack initiation and growth on fracture surface (R263-6)

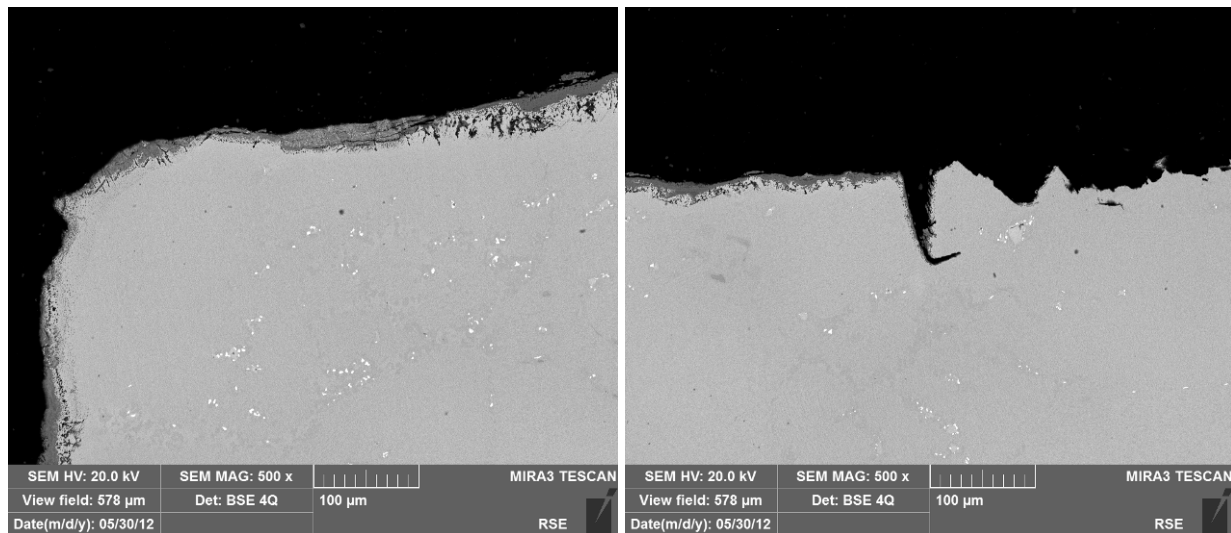
Figure 47 – Fracture surface on metallographic specimen from R263-6: a) crack initiation and growth with oxidation b) transition from oxidised surface to final tear with more fragmented aspect

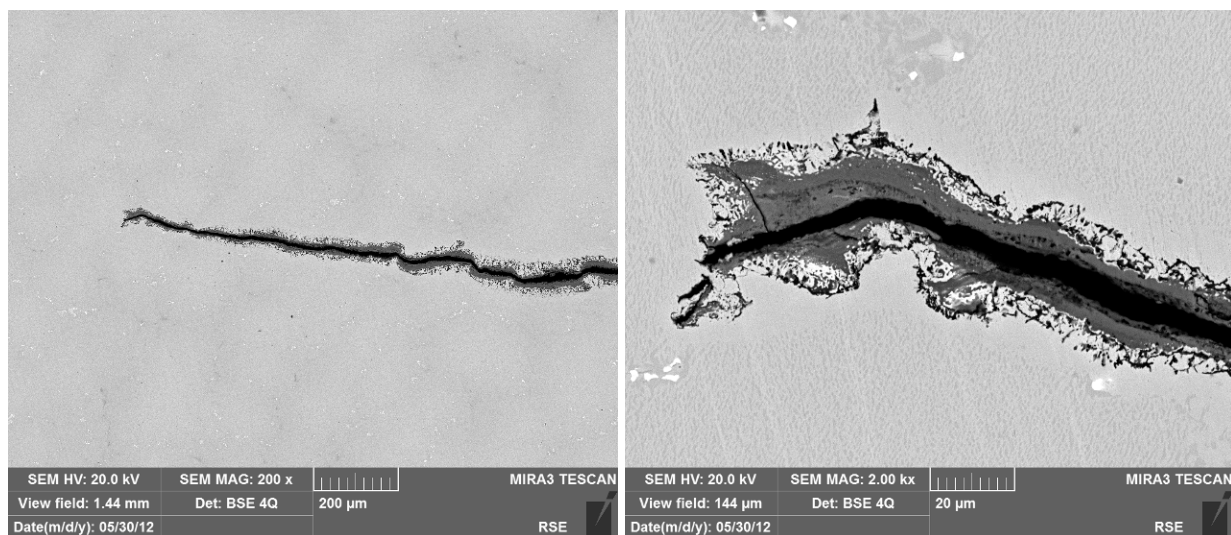
Figure 48 – Aspect of a secondary crack and detail of crack tip (R263-6)

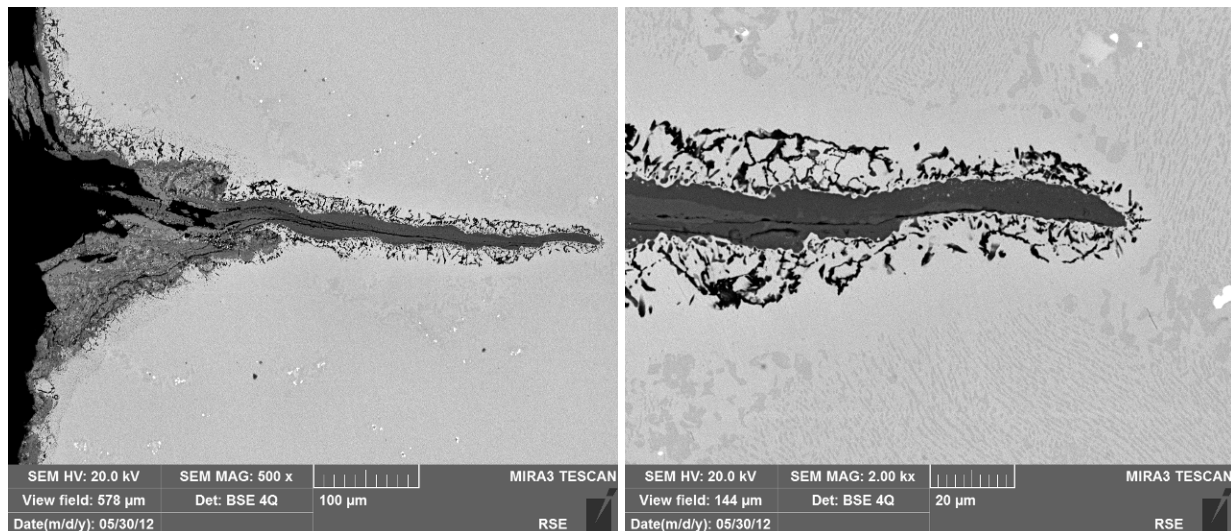
Figure 49 – Aspect of a secondary crack and detail of crack tip (R263-6)

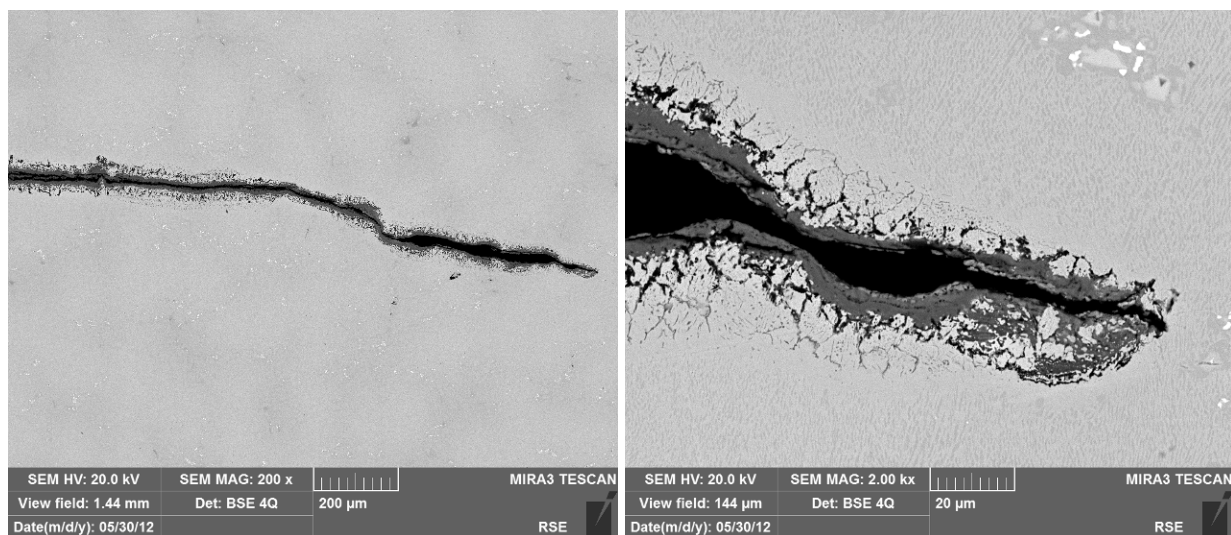
Figure 50 – Aspect of a secondary crack and detail of crack tip (R263-6)

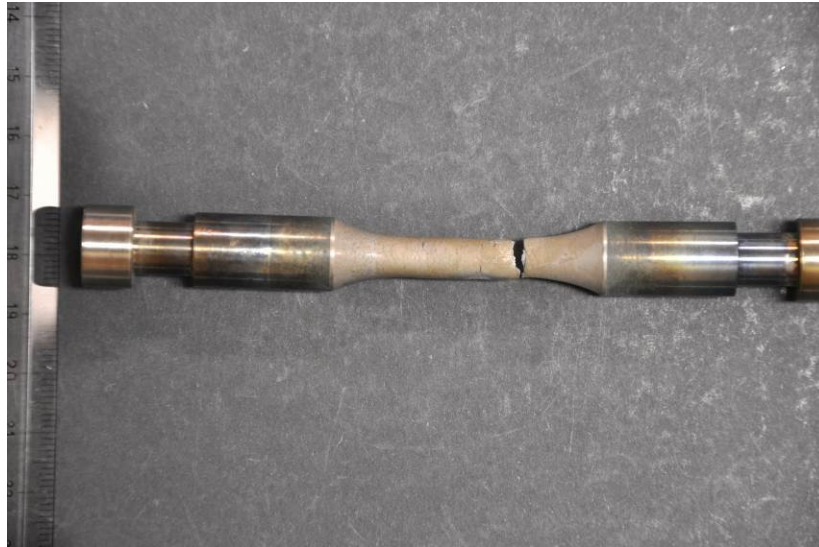
Figure 51 – R262-6 broken specimen after 665 cycles in TMF test

This specimen has been tested with the application of thermal cycle described in Figure 12 and a compressive mechanical strain (- 0.4%) at maximum temperature. Specimen went to failure after 665 cycle. The first cracks can be detected on gauge length after about 200 cycles, the crack leading to final failure can be detected later at about 500 cycles.

The aspect of broken specimen disassembled from TMF test machine is presented in Figure 51.

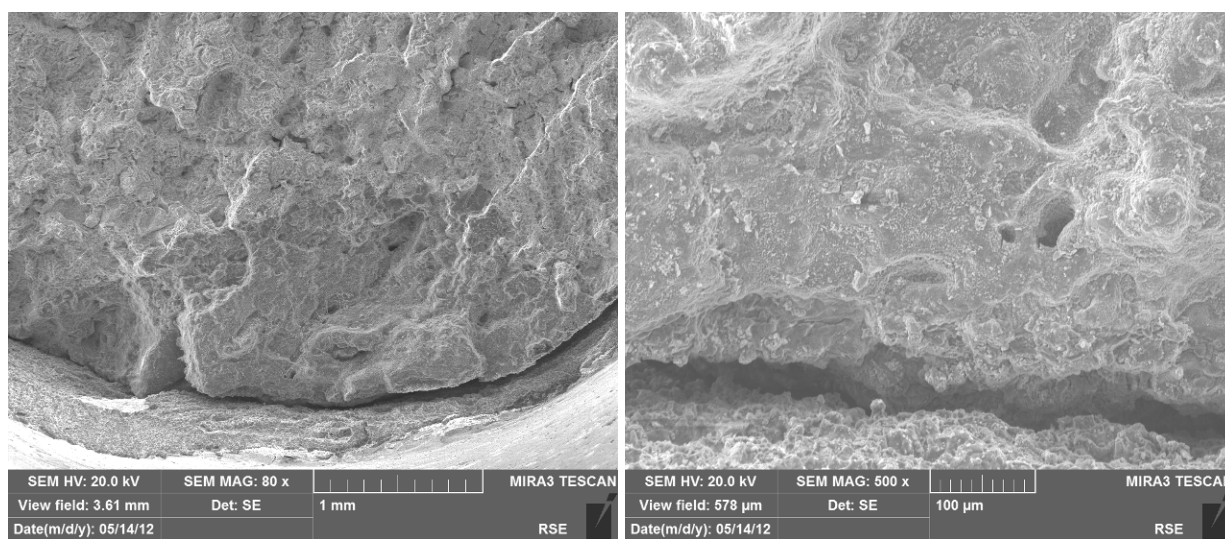
Figure 54 – SEM observation at different magnification of crack initiation area on fracture surface (R262-6)

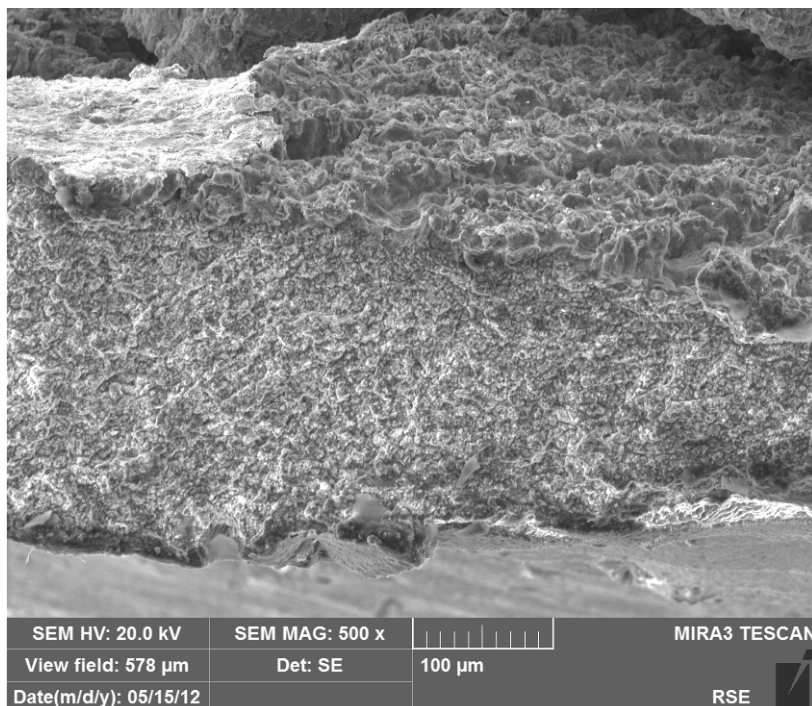
Figure 55 – Aspect of bond coat in crack initiation area of fracture surface (R262-6)

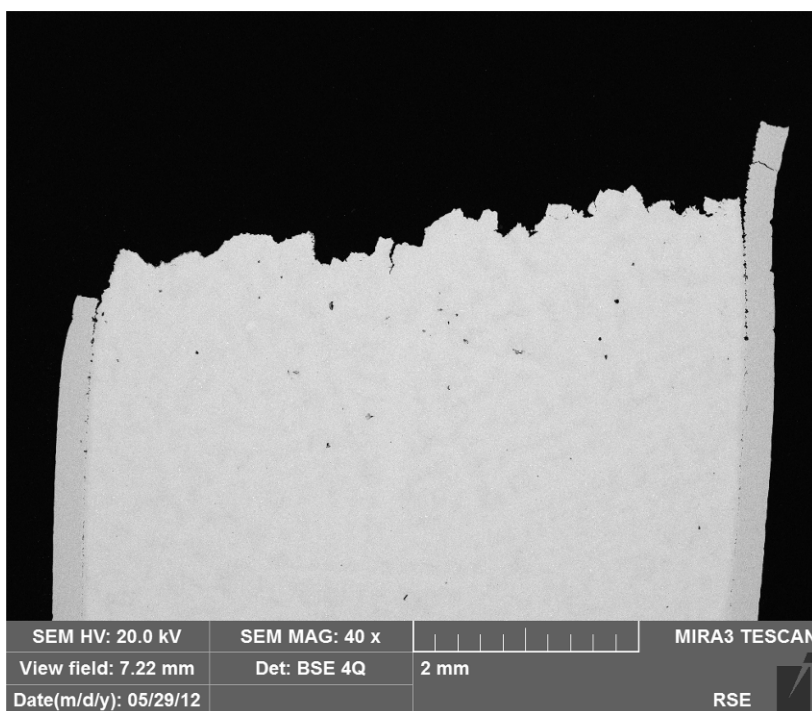
Figure 56 – Macro view of metallographic specimen transversal to fracture surface (R262-6)

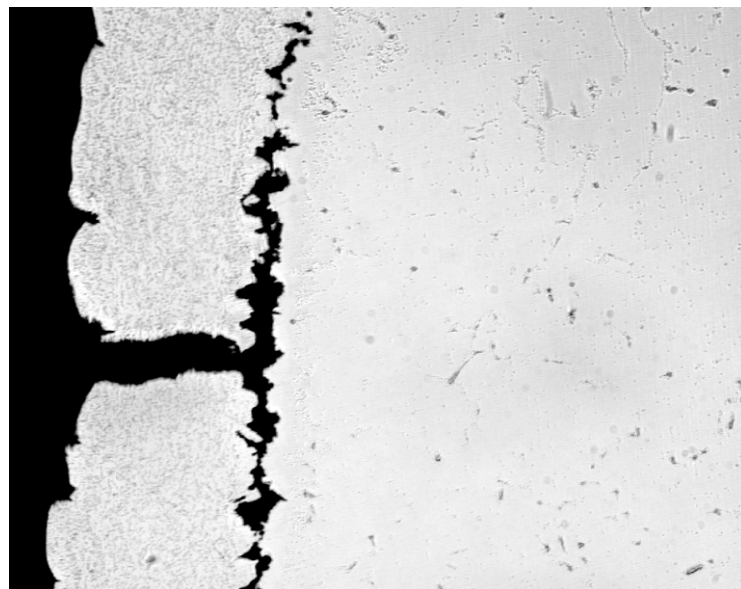
Figure 58 – Aspect of other cracks in bond coat or detachment of bond coat from base metal (R262-6)

Some additional cracks limited to bond coat and some detachments of bond coat from base material can be observed in the same metallographic specimen at a certain distance from fracture surface, as shown in Figure 58.

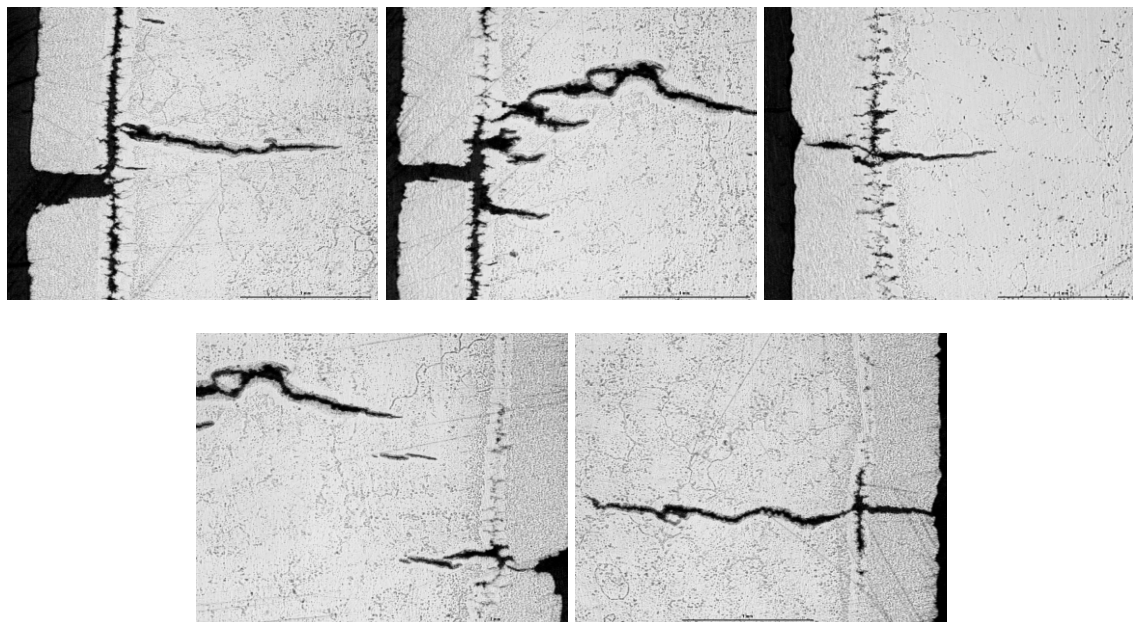
Figure 60 – Some cracks observed in metallographic specimen from R262-5

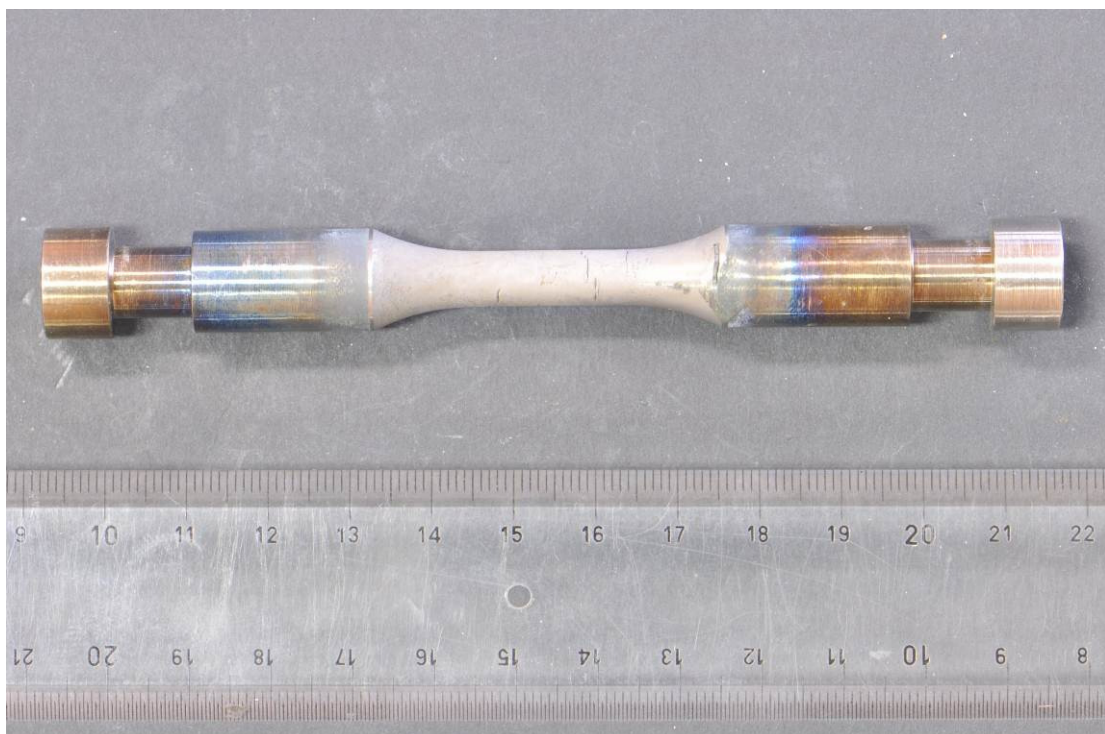
Figure 62 – Aspect of specimen R262-4 at the end of TMF test

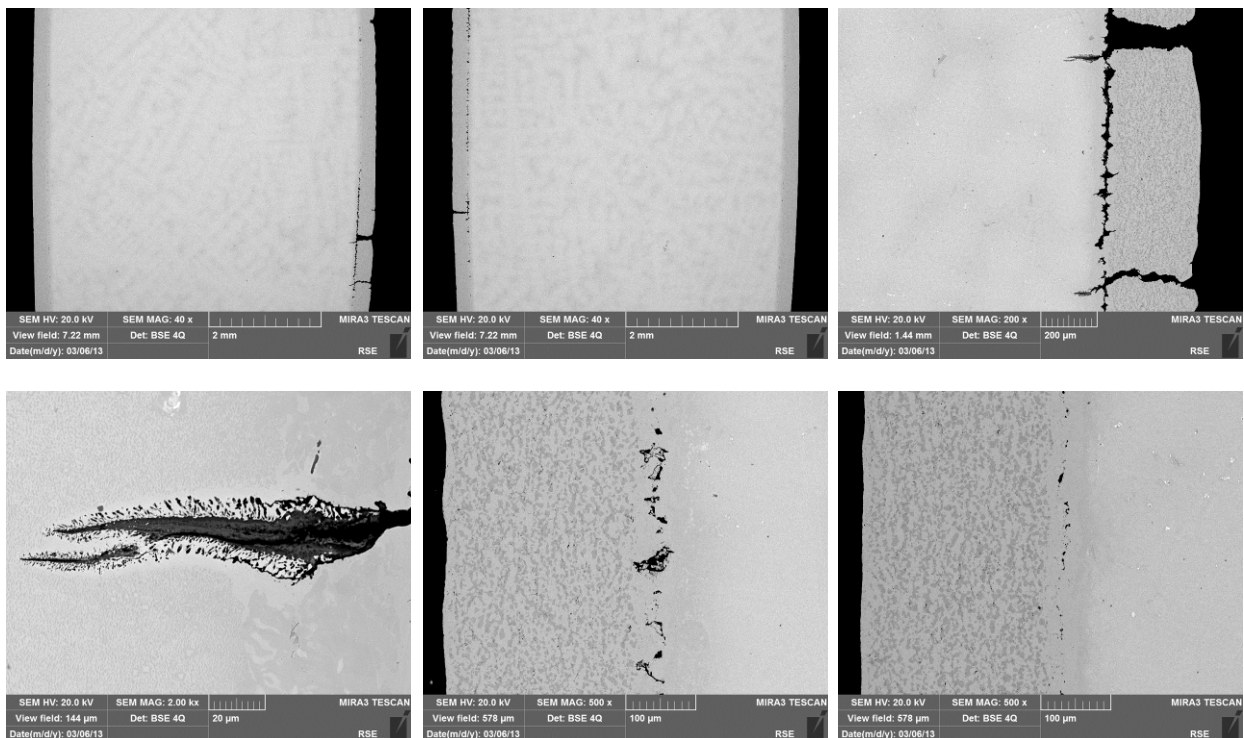
Figure 64 – The aspect of different cracks observed on metallographic section of specimen R262-4

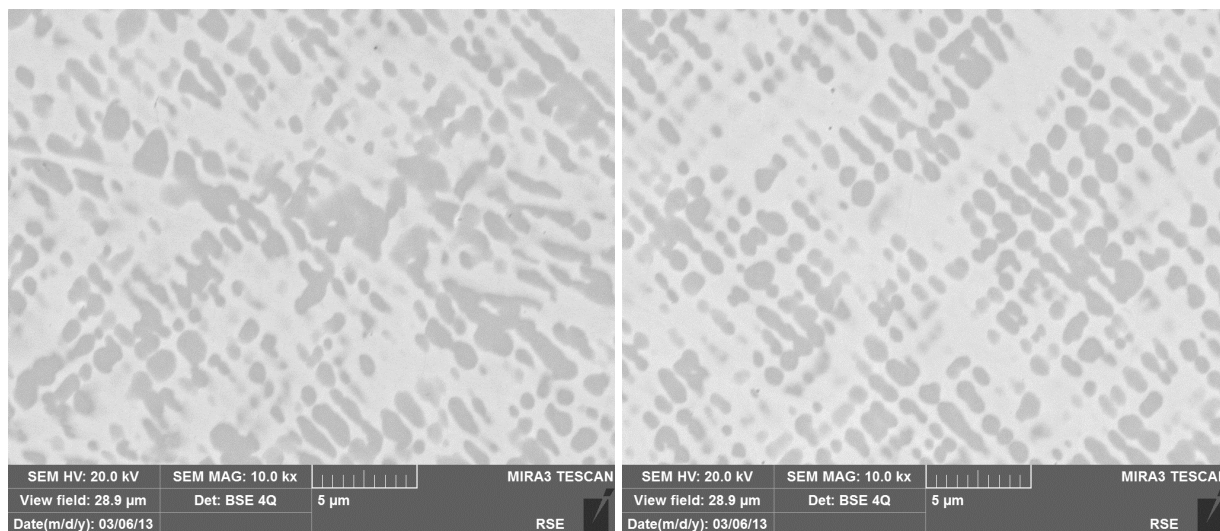
Figure 65 – Aspect of γ' in base metal of specimen R262-4 after test

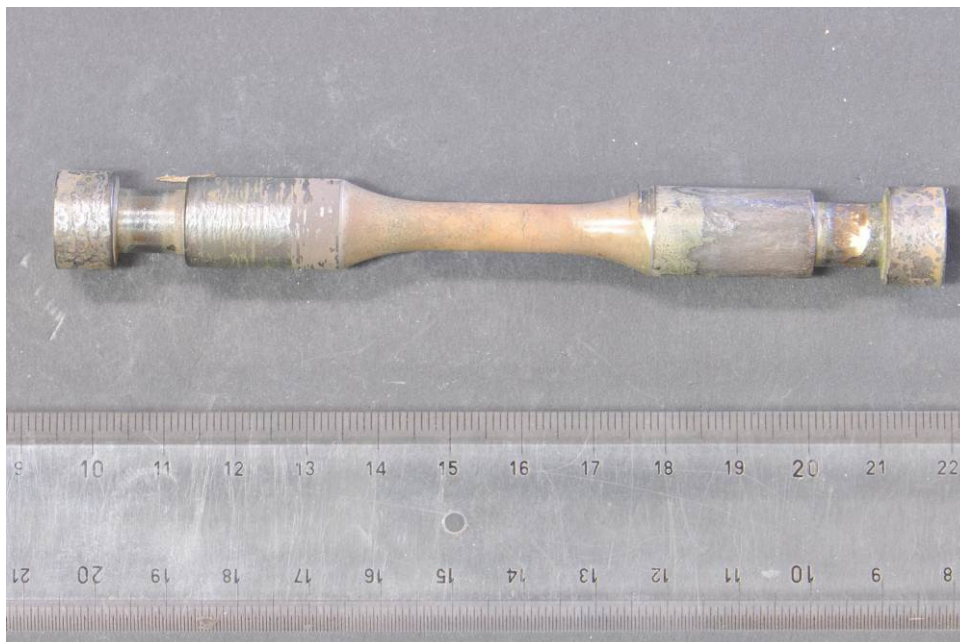
Figure 67 – Aspect of specimen R262-2 at the end of TMF test

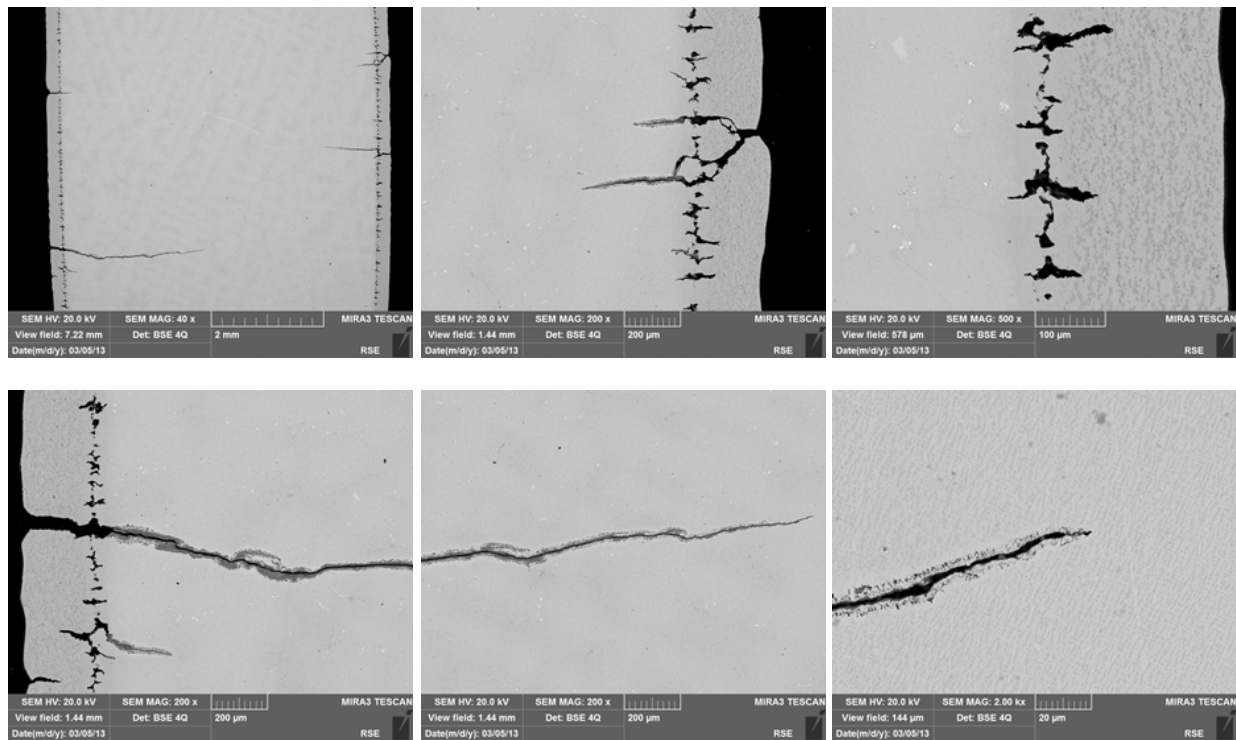
Figure 69 - The aspect of different cracks observed on metallographic section of specimen R262-2 with detailed zoom images of the biggest crack developed close to half section of the specimen

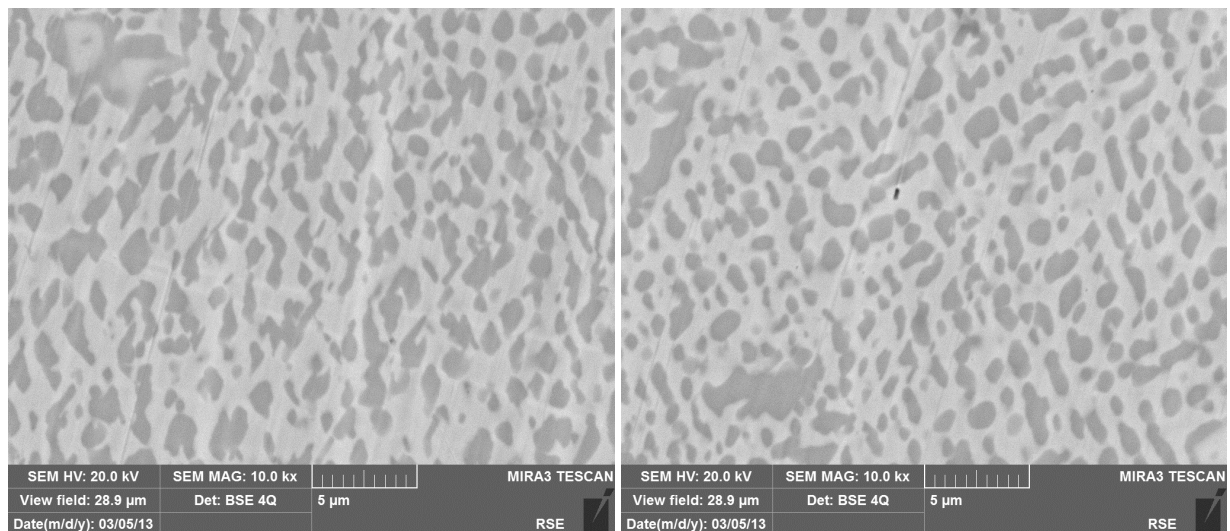
Figure 70 – Aspect of γ' in base metal of specimen R262-2 after test

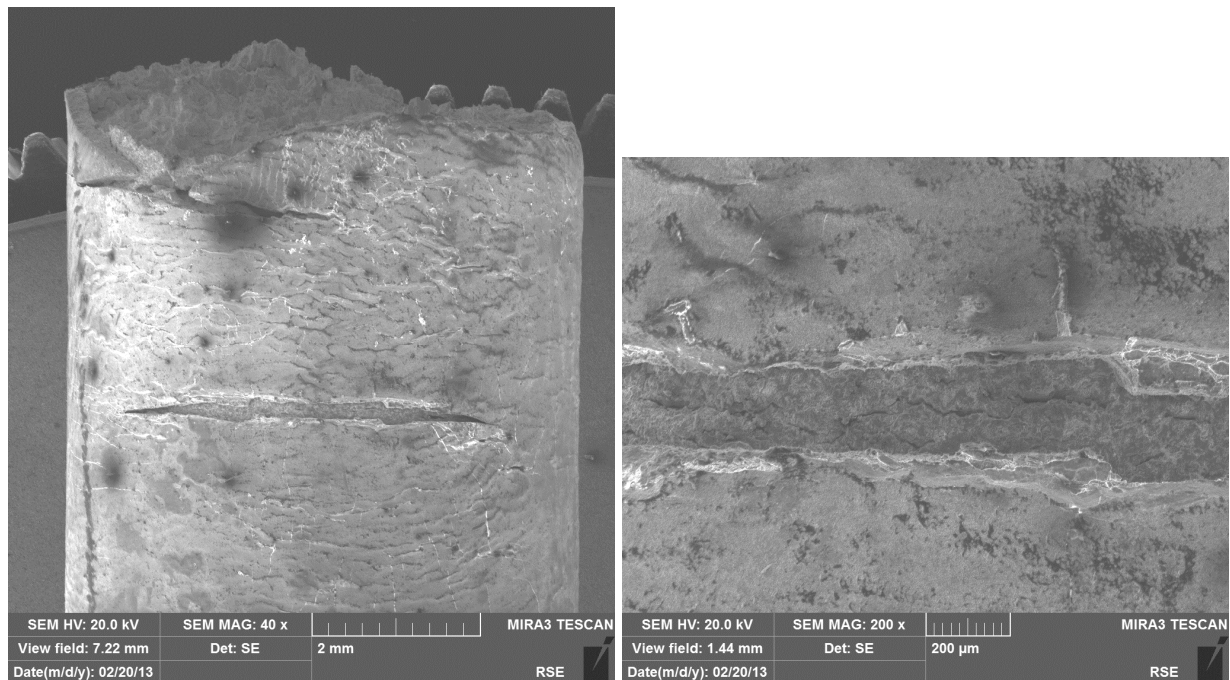
Figure 75 – Secondary crack developed on gauge length surface close to fracture in specimen R262-1

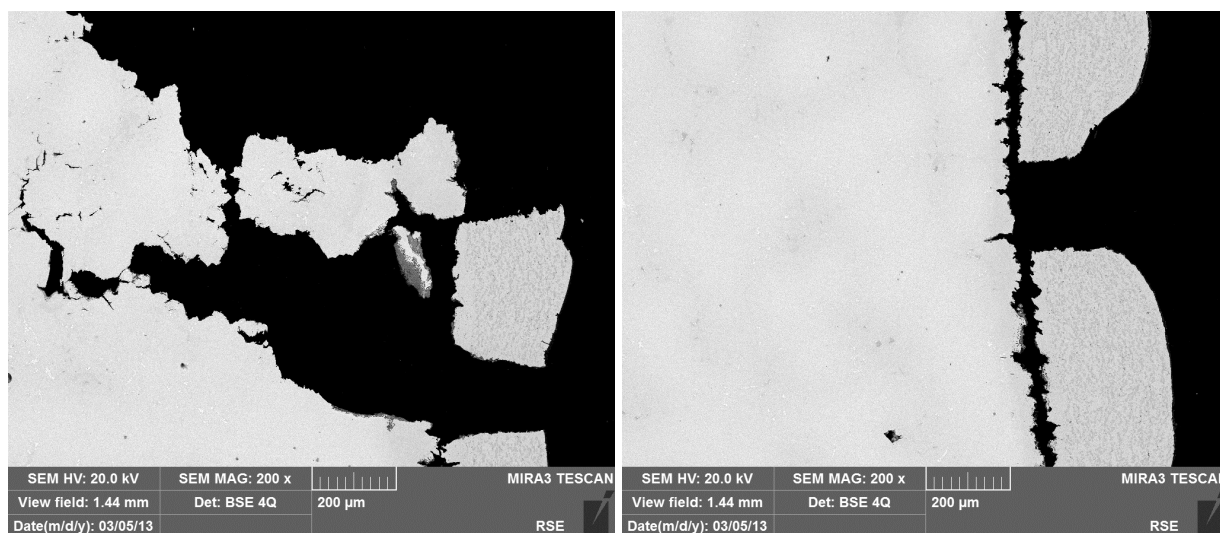
Figure 77 – Details of fracture surface crack initiation area (on the left) and secondary crack close to fracture surface (on the right)

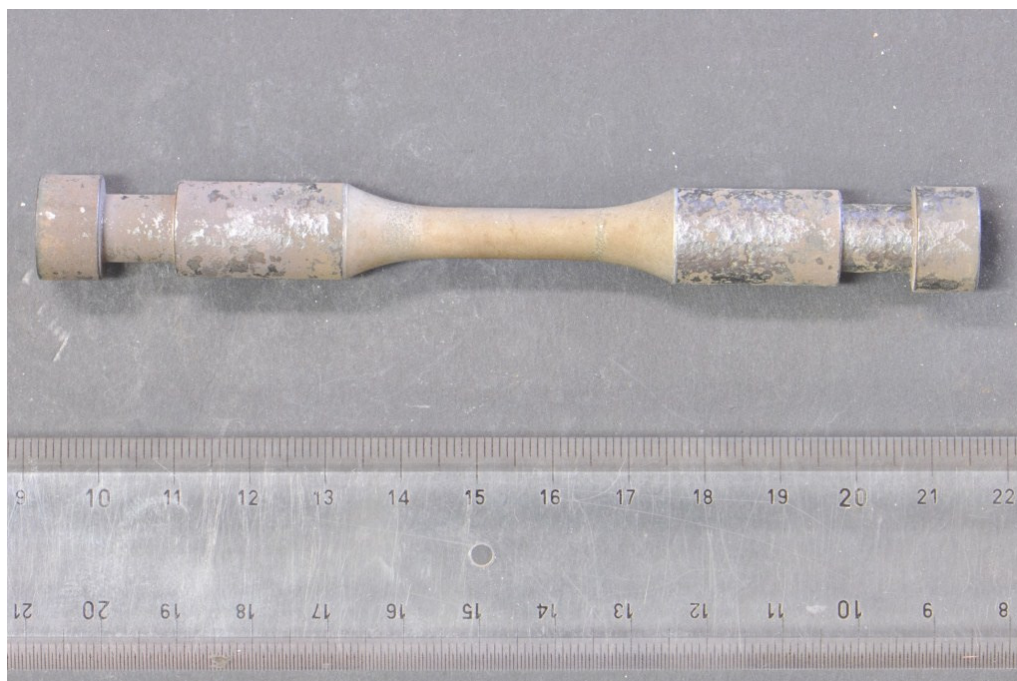
Figure 79 – Aspect of specimen R262-3 after ageing in air with 20% steam

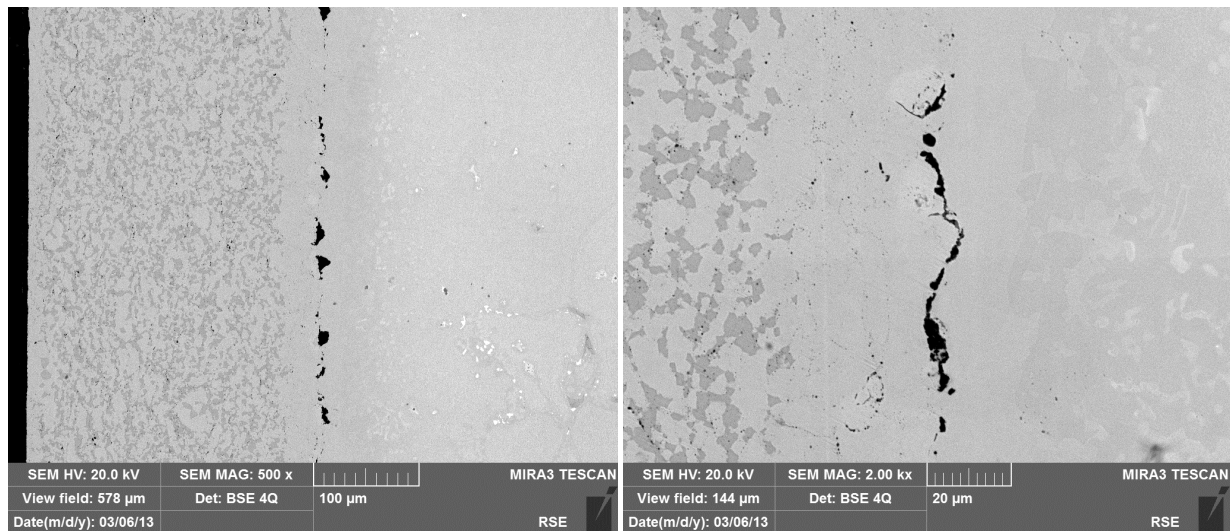
Figure 81 – Defects at the interface among base metal and bond coat in specimen R262-3

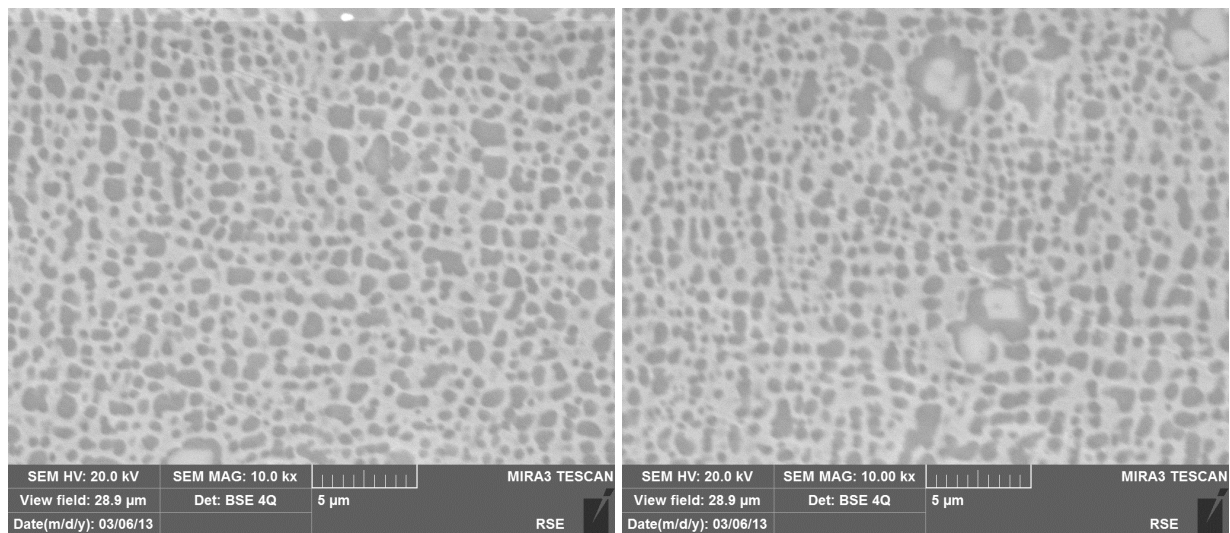
Figure 82 – Aspect of γ' in different positions of specimen R262-3 aged in air with 20% steam

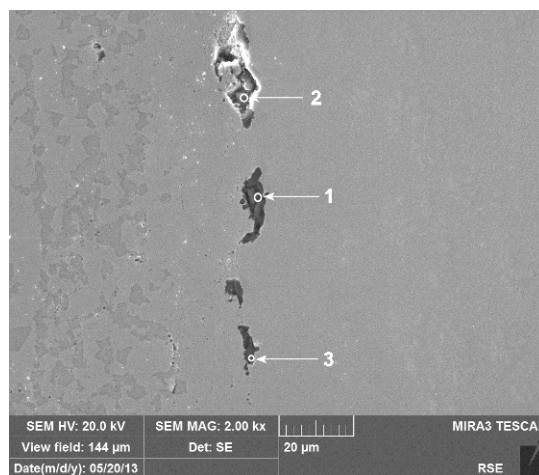
Figure 83 – Precipitates and defect at the interface between bond coat and base metal of specimen R262-3

The precipitates and precipitates at the interface presented in Figure 83 can be characterised by the EDS spectra presented in the following figures and referred to labelled areas.

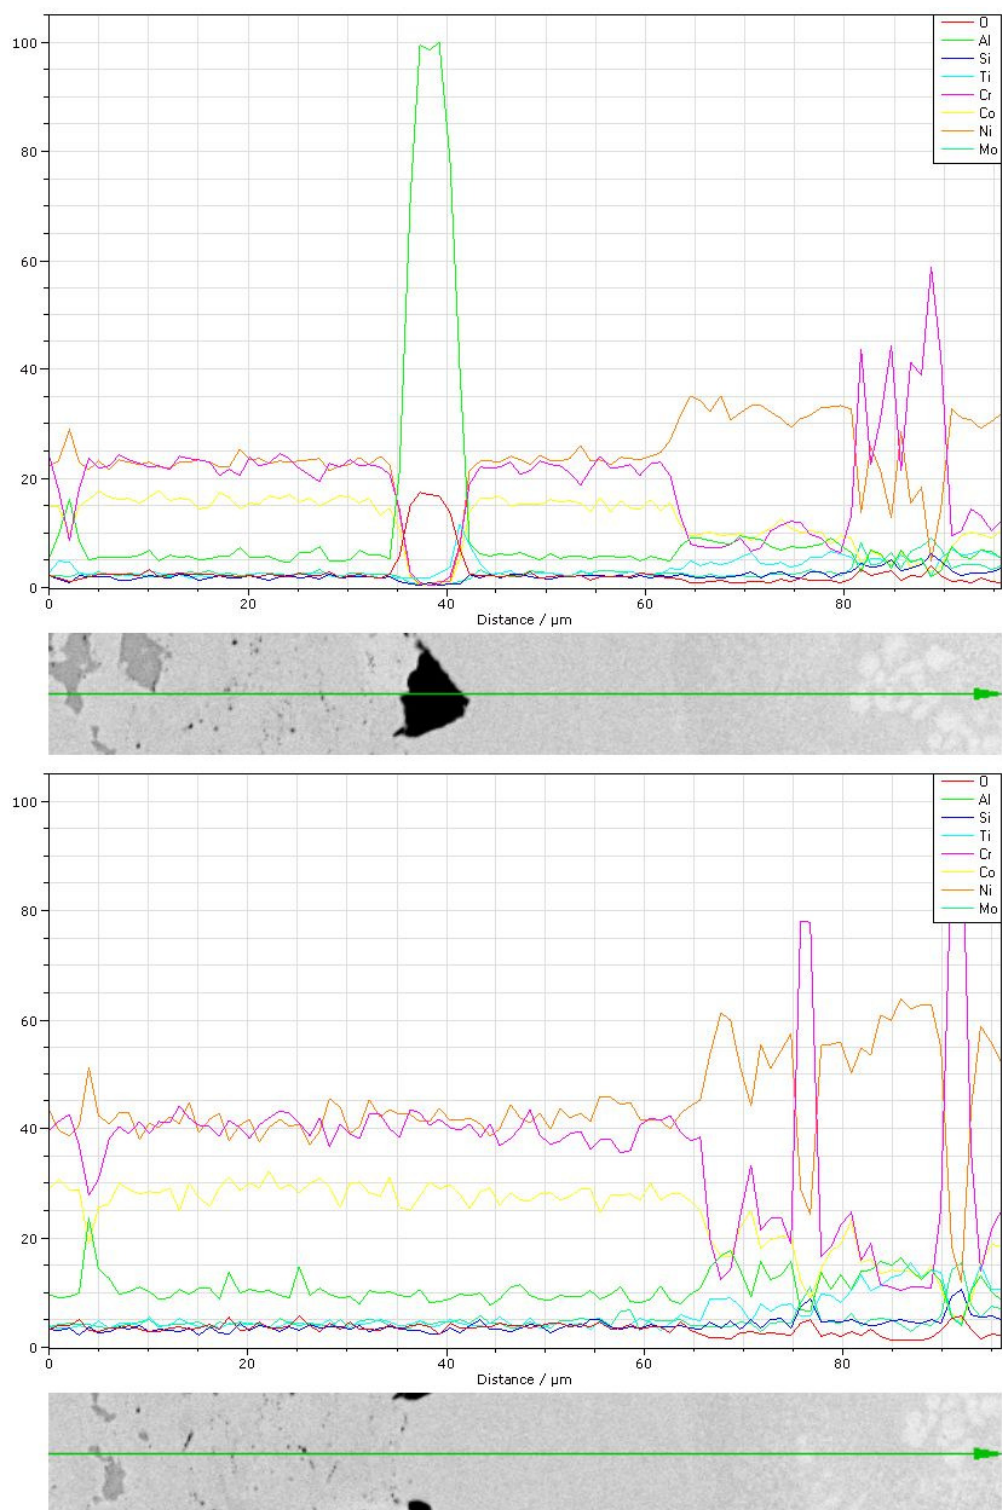
Figure 87- EDS-line analysis with chemical elements detectable at the interface between base metal and bond coat for specimen R262-3

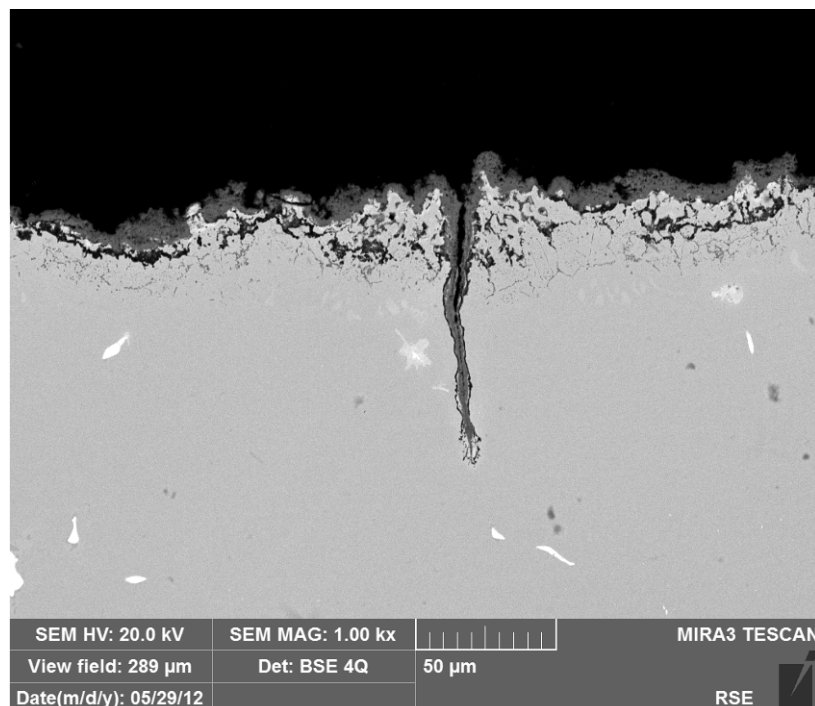
Figure 89 – SEM BSE micrograph of crack in gauge length with limited oxidation on external surface (R265-6)

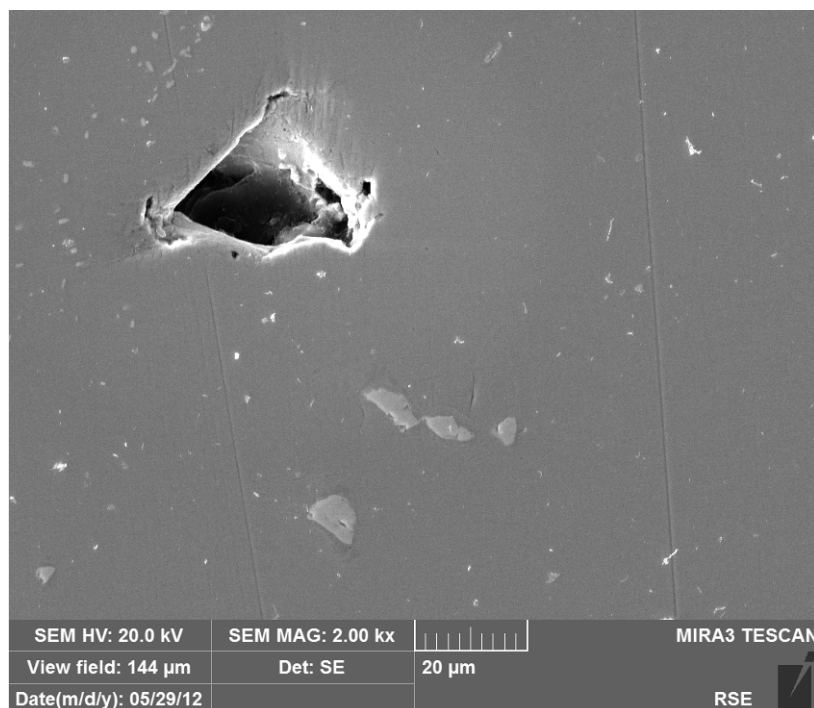
Figure 90 – Presence of a defect in base metal PWA 1483 detected on SEM (R265-6)

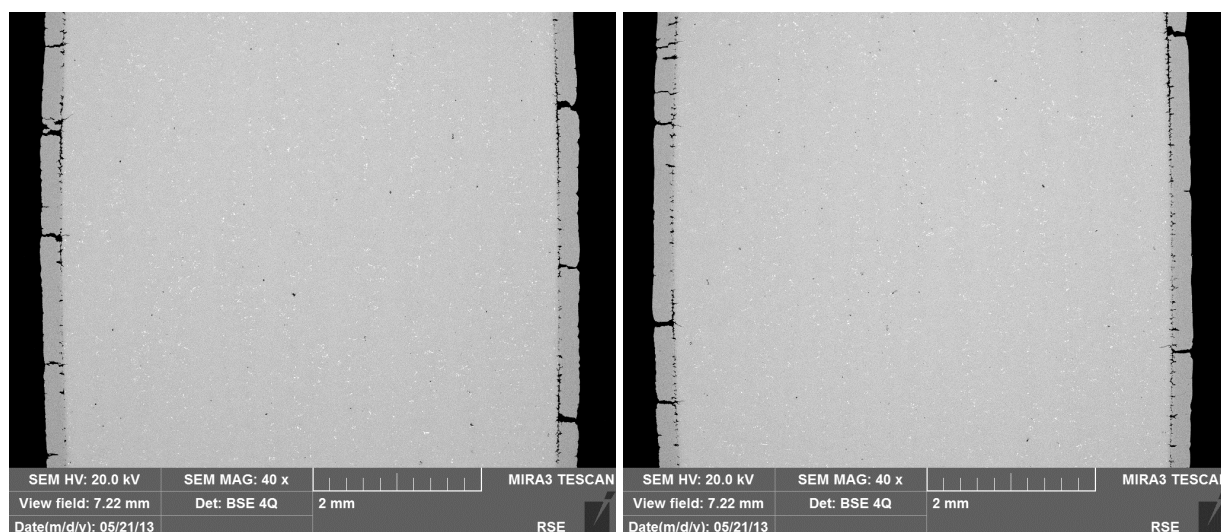
Figure 92 – Macro view of metallographic specimen prepared by R264-1 tested on TMF

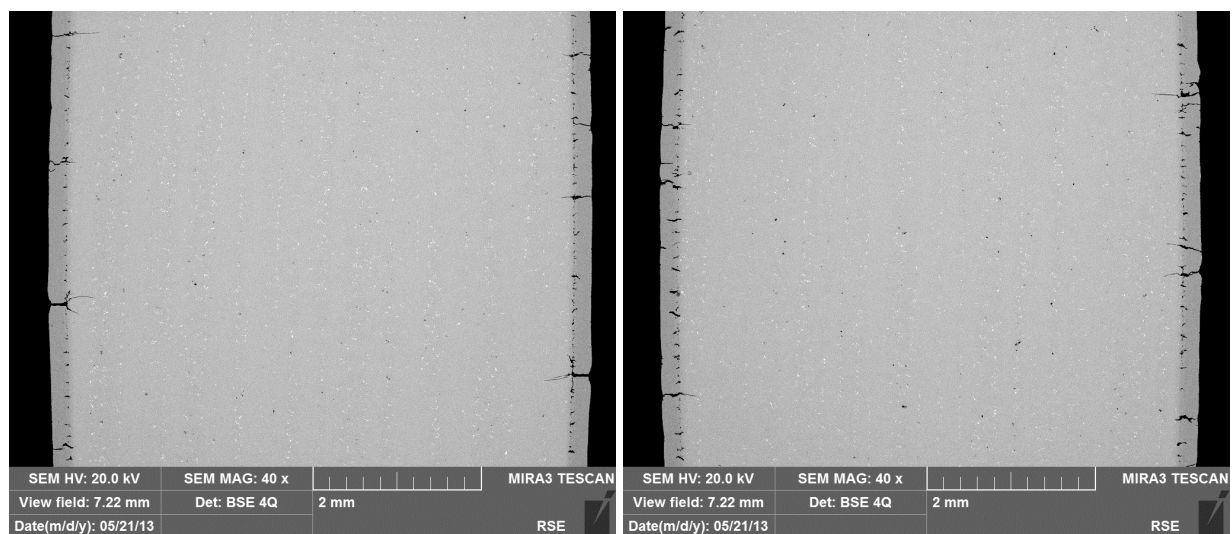
Figure 95 – Macro view of metallographic specimen prepared by R264-4 tested on TMF

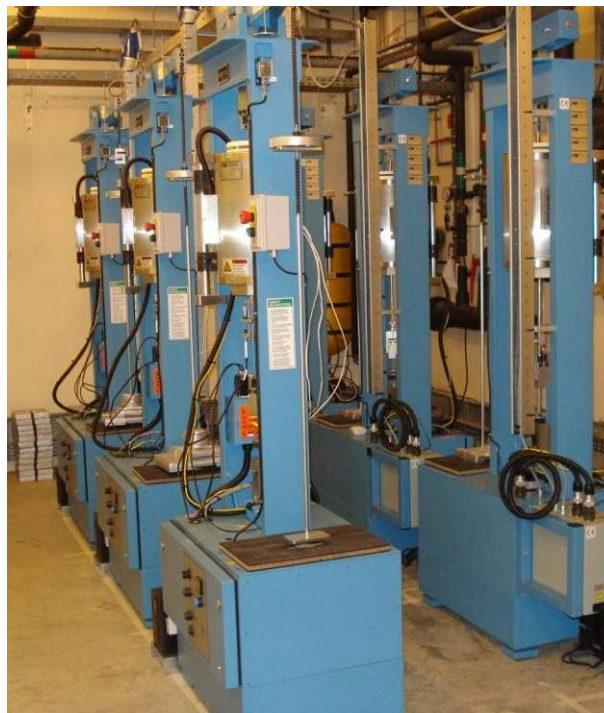
Figure 99 - ATS series 2320-MM dead weight single specimen lever arm creep testers with continuous strain monitoring.

Creep tests were carried out on ATS series 2320-MM dead weight single specimen lever arm creep testers with continuous strain monitoring (Figure 99). The calibrated load range of the frames is 1.11-11.1kN. Strain monitoring is done by means of series 4124 averaging extensometers type Heidenhain ST-12 (12mm range, 1 μ m accuracy). Furnaces are series 3210 split tube (three zone) type Kanthal A1 with a maximum temperature of 1100°C. Temperature is controlled and monitored by means of three N-type thermocouples attached to the specimen with quick tip connectors (Figure 100). These thermocouples are replaced for each test. For the creep samples coated with TBC all three thermocouples are attached on top of the TBC coating. Figure 101 shows a mounted creep sample inside the furnace.
