H₂-IGCC Project Deliverable

Grant Agreement number	239349
Project acronym	H ₂ -IGCC
Project title	Low Emission Gas Turbine Technology for Hydrogen-rich Syngas
Funding Scheme	FP7-ENERGY-2008-TREN-1
Subproject	2 Materials
Work Package	2.2 Performance of state-of-the-art materials/coatings in novel operating conditions
Delivery number - name	D 2.2.6
Lead Beneficiary	
Dissemination level	Limited
Delivery month	43
Name, title and organisation of the scientific representative of the project's coordinator	Christer Bjorkqvist Managing Director, European Turbine Network (ETN) Tel: 00 32 2 646 1577 Fax: 00 32 2 646 15 78 E-mail: cb@etn-gasturbine.eu Project website address: www.h2-igcc.eu

Subject Mechanical characterisation of materials.

Notes Deliverable D 2.2.6

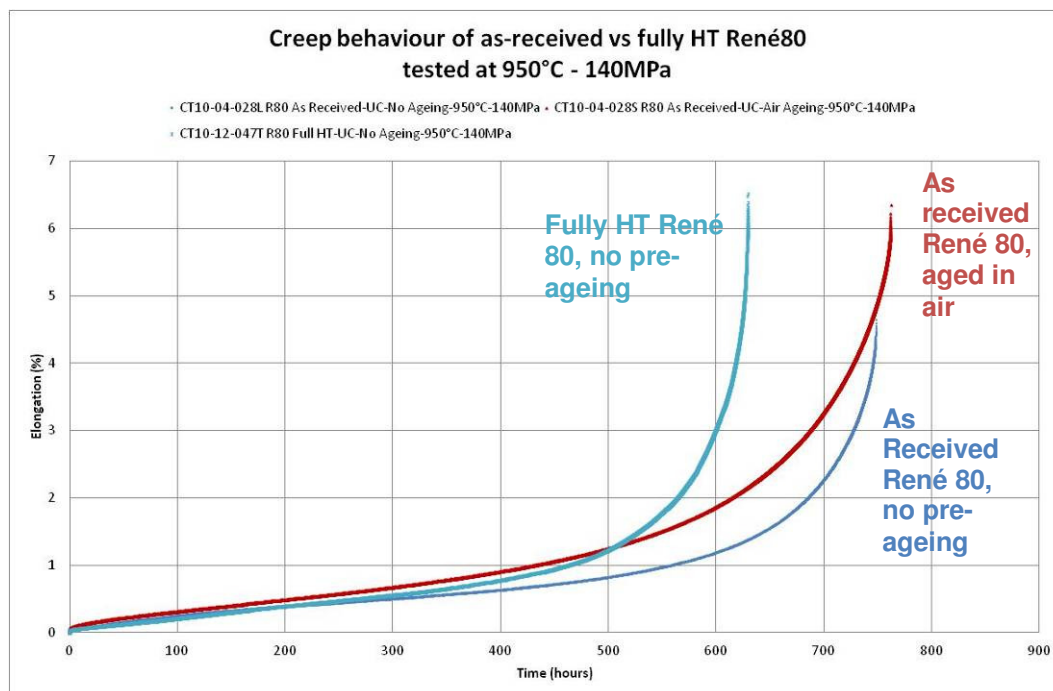
Figure 102 Creep curves of “as received uncoated René 80” without pre-ageing, with pre-ageing in air for 1000hrs at 1000°C and René 80 fully heat treated without pre-ageing tested at 950°C and 140MPa.

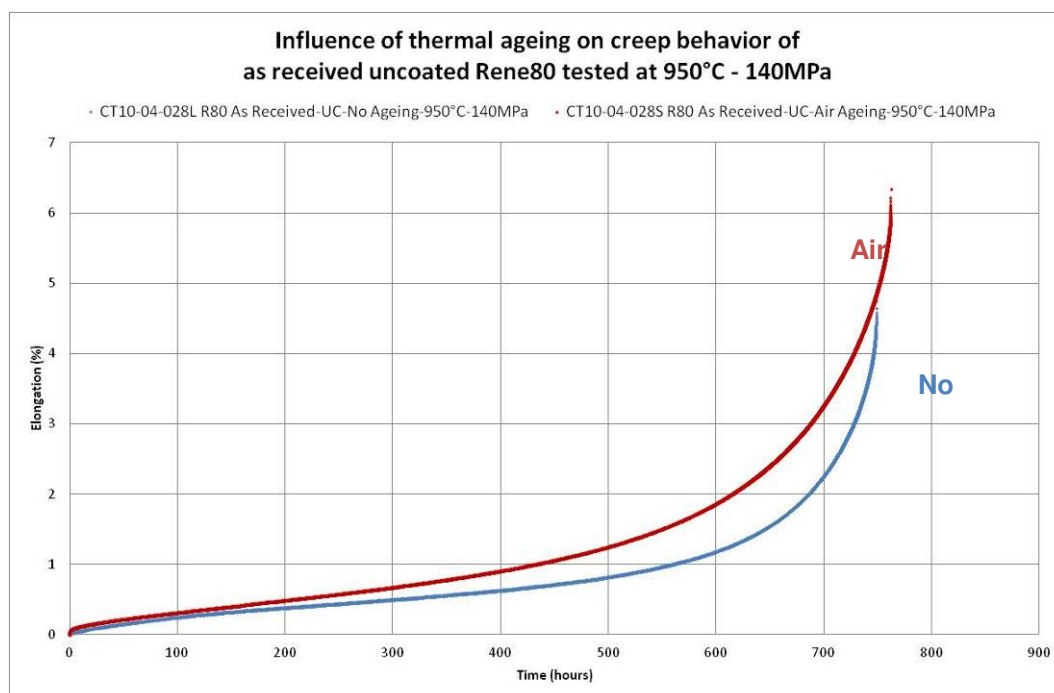
Figure 104 Creep curves of “as received uncoated René 80” without pre-ageing and with pre-ageing in air for 1000hrs at 1000°C tested at 950°C and 140MPa.

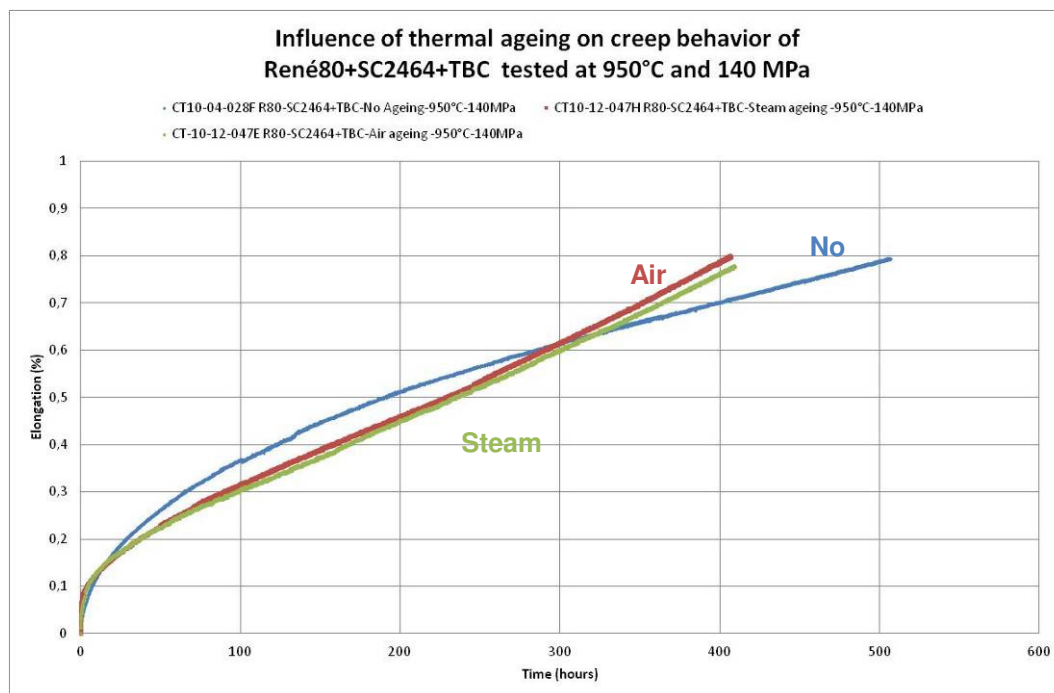
Figure 113 Creep curves of “René 80 + SC2464 + TBC” without pre-ageing, with pre-ageing in air and with pre-ageing in air + 20% steam, both for 1000hrs at 1000°C and tested at 950°C and 140MPa.

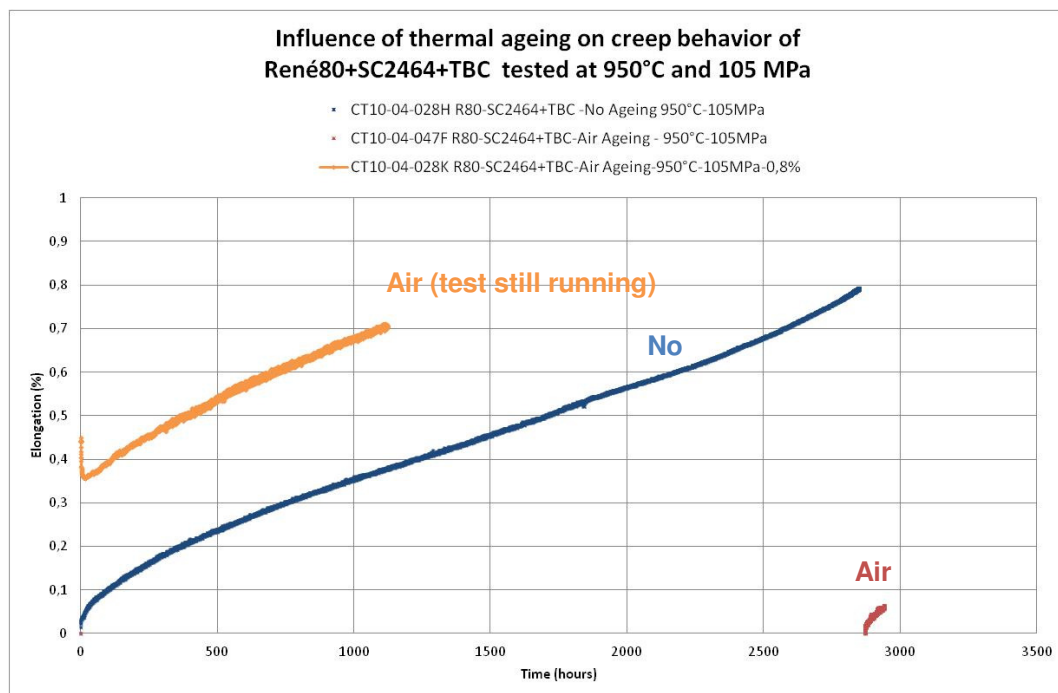
Figure 114 Creep curves of “René 80 + SC2464 + TBC” without pre-ageing and with pre-ageing in air for 1000hrs at 1000°C tested at 950°C and 105MPa.

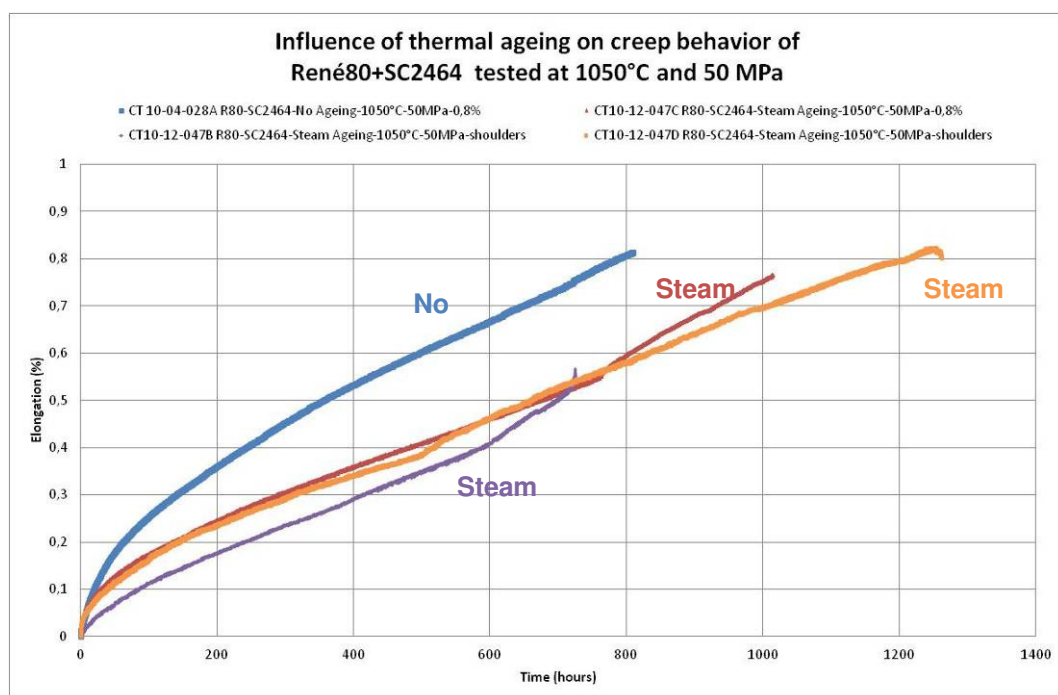
Figure 115 Creep curves of “René 80 + SC2464” without pre-ageing and with pre-ageing in air + 20% steam for 1000hrs at 1000°C tested at 950°C and 105MPa

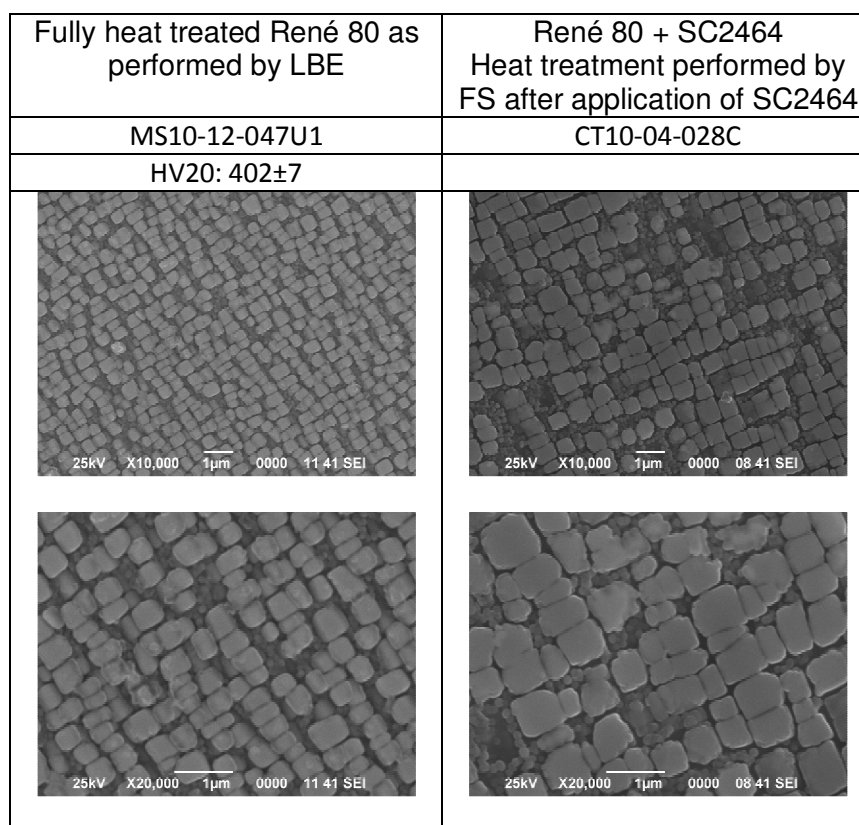
Figure 118: Comparison of fully heat treated René 80 by LBE and fully heat treated René 80 by Flamespray after application of SC2464.

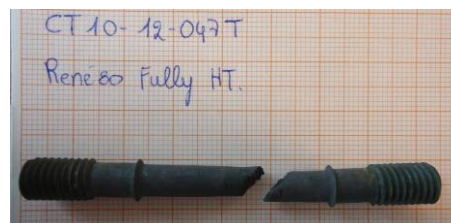
Figure 119: Creep SAMPLE CT10-12-047T René 80 fully heat treated by Laborelec, tested at 950°C and 140MPa

Figure 119 and Figure 122 show the broken samples of René 80 as received (CT10-04-028L) and René 80 fully heat treated (CT10-12-047T) after the creep test at 950°C and 140MPa. Figure 120 shows the embedded samples, the visual aspect of the surface of the samples, the fracture surface, LOM microstructures near the fracture surface and at the surface and SEM images of the gamma prime morphology. The oxide layer formed on base material is thicker on the Fully HT sample and has partly spalled as can be noticed both on the external surface as on the LOM pictures. Creep voids are present in both samples, but the As Received sample showed more secondary cracks. No clear signs of secondary gamma prime are observed in the As Received sample, while signs of grown secondary gamma prime are still visible in the Fully heat treated sample. The rafting of the star shaped gamma prime is shown in Figure 120n. In the fully heat treated sample, still some signs of star-shape gamma prime can be seen with more pronounced near the fracture surface. Table J summarises the comparison of the microstructural features of the 4 samples.

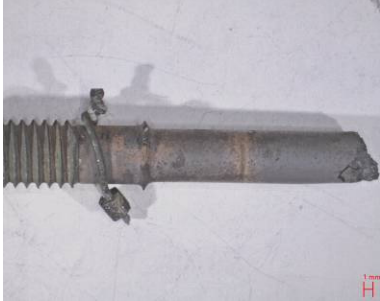
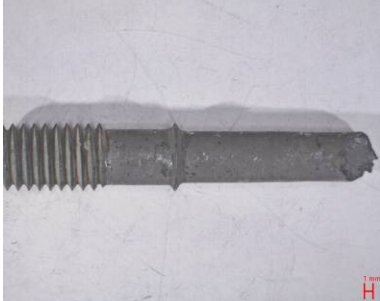
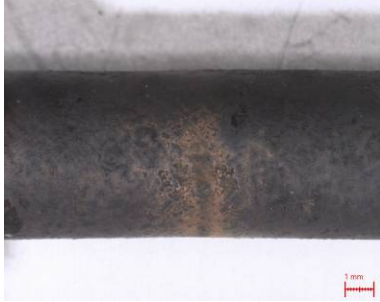
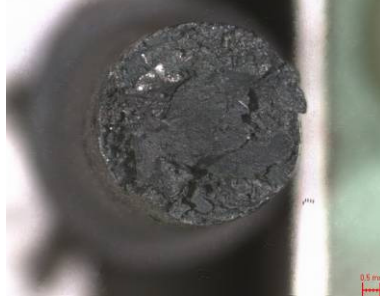
Figure 120: Metallurgical analyses of creep samples René 80 as received and René 80 fully heat treated after creep test at 950°C and 140MPa

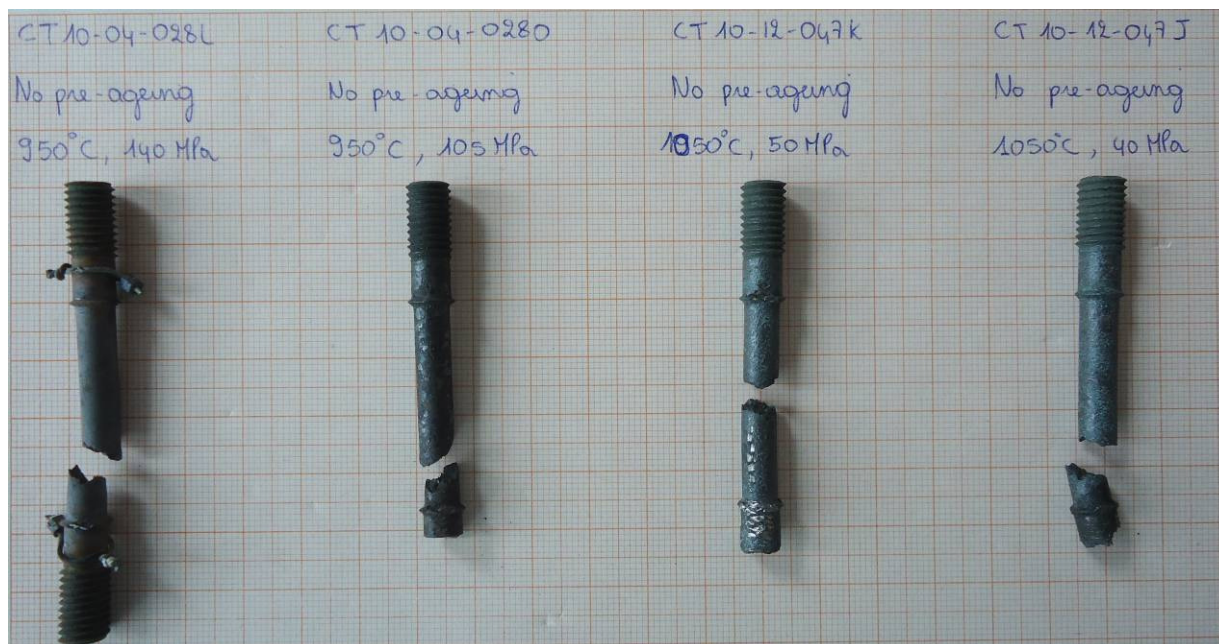
Figure 122: Creep samples of Uncoated as received René 80 after creep test till rupture at different test parameters.

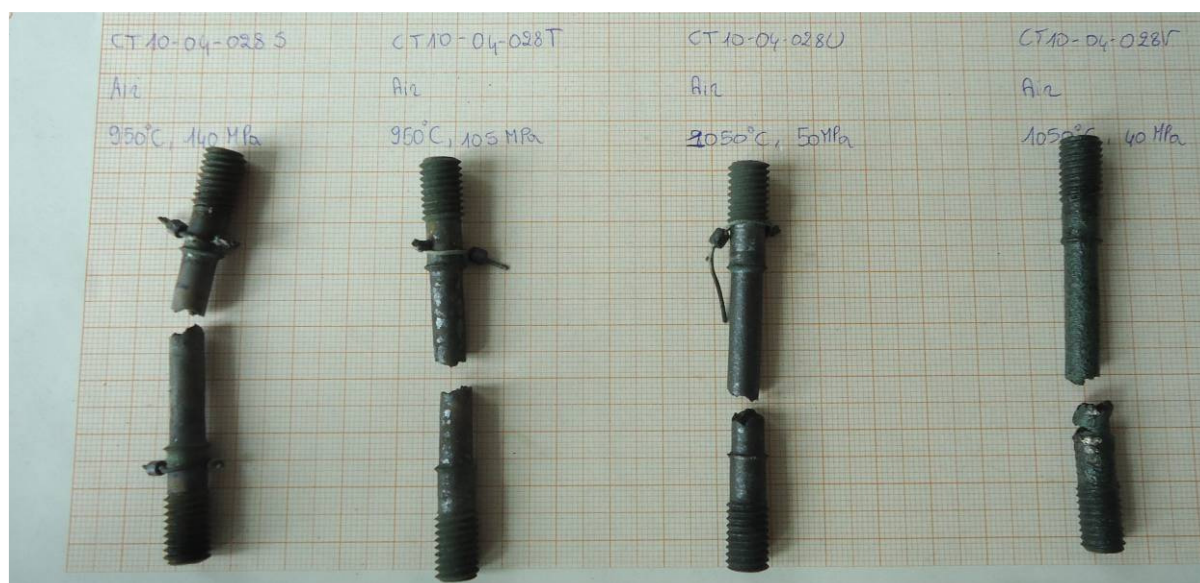
Figure 123: Creep samples of "Uncoated as received René 80 pre-aged in air (1000hr, 1000°C) after creep test till rupture at different test parameters.

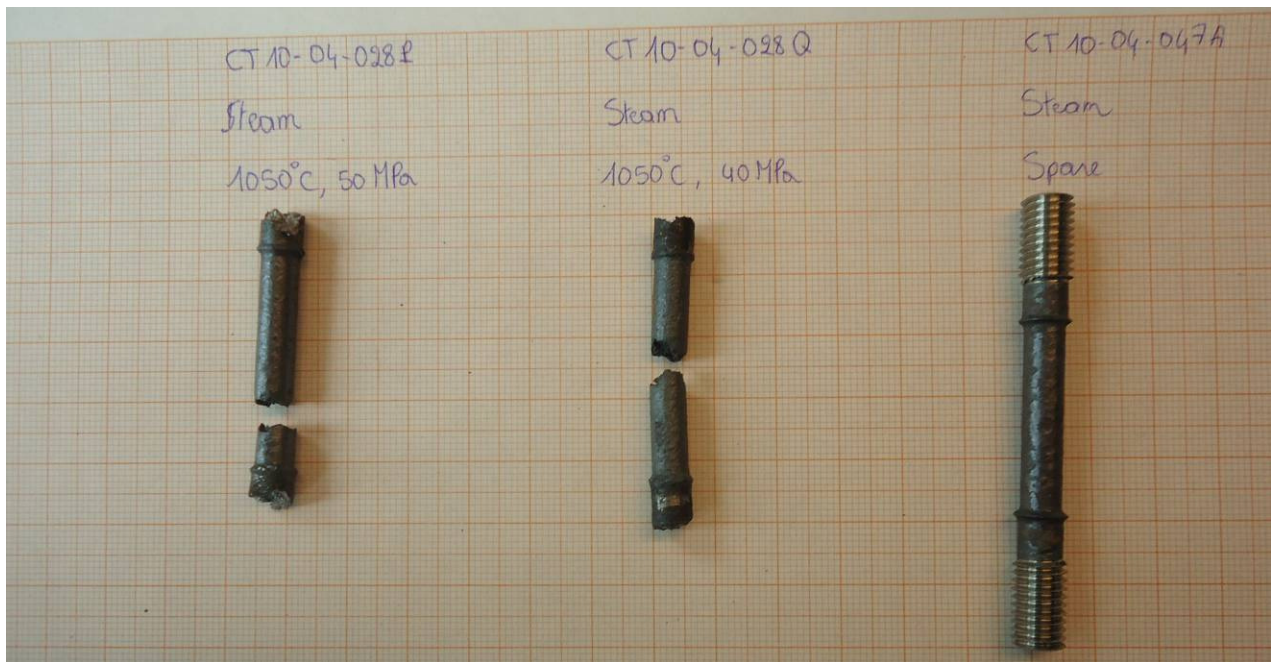
Figure 124: Creep samples of “Uncoated as received René 80 pre-aged in air+20% steam (1000hrs at 1000°C) after creep test till rupture at different test parameters. Sample on the right is not tested.

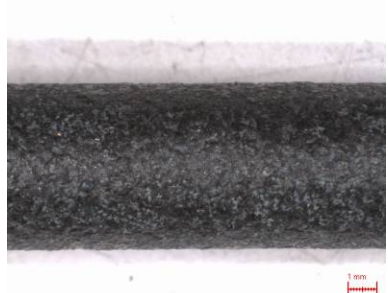
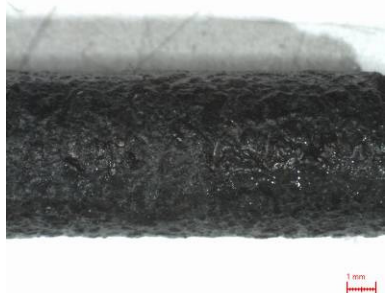
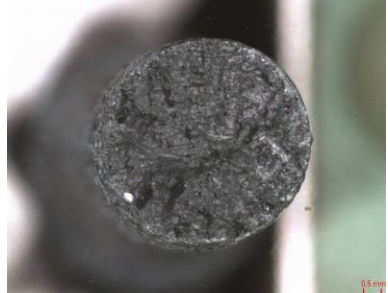
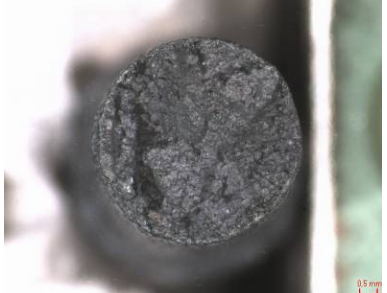
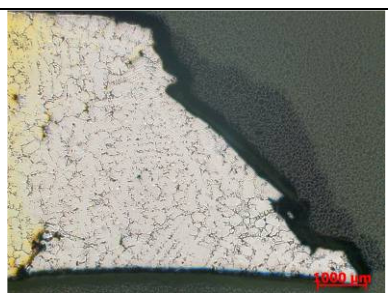
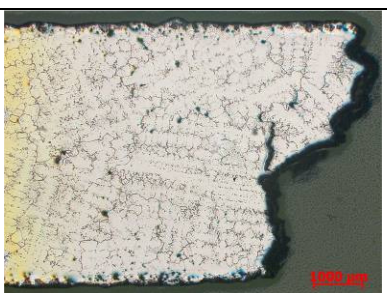
Fracture close to end of section	Fracture close to end of section	Fracture in middle of section

Figure 125: Metallurgical analyses of creep tests at 1050°C and 40MPa for uncoated René 80.

Figure 125 compares the metallographic investigation of the Uncoated René 80 samples tested at 1050°C and 40MPa. The samples without pre-ageing and pre-aged in air are broken close to the end of the section, while the sample pre-aged in air + 20% steam has broken in the middle of the section. Time to rupture of the three samples is between 1550 and 1900 hours. The visual aspect of the oxides at the surface of the mid-section of the samples is similar. The base metal is oxidised up to a depth of about 190µm. The oxide scale thickness on the analysed sections is up to 30µm. Creep porosities can be observed in the three samples as well as secondary creep cracks.

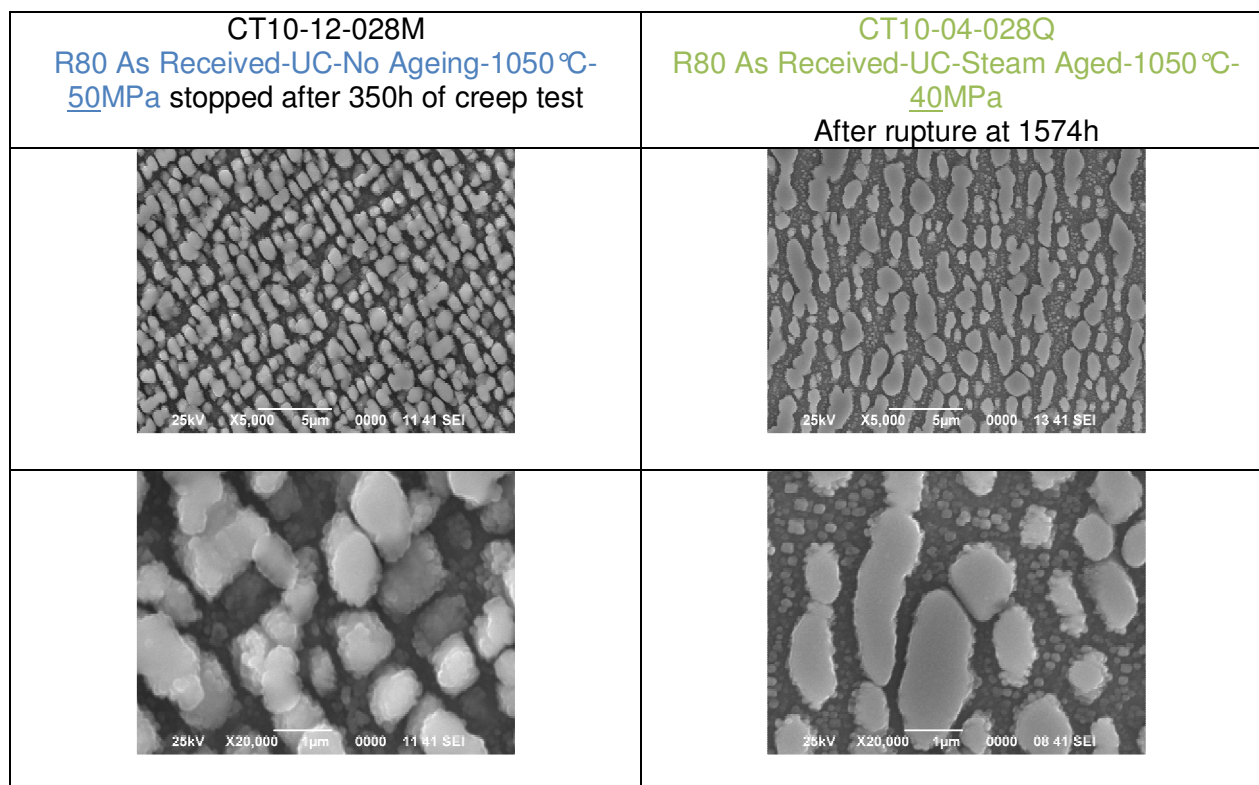
Figure 126: Metallographic structure of 2 René 80 samples tested 350h at 1050°C and 50Mpa and tested for 1574h at 1050°C and 40MPa.

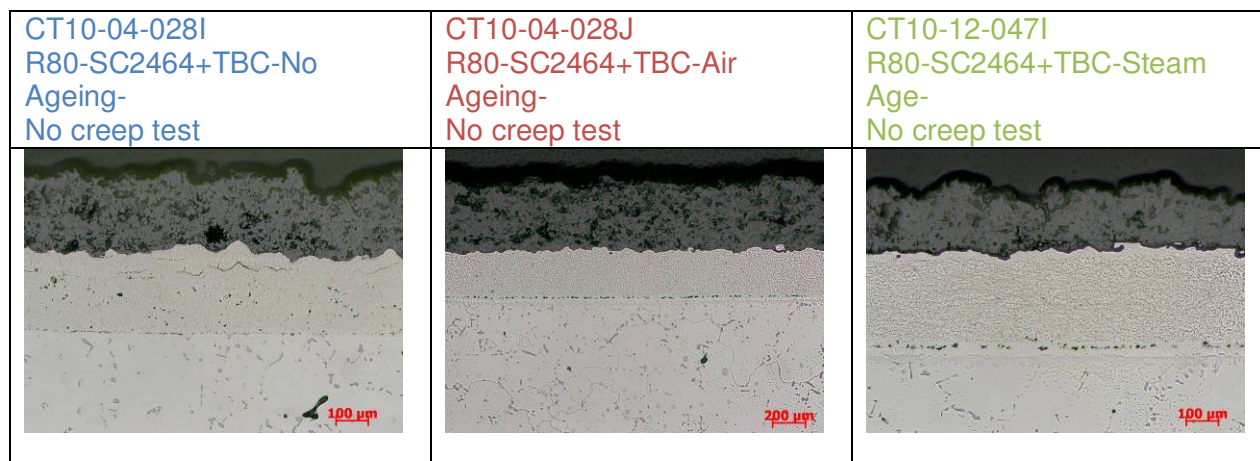
Figure 127: Microstructural features of “René 80 + SC2464 + TBC” without pre-ageing, with pre-ageing in air for 1000hrs at 1000°C and with pre-ageing in air + 20% steam for 1000hrs at 1000°C before creep test.

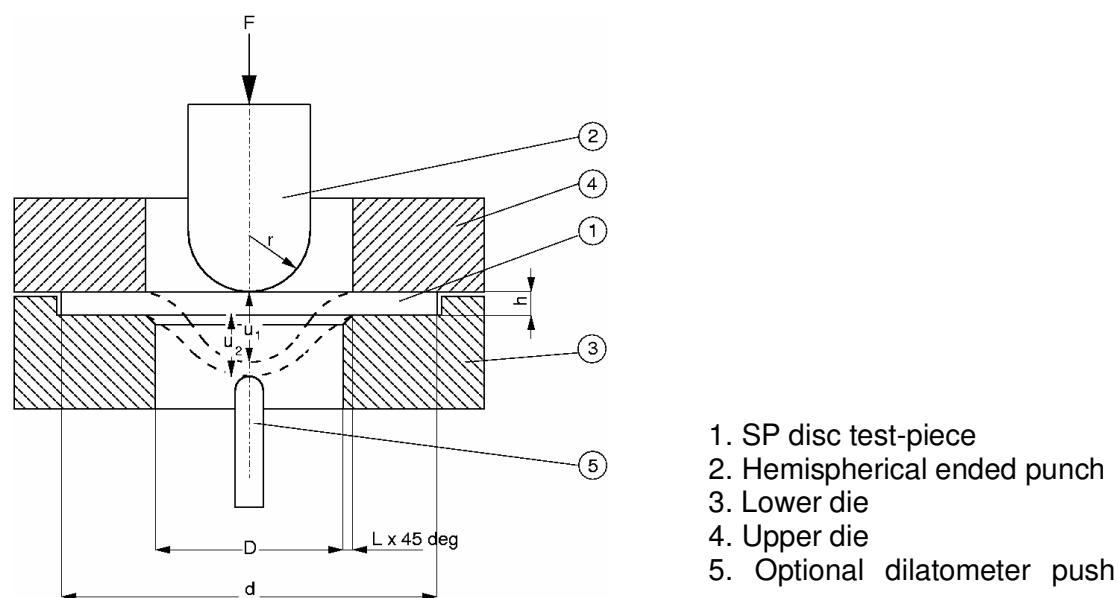
Figure 133 – Small Punch Test schematics

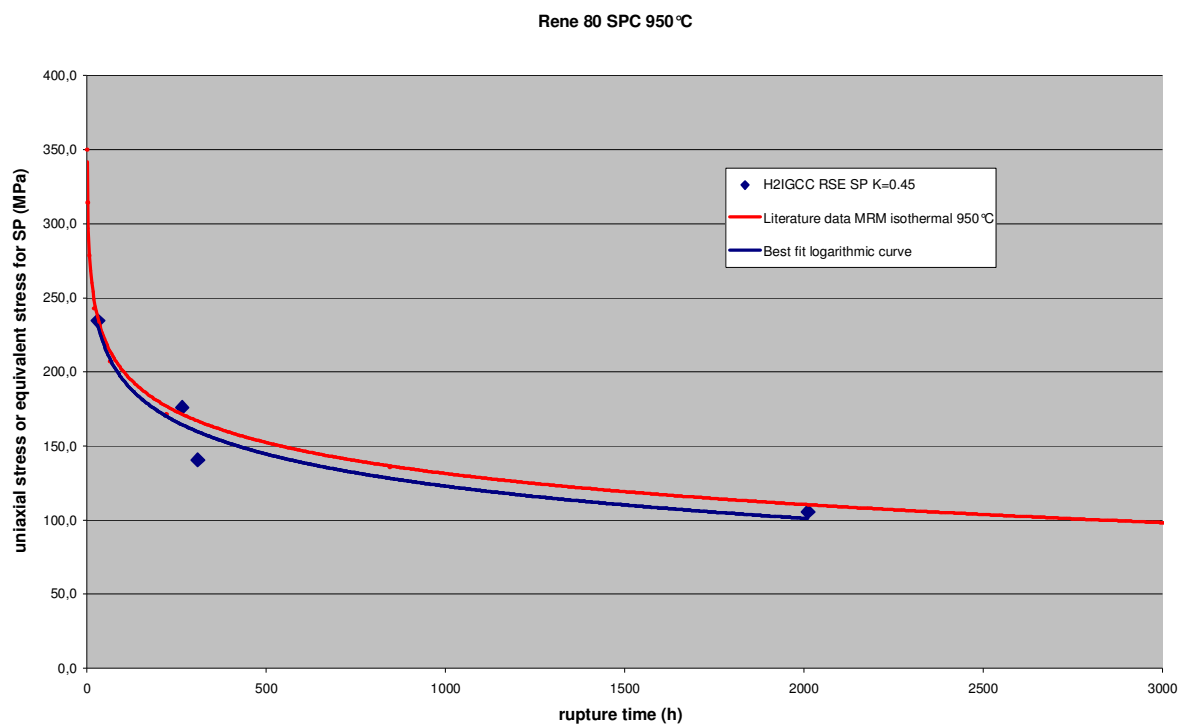
Figure 138 – Creep rupture time vs. stress at 950°C: small punch creep results compared to curve from literature uniaxial data

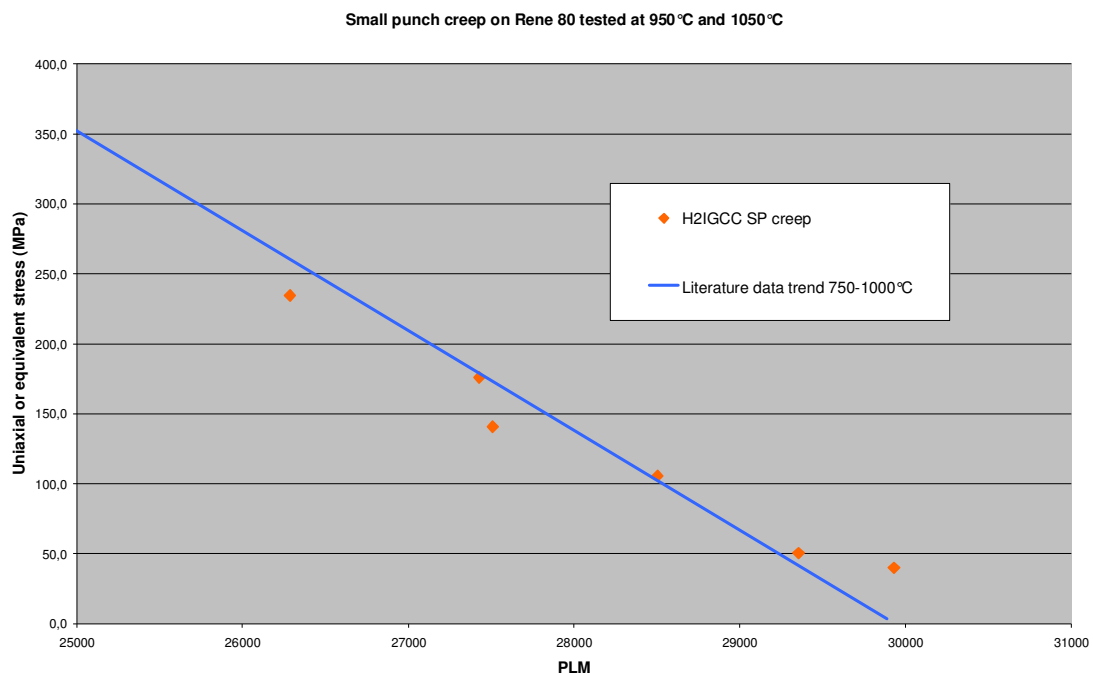
Figure 141– Larson Miller parameter vs. stress: small punch creep results at 950 and 1050°C compared to curve from literature uniaxial data in the range 750-1000°C.

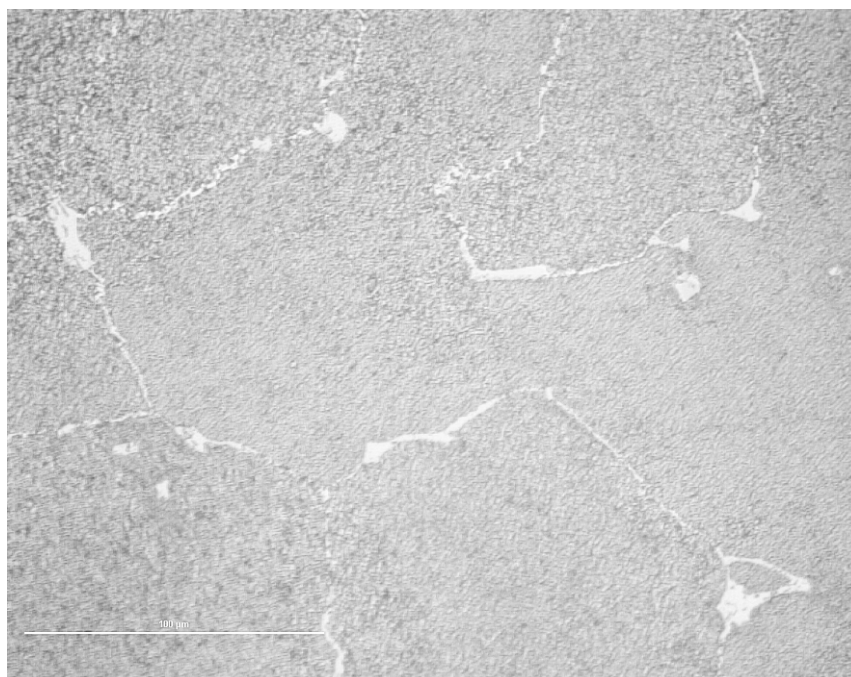
Figure 149 – LO micrographs of as received Rene 80

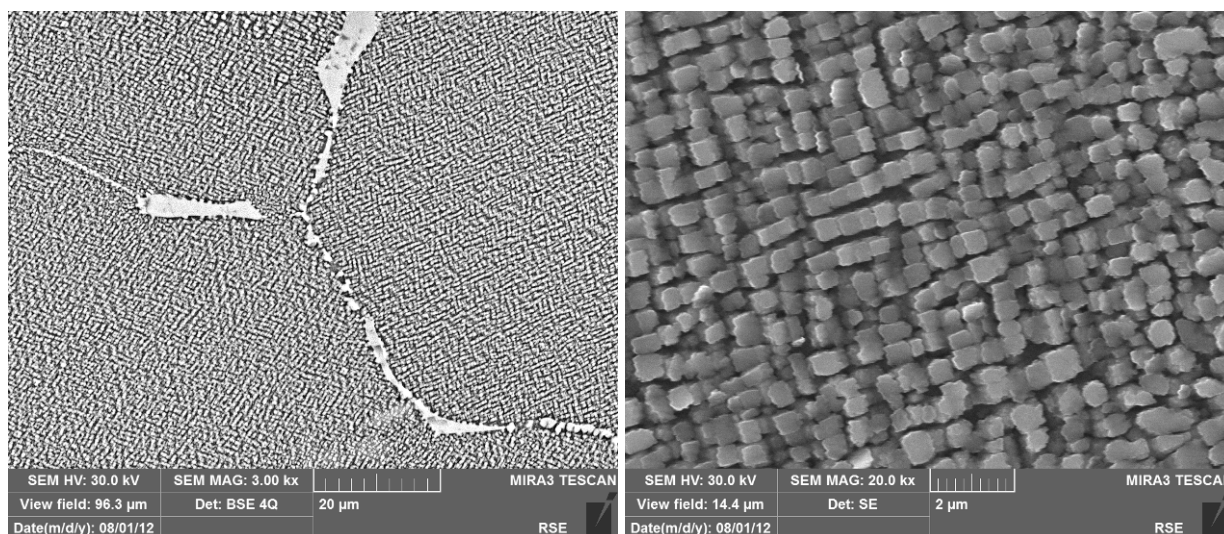
Figure 150 – As received Rene 80 etched in order to detect γ' phase

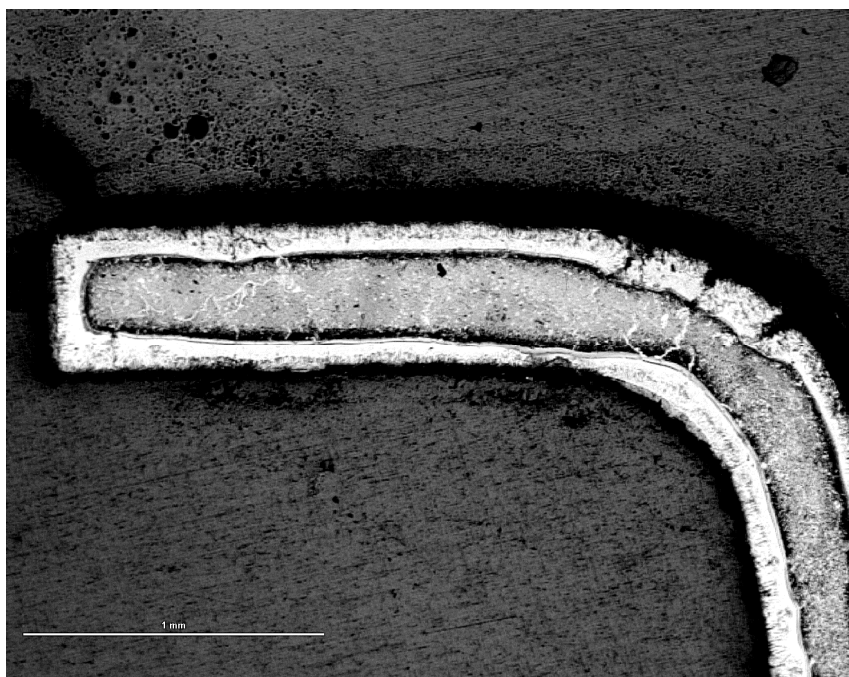
Figure 153 – Half section of metallographic specimen prepared by R266-4

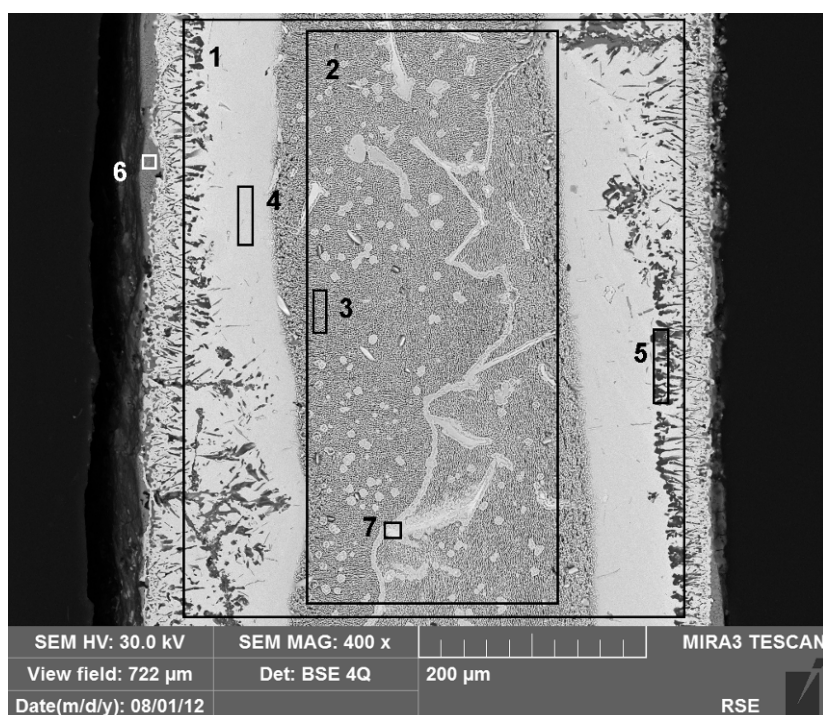
Figure 154 – Metallographic section of disc R266-4 with indication of the areas where EDS spectra have been collected

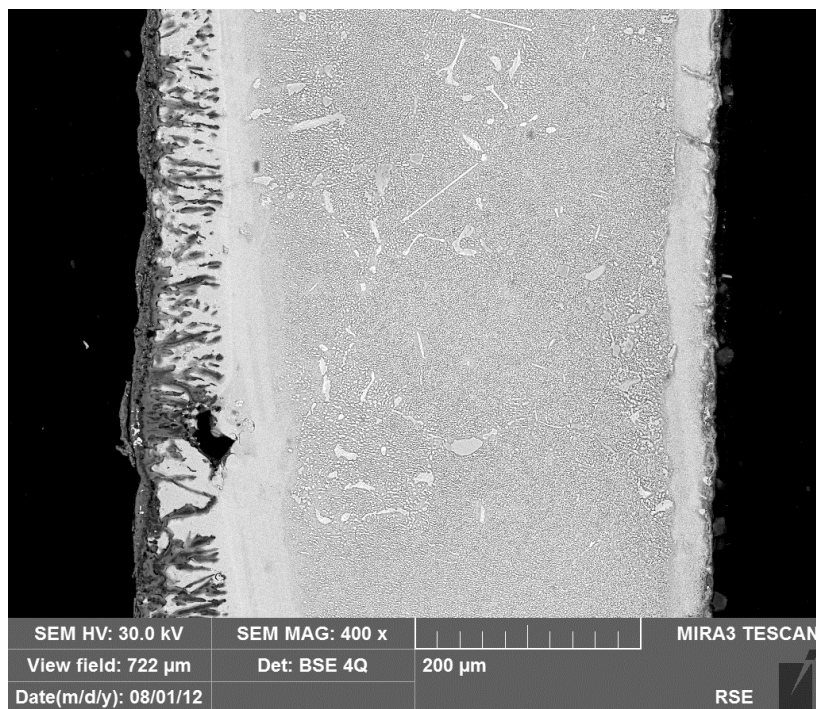
Figure 165 - Metallographic section of disc R266-6

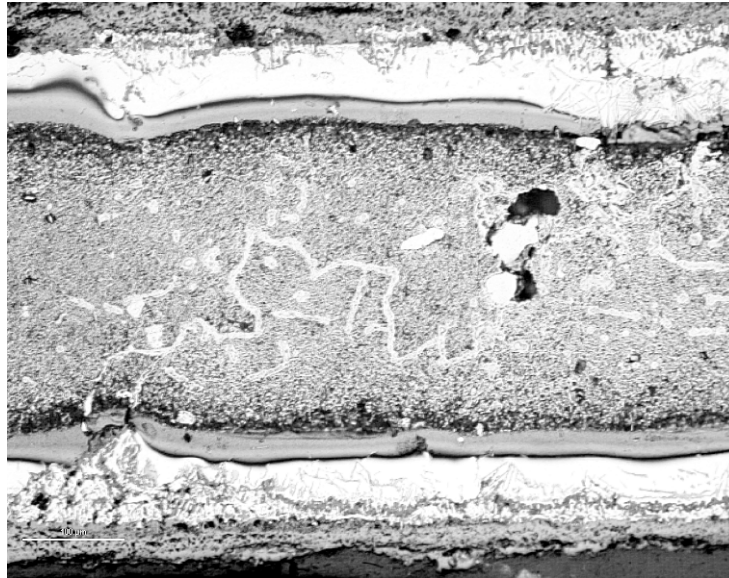
Figure 168 – Metallographic specimen of a disc aged in air

This specimen shows a situation very similar to that observed for the as received Rene 80 disc tested in SPC, as shown in Figure 168. The external layer of oxidation products is thicker than in the tested discs (SPC tests are performed in inert argon atmosphere). Also in this case in the metallic layer, the evidence of a central layer still strengthened by γ' and of external depleted (no γ') layers can be observed; some large voids are included in base metal, too.

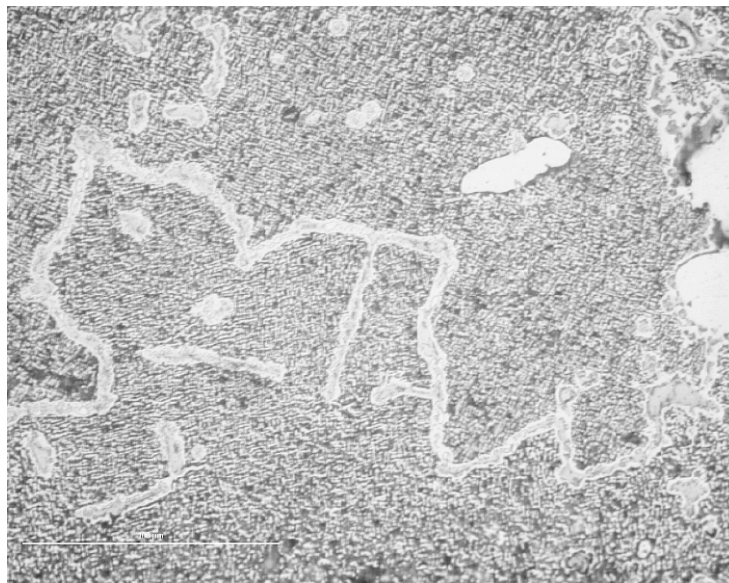
Figure 169 – Grain boundaries precipitates of a disc aged in air

Grain boundaries precipitates appear coarsened compared to virgin material (see Figure 169) and γ' cuboid are coarsened and coalesced without a preferential direction (see Figure 170).

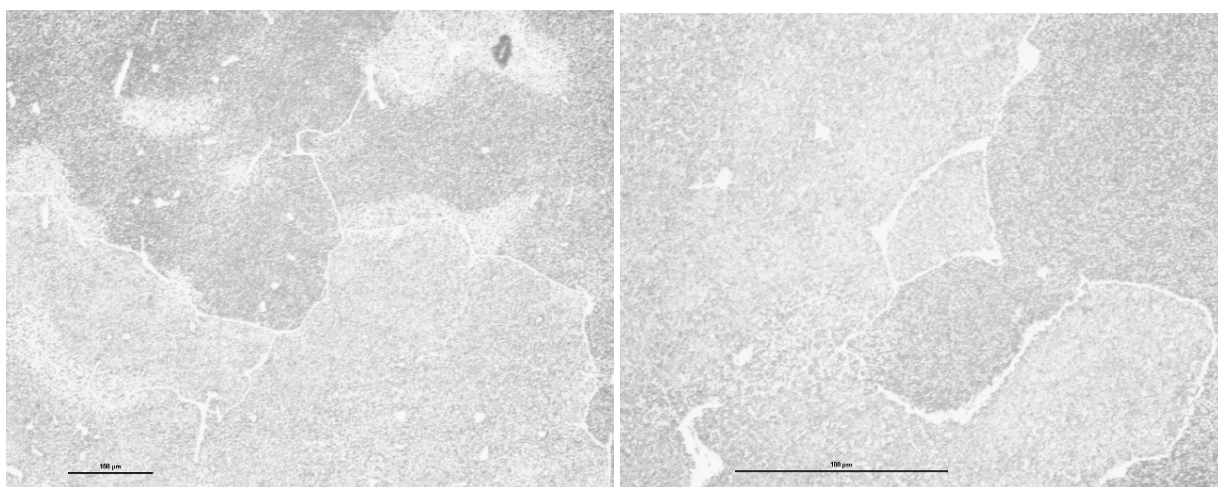
Figure 173 – LO micrographs of Rene 80 completely heat treated

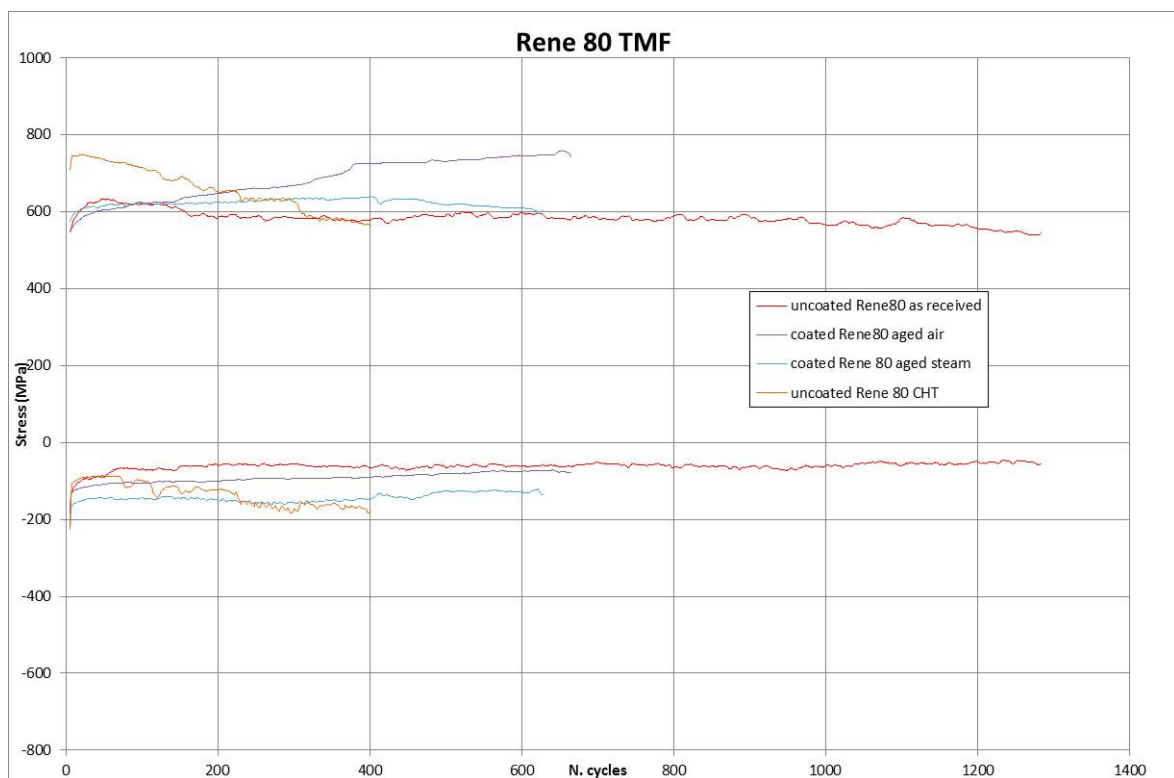
Figure 179 – Summary of TMF tests on Rene 80 performed with an OP mechanical strain -0.4 %

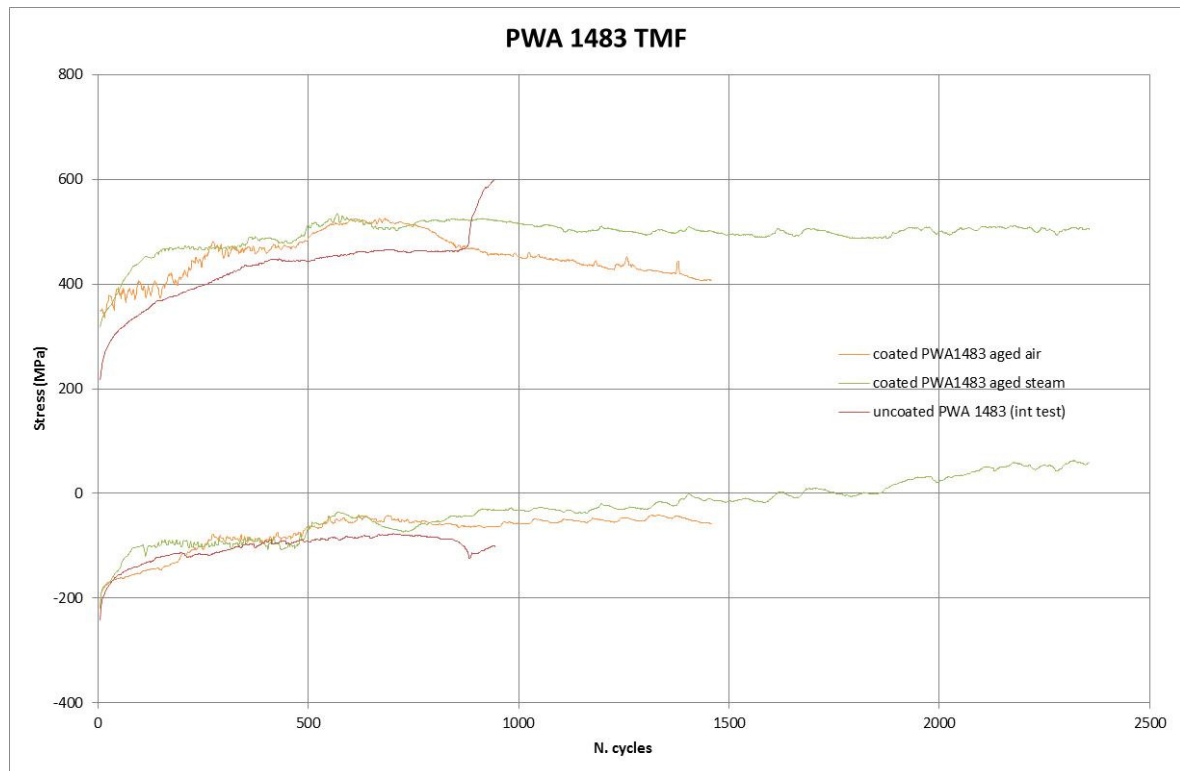
Figure 180 - Summary of TMF tests on PWA 1483 performed with an OP mechanical strain -0.4 %

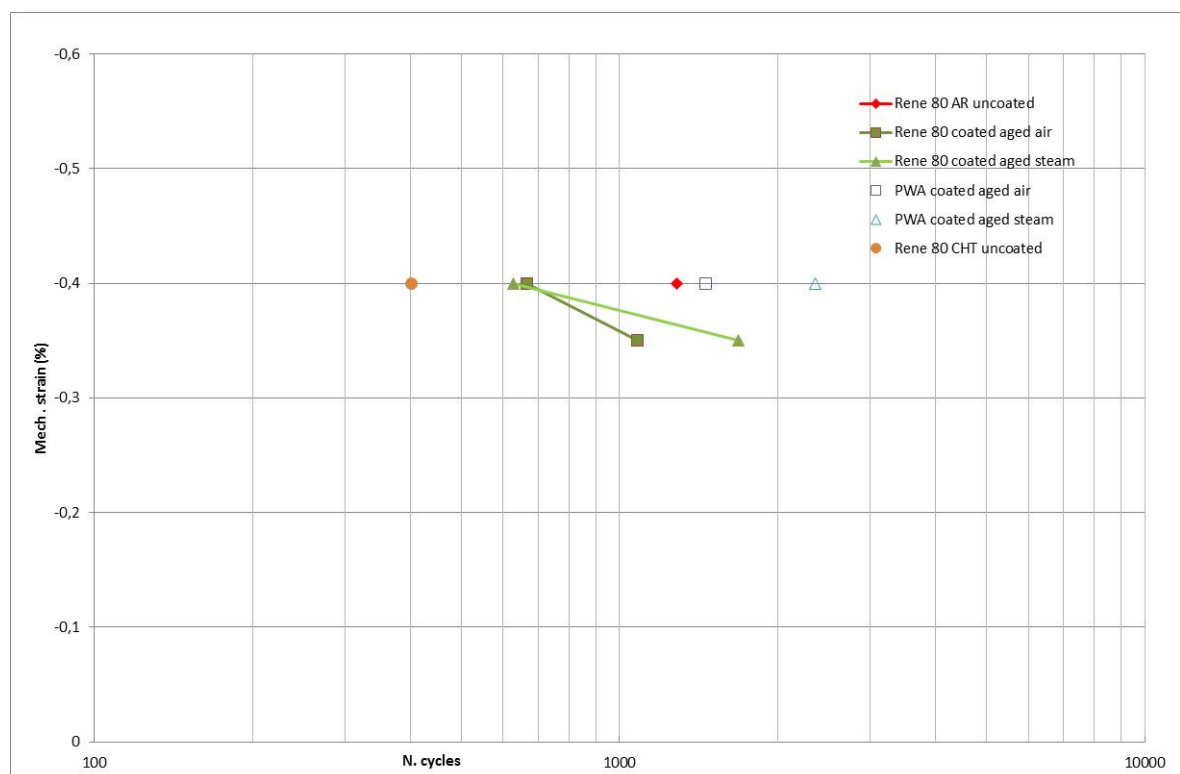
Figure 181 – Summary of TMF life as function of applied OP mechanical strain with the same thermal cycle
