# Early Experience Applying PCRT to Turbine Blade Quality Assurance

J. Scheibel, N. Smith, EPRI  
E. Biedermann, R. Livings, G. Gatewood,  
Vibrant Corp.

ETN 10<sup>th</sup> International Gas Turbine Conference  
11-15 October 2021

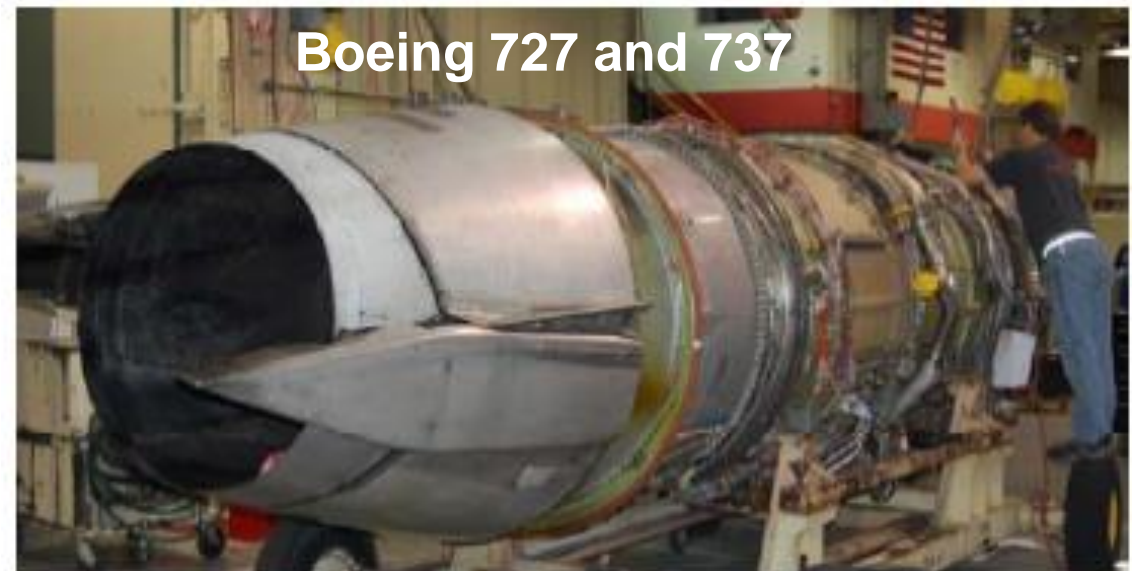
# Turbine Blade Over-Temperature Evaluation

- P&W JT8D-219 commercial engines prone to over-temperature incidents
- PCRT offers increased sensitivity to defects, less engine down time and reduced waste
- PCRT was added in 2009 for prescreening over-temperature blades
- FAA approved PCRT in 2010
- Reduced Engine Inspection Costs by Nearly \$2M Annually

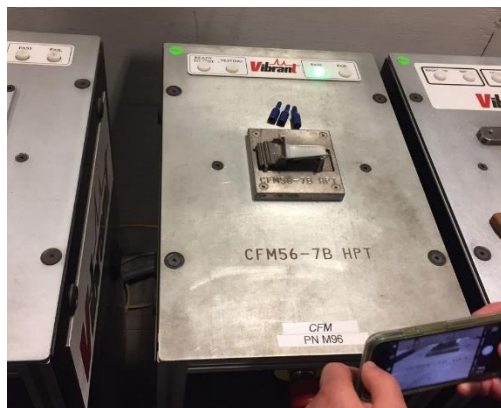
# Detecting Aircraft Gas Turbine Blade Anomalies with PCRT

- Targeted anomaly detection trained for:
  - Over temperature
  - Thin Wall
  - Inter-Granular Attack
  - Cracking
- Replaced destructive sample cut-up
- Allowed salvage of previously rejected blades
- Reduced inspection bottleneck

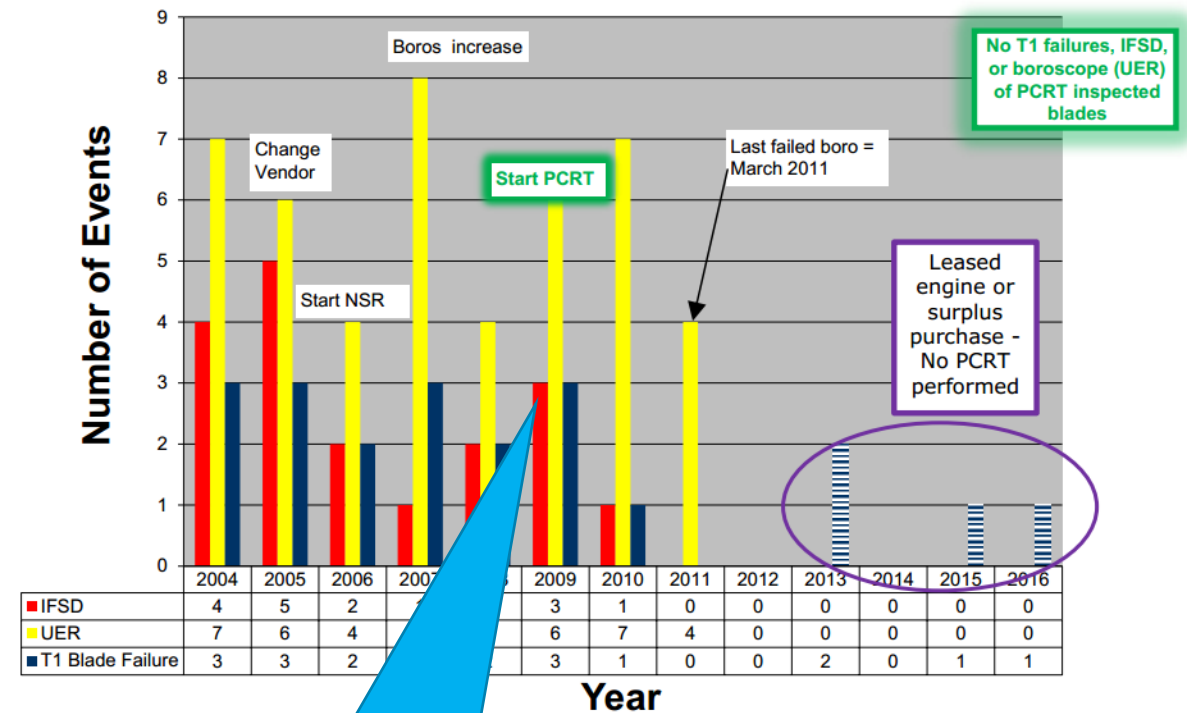
## Operational results w/PCRT - Stellar JT8D T1 Blade Pareto

**PCRT Targeted Defect Sort implemented Feb 2009**

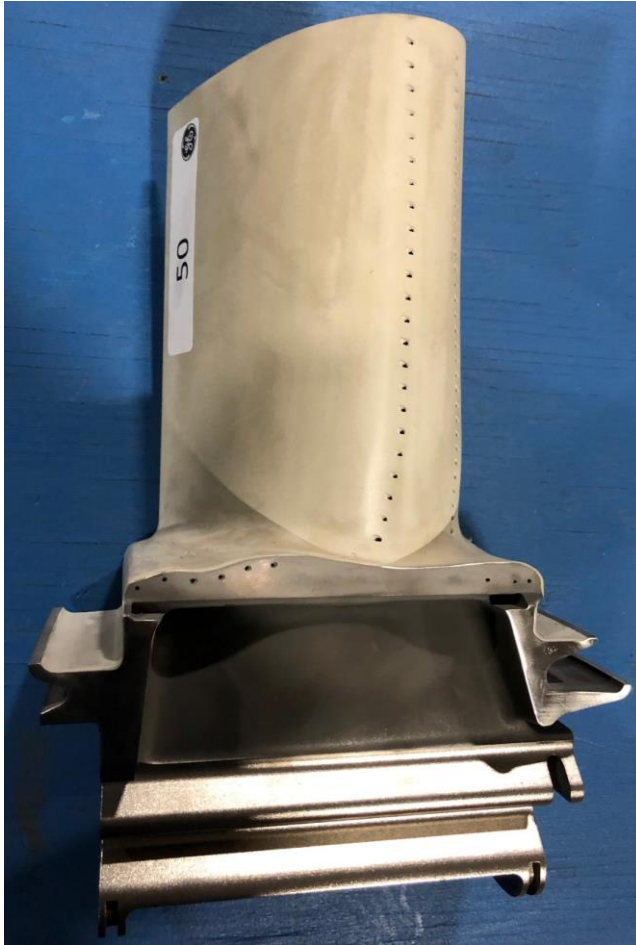
# Recommended Areas of PCRT Testing for IGT

- Blade types of Advanced F class and above
- Blades undergoing novel repairs
- Blades undergoing extensive/heavy repairs
- Blades undergoing rejuvenation heat treatments
- Blade groups of mixed or unknown prior service histories
- Qualification of new repair service vendor or otherwise inexperienced with the specific component repair

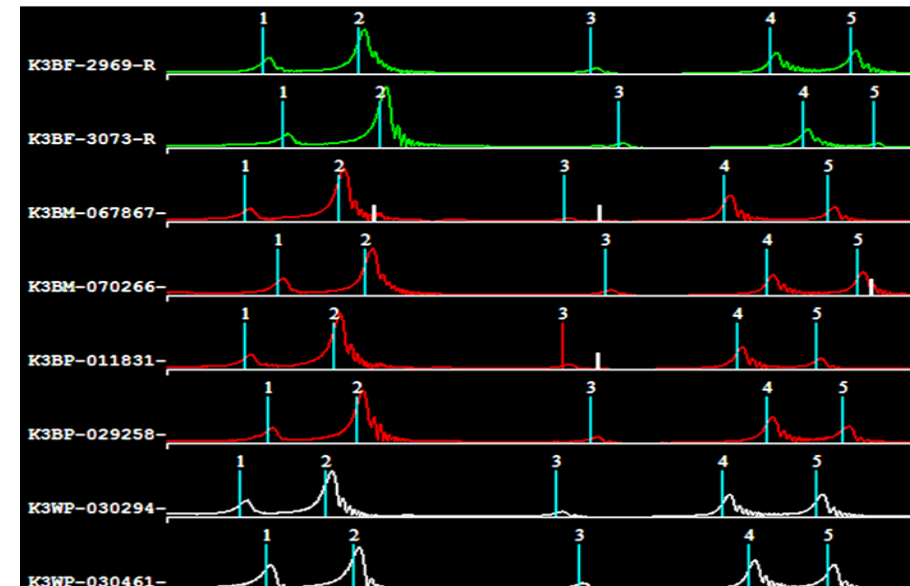
Example Spectra Stack

- Collect resonance spectrum for each part
- Group by part type
  - Identify consistent resonance modes
  - Store N frequencies (f) for each part

- Use stored frequencies in statistical analyses
  - Disk characterization
  - Population characterization
- Collect future part spectra for comparison
  - Part-to-Itself (PTI) analysis to characterize a process such as repair

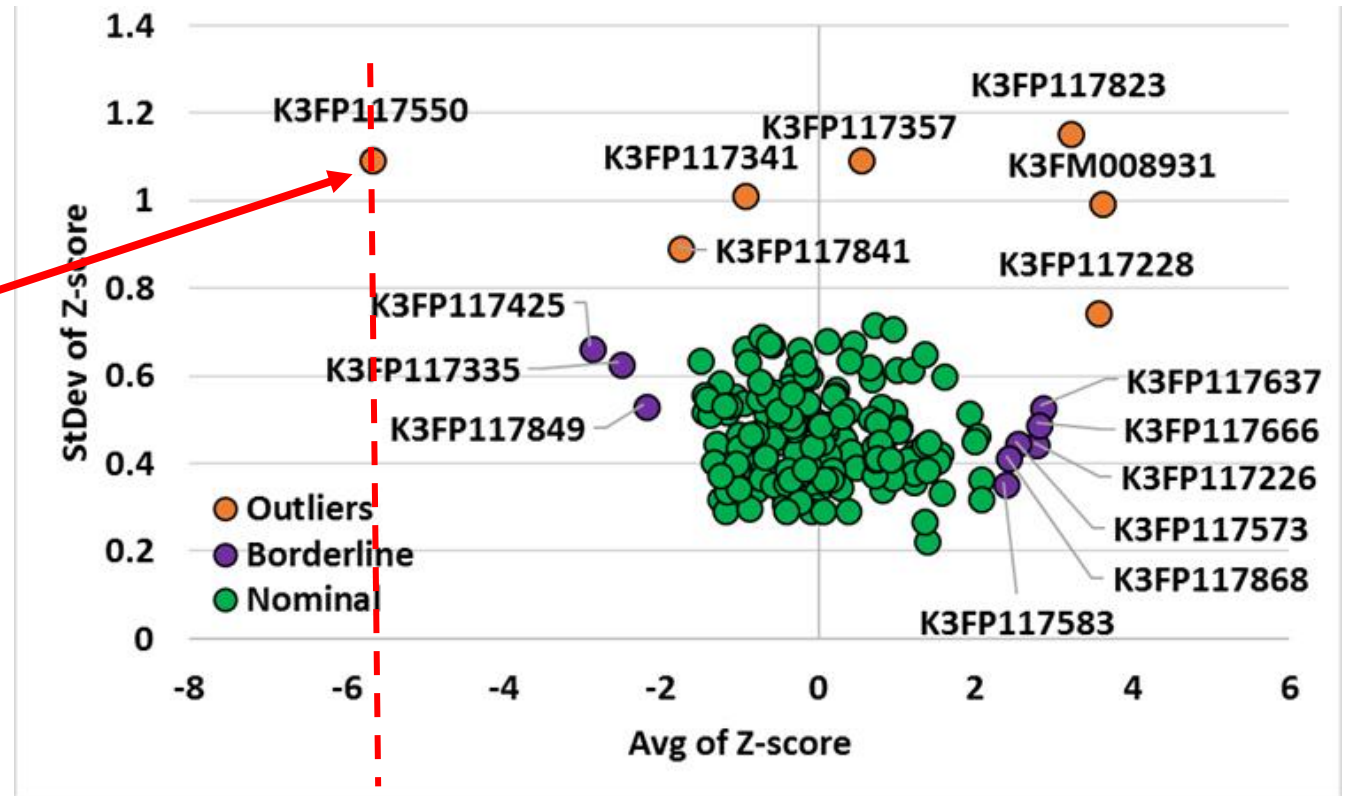
# Example: Analysis of New 3<sup>rd</sup> Stage 7FA.04 Blades

- 184 total blades examined
- 168 nominal parts
  - Cluster exhibits moderate spread → multiple clusters with overlap.
- 7 obvious outliers
  - Part K3FP117550 is a drastic outlier and exhibits a Z-score difference larger than the vast majority of outliers.
- 9 borderline parts

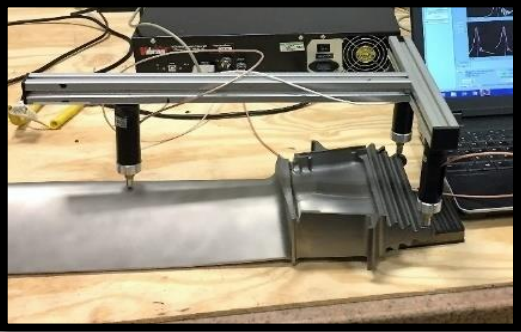
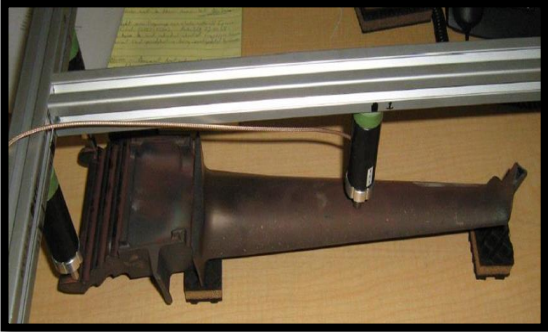
New Blades – Use PCRT to identify outliers

Service-run Blades – Use PCRT to identify candidates to repair or replace

Repaired Blades – Use PCRT to monitor repair process

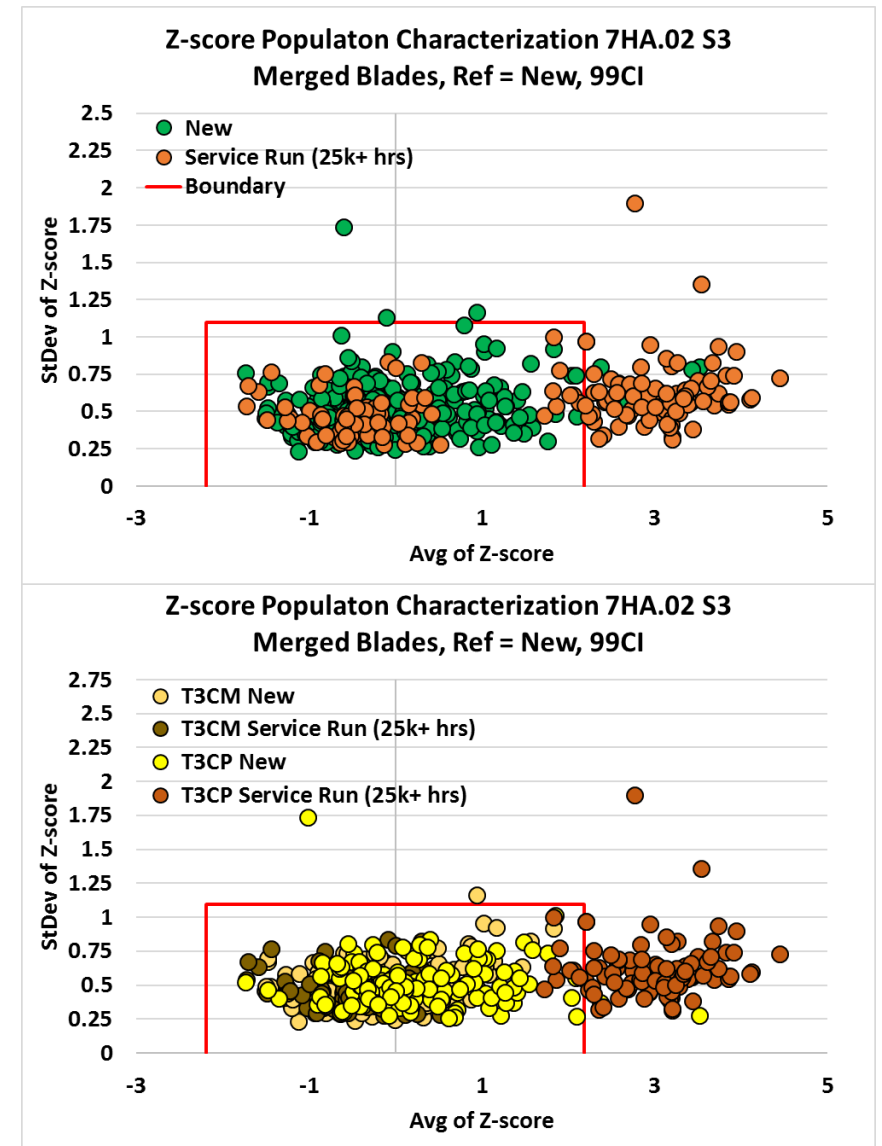
# Analysis of 7HA.02 Stage 3 Population – Merged

- Parts examined
  - Current Parts
    - 2 disk sets, 160 blades total
    - Service Run condition
  - Previous Parts
    - 4 disk sets, 320 blades total
    - New Condition

- Population characterization
  - New blades are the reference set
  - Service Run blades in casting lot T3CP drift significantly higher in Average Z
  - Casting lot T3CM does not significantly change

- Interpretation
  - T3CP and T3CM casting lots come from different suppliers
  - Casting lot T3CP shows a larger aging effect than casting lot T3CM
    - Consistent with T1CP and T2CP casting lots
      - Continues trend with ‘CP’ supplier
  - Casting lot T3CM shows minimal change
  - It is possible that the materials from the separate suppliers react differently to operational loading

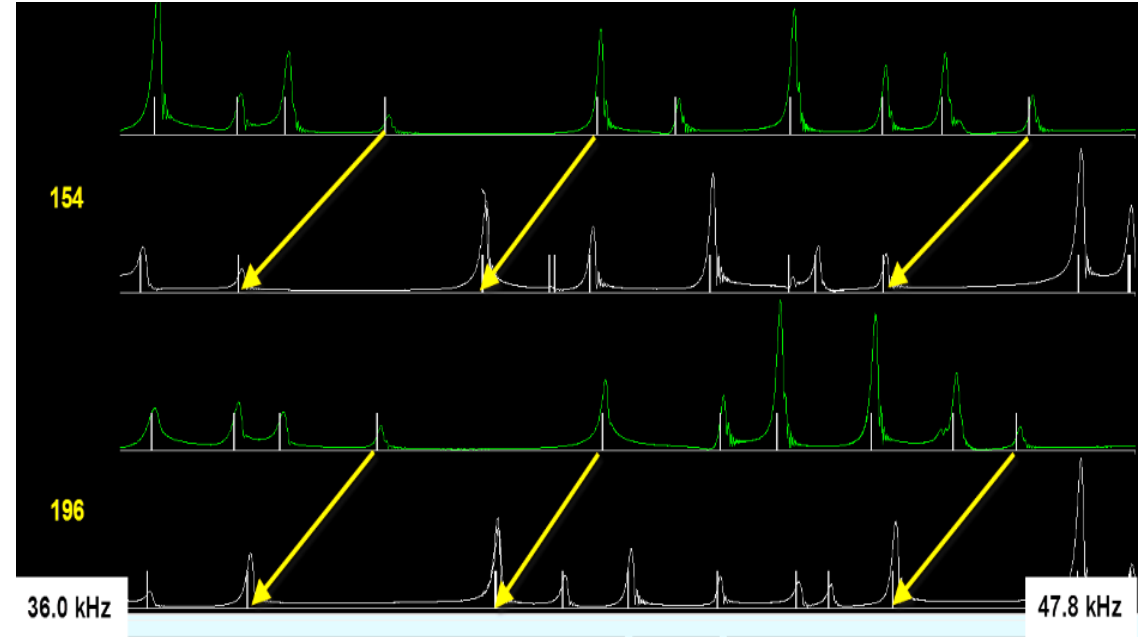
# PTI = Part-to-Itself

- Measure a part before and after an event
  - Service Cycle
  - Repair
  - Critical Processing Operation
    - HT
    - Coating
    - Hardening
    - HIP
    - Rejuvenation
- Evaluate the change
- Compare to expectations

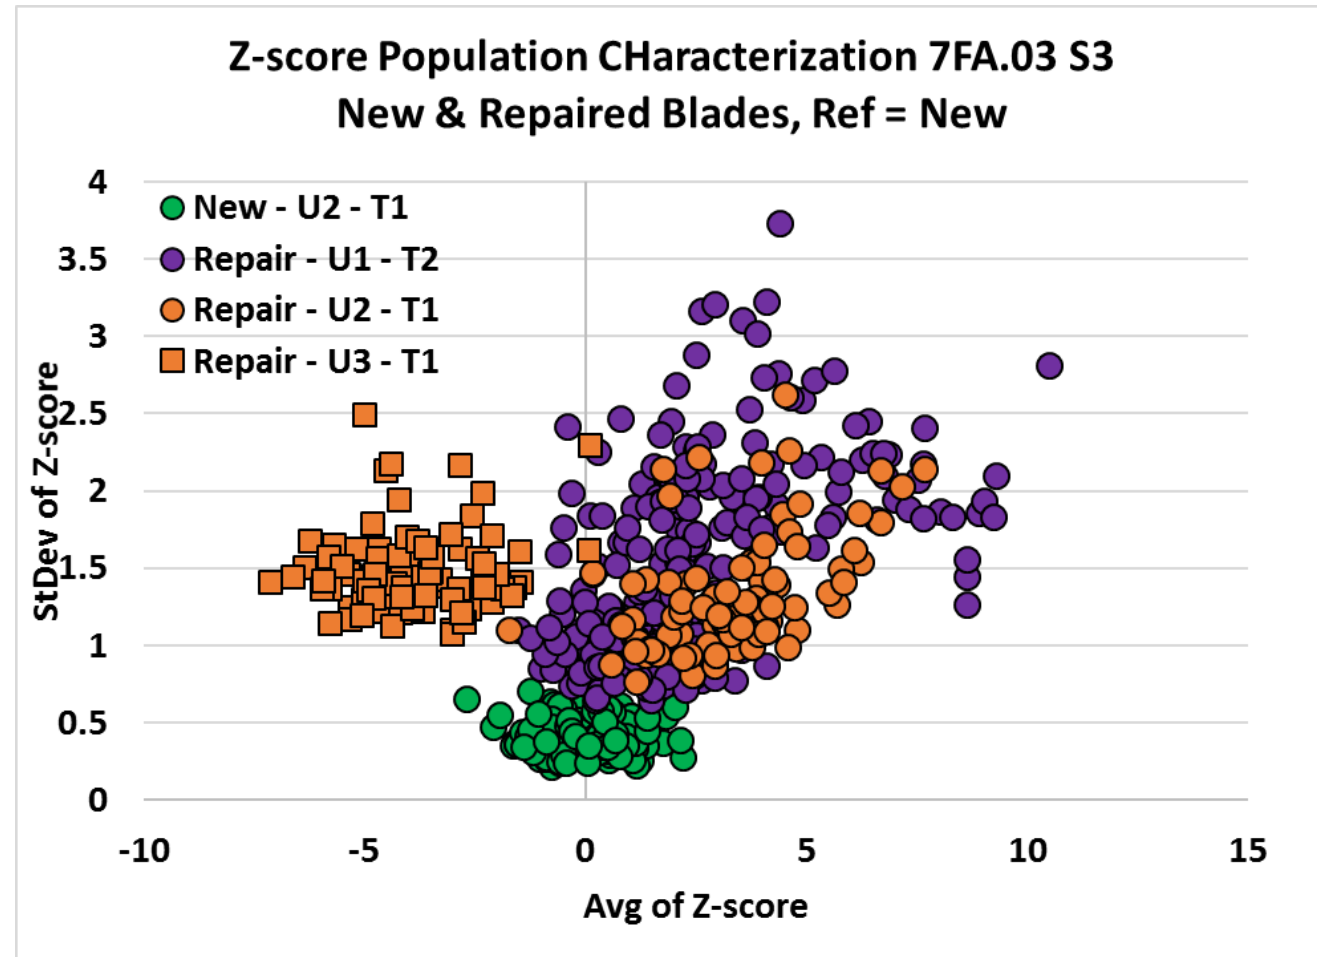
# 7FA Changes in OEM Rejuvenation Heat Treatment

- OEM changed rejuvenation heat treatments on S3B
- Member had experienced several S3B failures and needed to validated the rejuvenation
- PCRT validated the microstructural changed in effective stiffness with new HT process

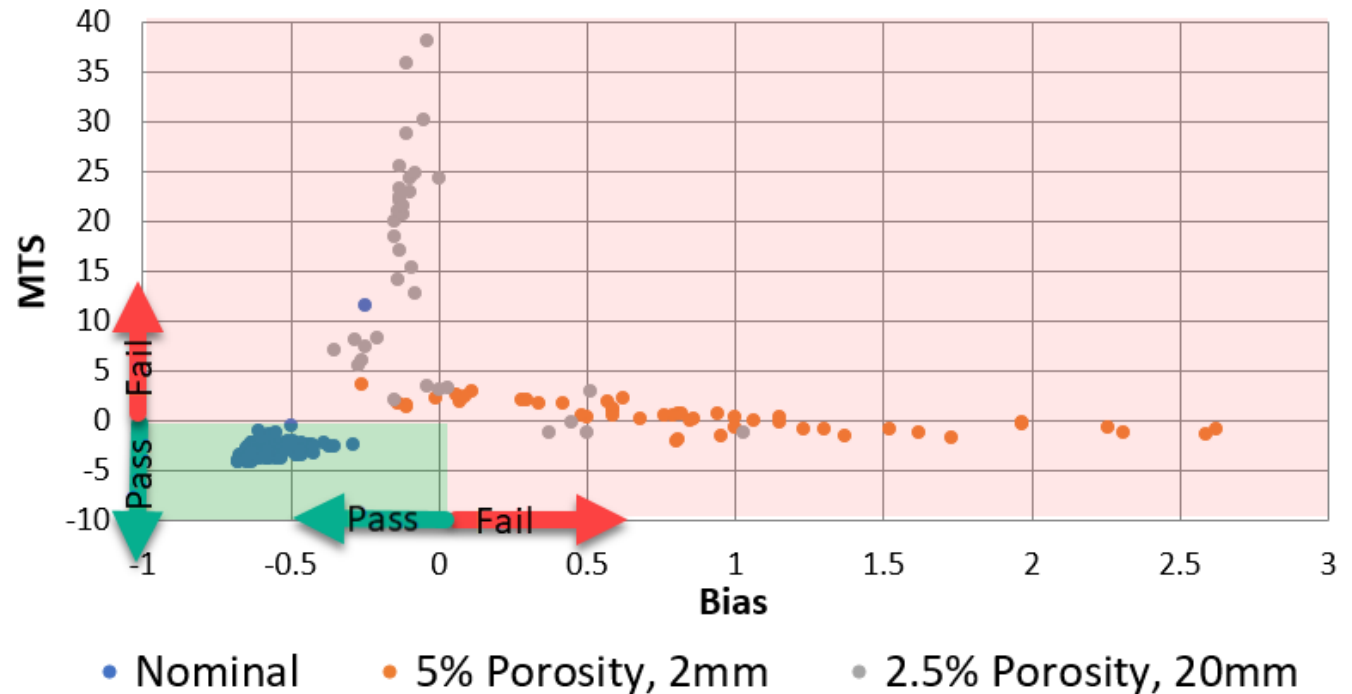
**AM Built Turbine Blades with Tip Porosity  
VIPR Plot**

- 5 Builds
- Builds 1-4 had 5% porosity in the top 2mm of the blade tip
- Build 5 was a 'gross' example with 2.5% porosity for the top 20mm of the blade tip

**Using VIPR, the nominal and parts with porosity were 98% successfully separated**

- 1 'Nominal' part failed
  - Part was a 'corner' part on the build, may not have been robust

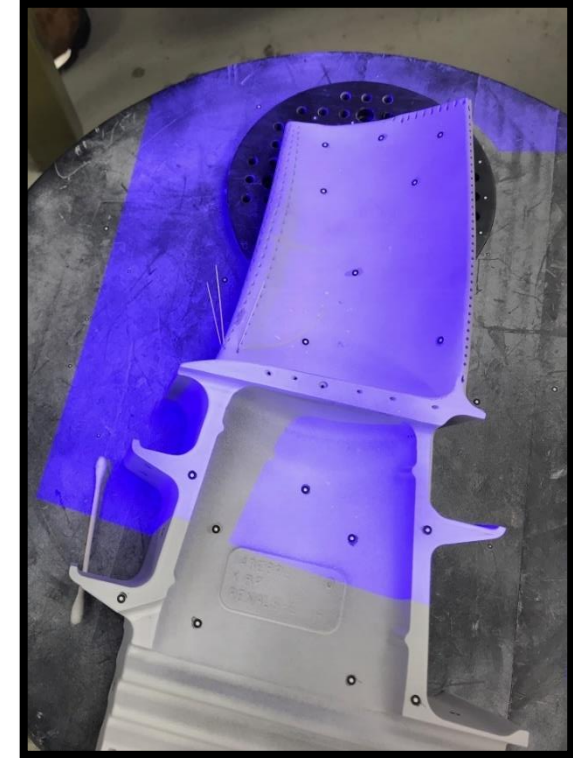
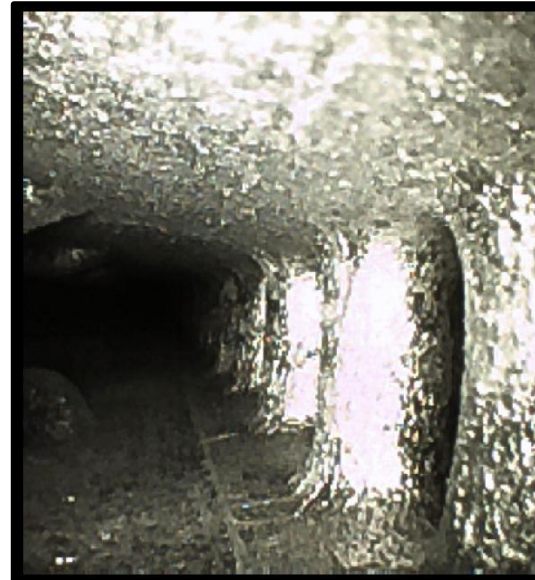
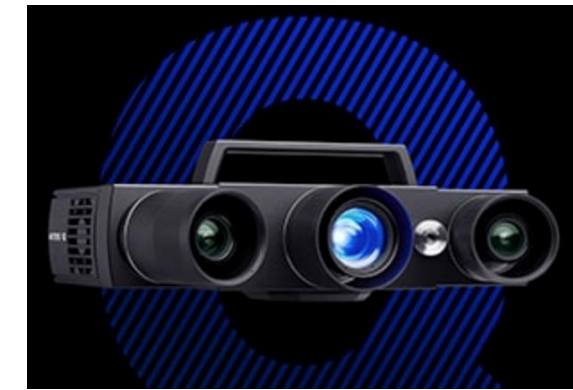
- Dimensional:
  - Laser scanning
  - Blue light scanning (new)
- Visual/Surface
  - Borescopes
  - Dye Penetrant
  - Eddy current & advanced electromagnetics
- Volumetric
  - Ultrasonics technologies
  - Process Compensated Resonance Testing (PCRT)
  - Microwave
- Dedicated laboratory space for NDE and configurable space for specific jobs

**Most tools are field deployable**
