# **LASER POWDER BED FUSION (LPBF) MACHINE EVALUATION INITIATIVE**

ETN Global Report

January 2025

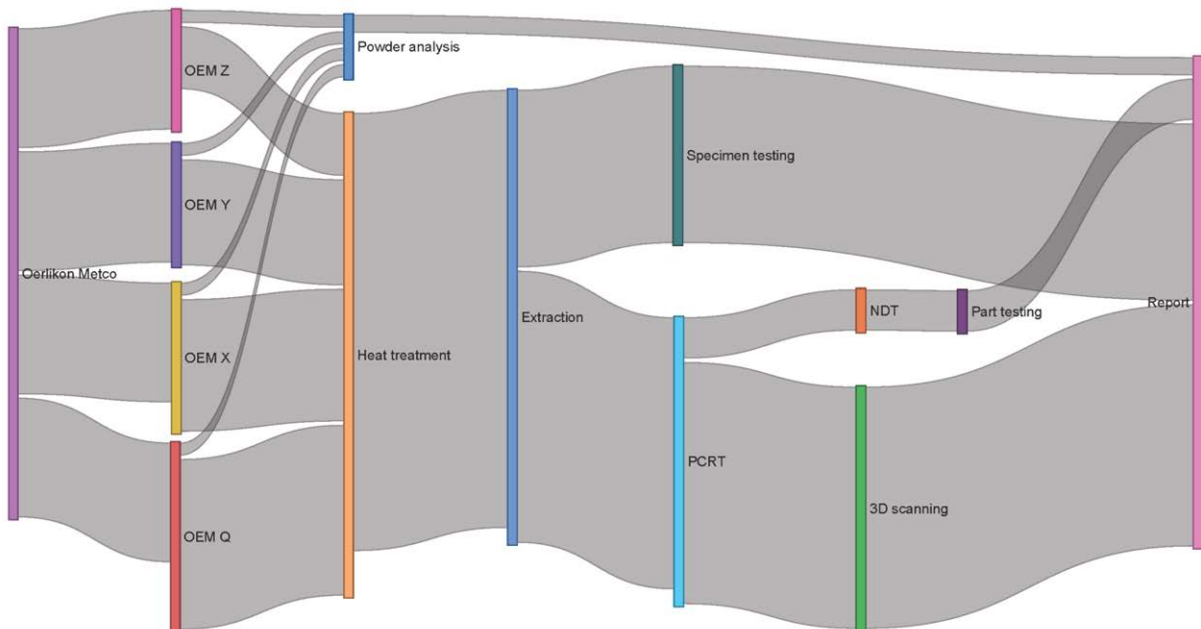
The sequence of activities is illustrated by the chart in *Figure 2*. The following activities were carried out:

Figure 2: Chart showing the flow of parts and samples during the project execution.

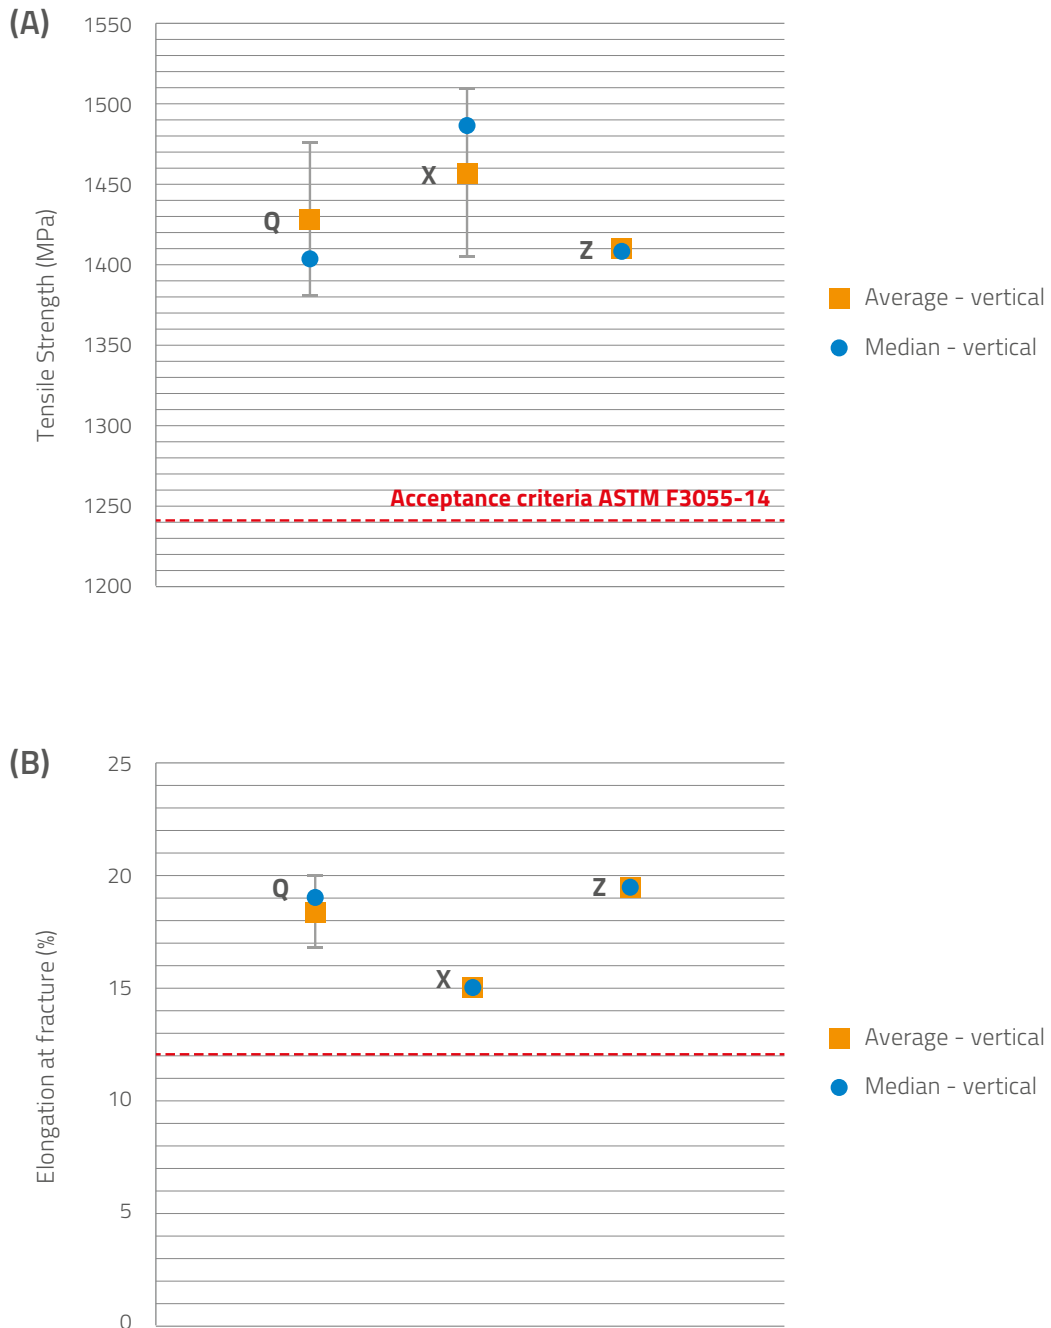
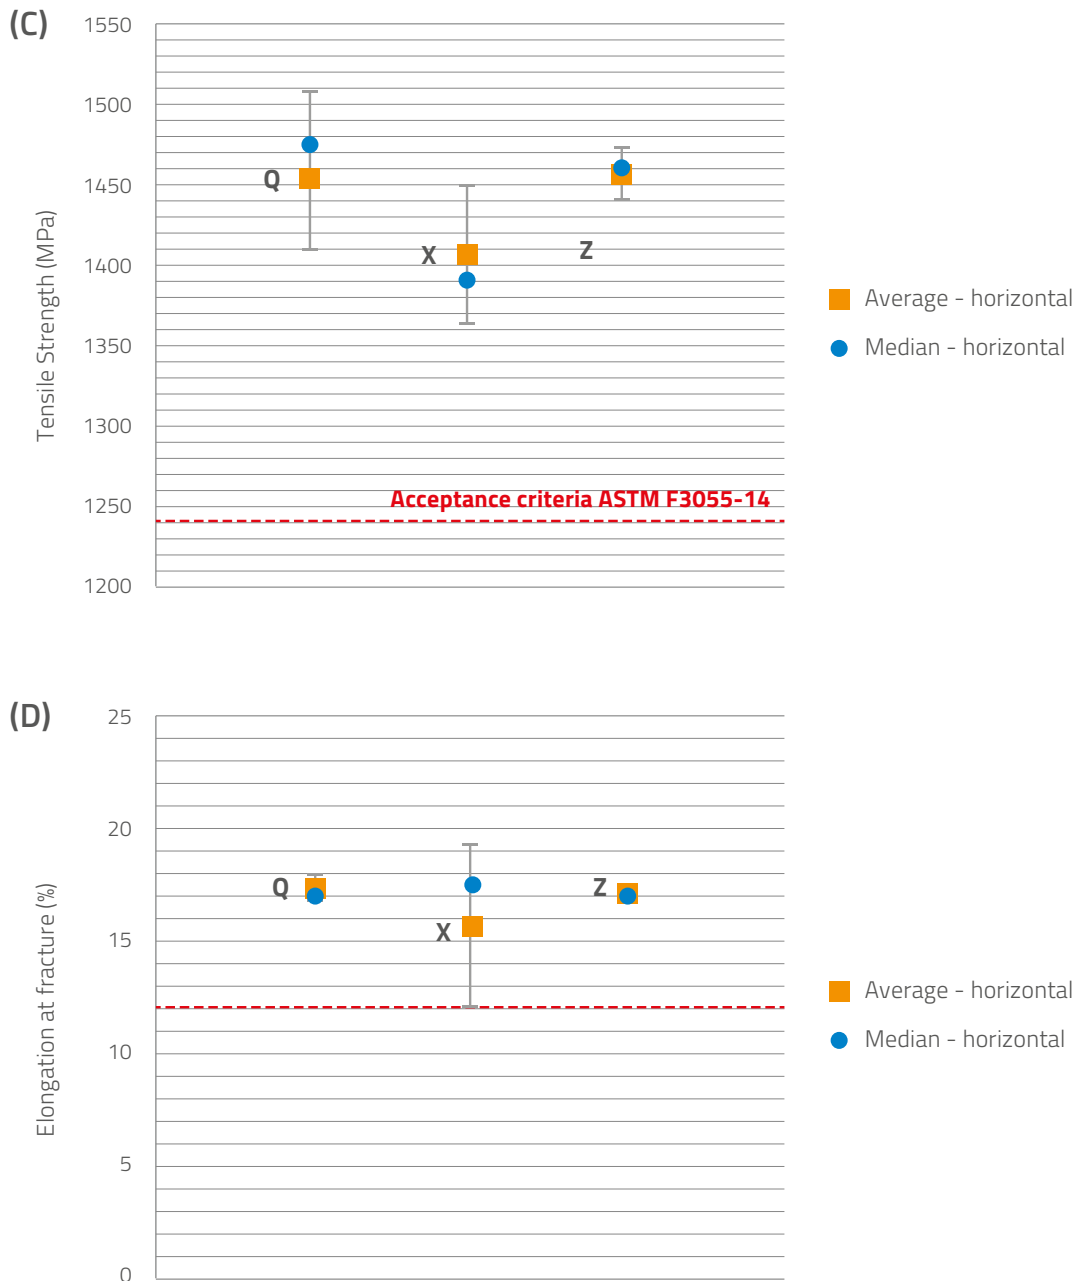
The tensile sample set consists of the 3 horizontal and 3 vertical printed tensile specimens tested at room temperature. The testing was performed in accordance with the test standard: ISO 6892. *Figure 4* below shows the tensile test results in the vertical (4a, 4b) and horizontal (4c, 4d) direction for each of the OEMs.

Figure 4: (A) shows the results of the average tensile strength values and the deviation of results for the OEMs for vertical (z-direction specimens); (B) shows the results of the average fracture strain values and the deviation of results for the OEMs for vertical (z-direction specimens); (C) shows the results of the average tensile strength values and the deviation of results for the OEMs for horizontal (x/y-direction specimens); (D) shows the results of the average fracture strain values and the deviation of results for the OEMs for horizontal (x/y-direction specimens).

The tensile strength and yield strength results exceeded the minimum requirements in all tested samples. However, one tensile test samples failed to meet the elongation criteria of min. 12%.

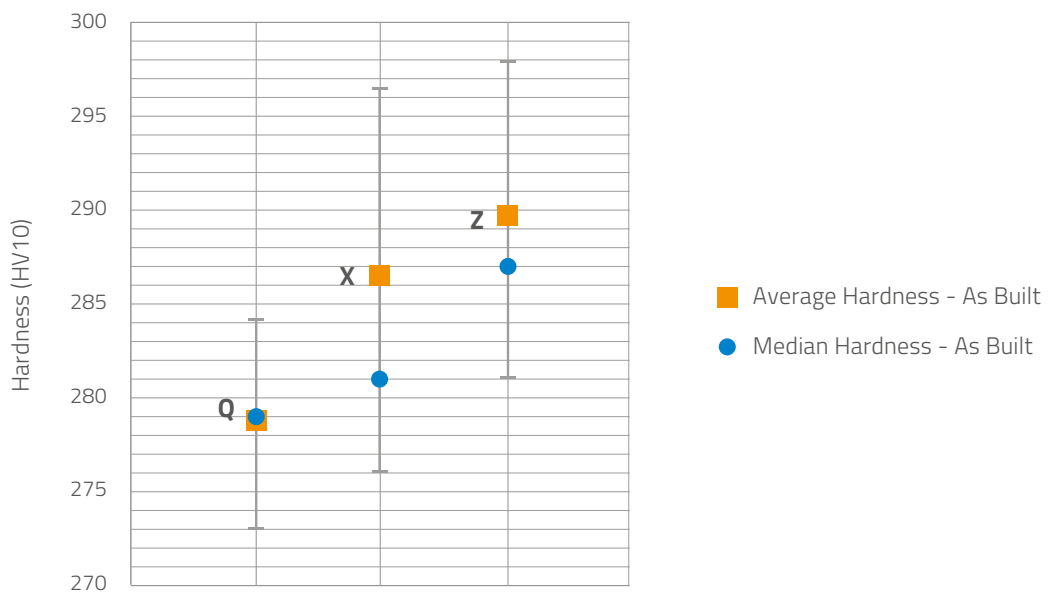
The powder container was removed from each of the OEM plates prior to the heat treatment of the plates. The wall of the powder container was tested for micro-hardness using Vickers Harness with 1 kg load, in order to measure the hardness in thin-walls in the as built condition. Further hardness indentations were carried out on the wall of the powder container after heat-treatment as well as on material from the heat-treated density cubes. The results are presented in the graphs below. Although some trends may be deduced from the measured values, all hardness values remained broadly within 20 Hv10, which is insignificant. As expected for age hardening material, hardness increased after heat treatment.

Figure 7: A graph of the average hardness values and the deviation of results for the OEMs carried out on material that has not been heat treated (as built) from the powder capsule.

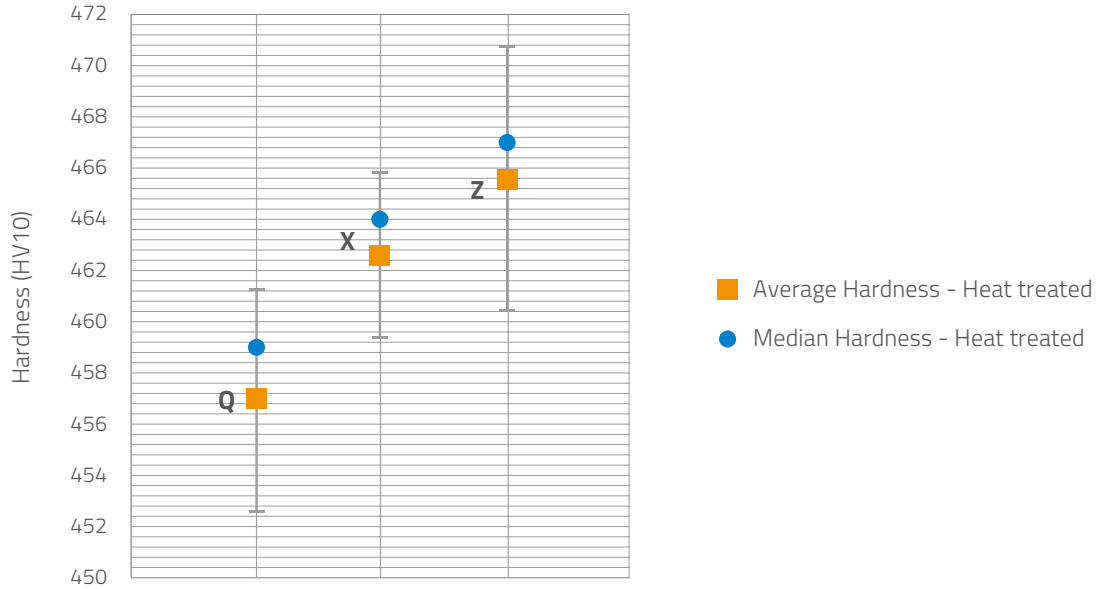
Figure 8: A graph of the average hardness values and the deviation of results for the OEMs carried out on heat-treated material from the powder capsule.

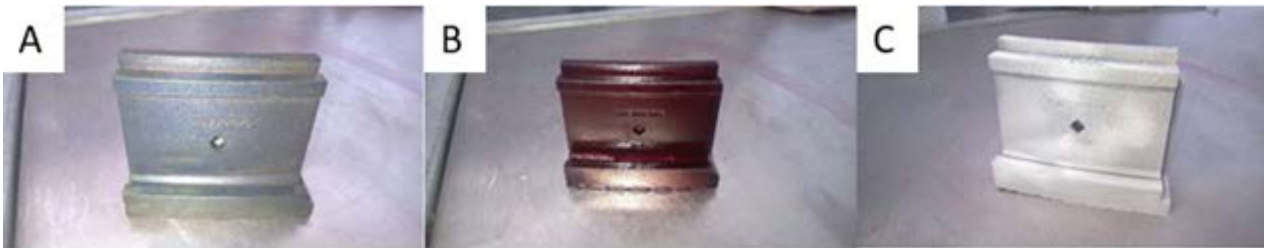
In addition to the shield that was analysed by CT two further scaled up shields and two standard sized shields were selected from each of the OEM plates to act as representative parts. PT testing was carried out using red colour contrast penetrant with a 15-minute penetration time and developer with a 12-minute development time.

Figure 13: PT test being carried out on a shield (A) shows shield before inspection (B) shows the shield with contrast penetrant (C) shows the shield with the developer.

An example of the PT test being carried out on a shield can be seen below in *Figure 13*. All inspected walls passed PT inspection, with no relevant indications reported. An example of the shield after the development time was completed can be seen in *Figure 14*.

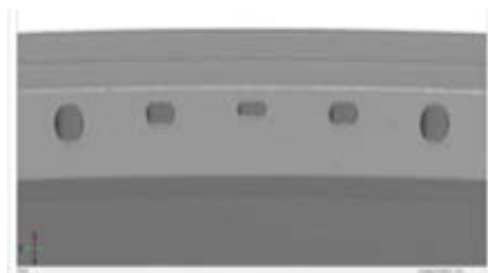
The channel at the edge of the shield (*Figure 19*) was sectioned for macro-analysis (see *Figure 20*). Each section displays fine spherical porosity on the order of 1-10 µm distributed throughout the section. Irregular shaped pores up to 100 µm in length containing un-melted particles were identified ~100 µm below the surface. The presence of un-melted powder correlates with defects noted in the CT analysis.

Figure 19: Diagram showing the location of the cross-section sample.
