## INTEGRATED APPROACH TO GAS TURBINE ROTOR CONDITION ASSESSMENT AND LIFE MANAGEMENT

**John Scheibel/Electric Power Research Institute**  
3420 Hillview Avenue; Palo Alto, California, USA  
650.855.2446  
Jscheibel@epri.com

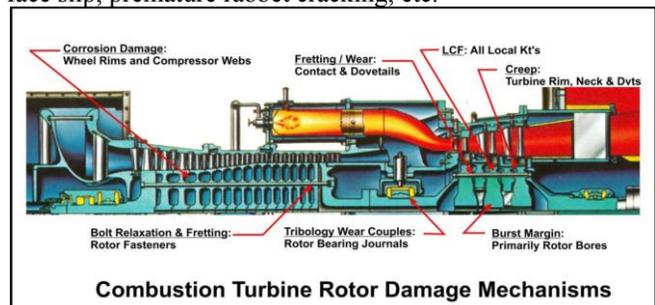
**Figure 2. Some of the common damage mechanisms in GT rotors**

A generalized map of some of the more common damage mechanisms in gas turbine components are shown in Figure 2. Depending on the location and the service conditions, rotor and disc crack initiation and propagation mechanisms may vary. On the compressor discs, corrosion pitting, stress corrosion cracking, low-cycle fatigue (LCF) crack initiation and growth, high-cycle fatigue (HCF) cracking of the blade attachments may limit the useable life. On the hot section turbine side the damage mechanisms are creep crack initiation and growth, low-cycle fatigue and thermal-fatigue (TMF) damage, embrittlement, etc. Other damage mechanisms include rim dovetail cracking due to excessive staking, flange cracking due to both HCF and LCF, vibration due to rabbet / bolt face slip, premature rabbet cracking, etc.

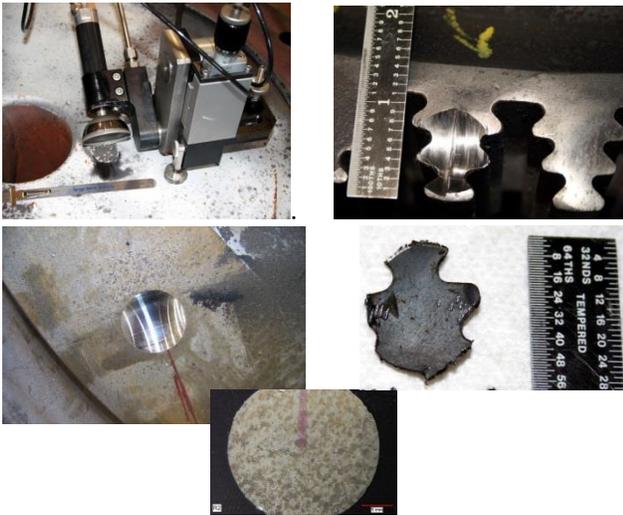
**Figure 8. Miniature surface scoop sampling from MS5001 turbine discs for material condition and property assessment**

An example of miniature sample removal from a MS 5001 disc is shown in Figure 8.

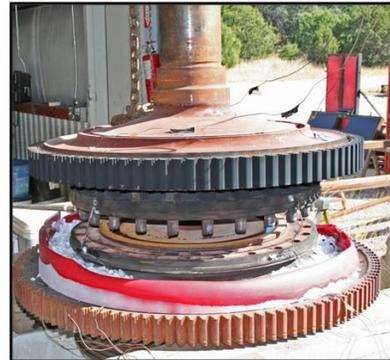
**Figure 11. Disassembly of MS 5001 rotor using heating/cooling to disengage shrunk on rabbet fits**

The rotor was removed from the power plant and shipped to a facility in Texas. Rotor disassembly procedures were prepared and the rotor disassembly performed as shown by Figure 11. Standard methods of thermal disengagement were applied with field tooling used to facilitate the rotor disassembly.

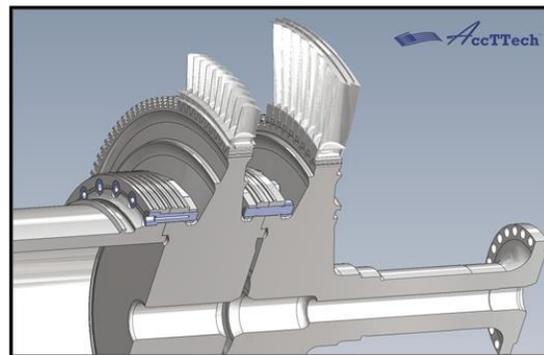
Figure 15. 3-D CAD model of the MS-5001 rotor showing the distance piece, Stage 1 and Stage 2 disc assembly

The dimensional characterization is an important part of the life assessment process. This step provides the geometric definition for the analysis, as well as describing abnormal wear, corrosion or other dimensional defects of the rotor components. Dimensional characterization was performed by AccTtech using laser scanning coordinate measurement machines (CMM) and other techniques. These results are used to produce a detailed 3-D CAD model of the turbine, shown by Figure 15.
