HOT SECTION LIFE MANAGEMENT THROUGH IMPROVED MATERIAL PROPERTY RECOVERY

John Scheibel/ Electric Power Research Institute, **Rajeev Aluru**/ Duke Energy,
Hans van Esch, Stijn Pietersen/ Turbine End User Services

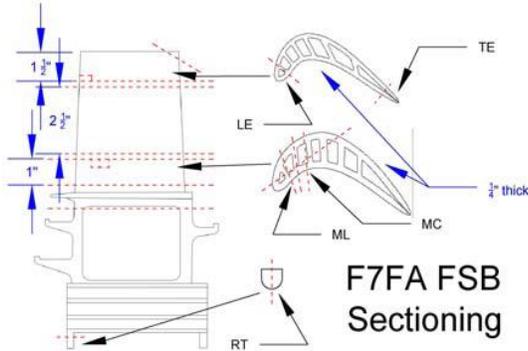
Figure 1: Sectioning plan used for the study

The sectioning plan for microstructural investigations included five sections taken across the length of the blade as shown in Figure 1.

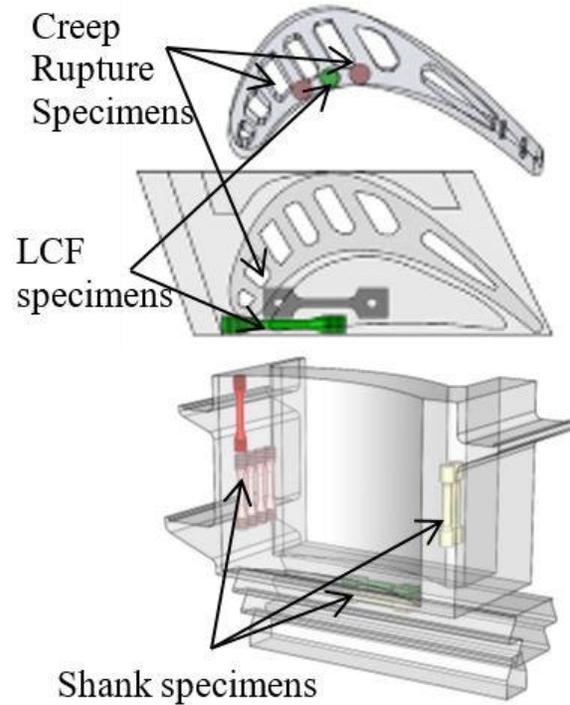
Figure 2: Mechanical testing specimen plan used for the study

testing at 1650°F, 0.7% strain range. The specimens for mechanical testing are detailed in Figure 2. The stress rupture tests included two cylindrical stress rupture specimens from airfoil in the longitudinal direction, and one flat specimen from platform in the transverse direction, and the LCF tests included one cylindrical specimen from the airfoil in the longitudinal direction and another cylindrical specimen from the platform in the transverse direction. The locations of the specimens were obtained from the finite element models generated as a result of the studies published elsewhere [1].

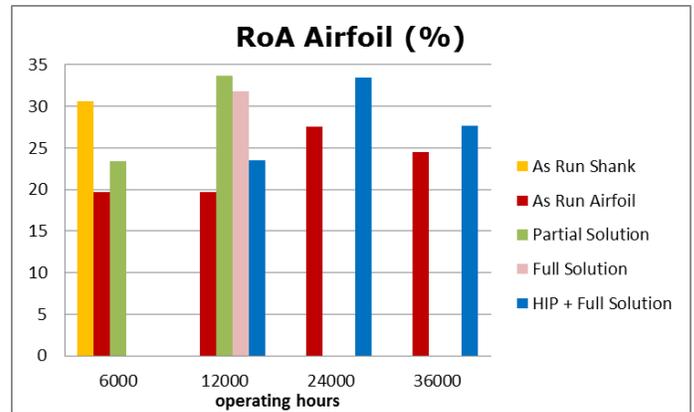
Figure 9
Average values of stress rupture RoA airfoil specimen

The elongation and RoA (Reduction of Area) of the stress rupture samples are taken as a measurement of the ductility. All ductilities were between 16.8% and 24.6% and thus no significant differences for all the different operating conditions and heat treatments were observed. See Figure 10 for the elongation and Figure 11 for the RoA. An exception is the elongation for the 12000 hours specimen with the partial solution heat treatment which averaged 32% while HIP + full solution average 19%. This can be due to the heat treatment performed or just an outlier due to the low number of tests performed.

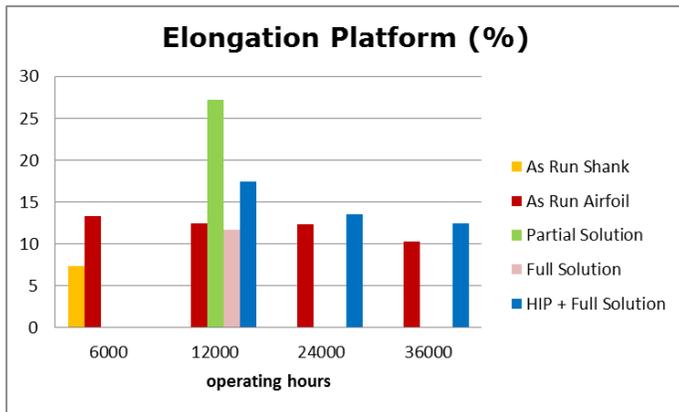
Figure 11
Average values of elongation of stress rupture tests platform specimens

The specimens for the as run condition after 6000 hours from the root have a lower ductility than those of the airfoil in the as run condition. Note: The grain size structure is equiaxed with large grains.
